Accessibility Survey

Public Works Utility Yard

9252 Stewart and Gray Road
Downey, CA 90240

Date of Inspection
1/17/2017

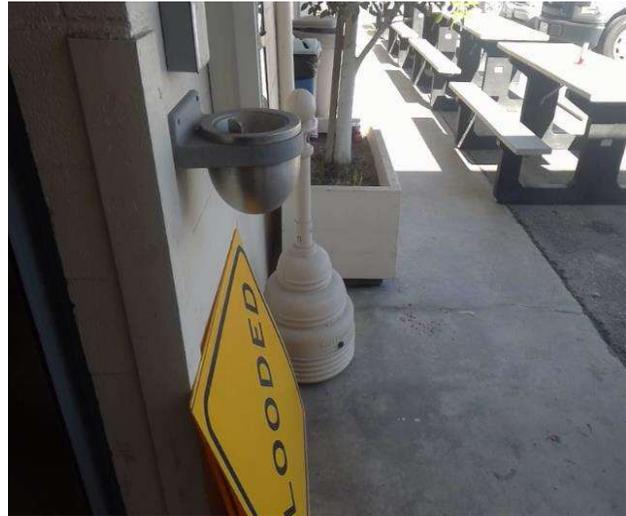
Ash Tray

The leading edge of the wall-mounted item is more than 4 inches from the wall. The item is greater than 27 inches, and less than 80 inches from the floor and protrudes into the primary path of travel.

On-Site Finding 9.62 inches

Code Reference ADA 307, 307.2, CA 11B-307.2

Install side extensions, modify, relocate, or lower the item so that the leading edge protrudes less than 4 inches from the wall, is less than 27 inches from the floor, or more than 80 inches from the floor.

Recommendation Up to 4.00 inches

Install wing walls or relocate object \$1,280

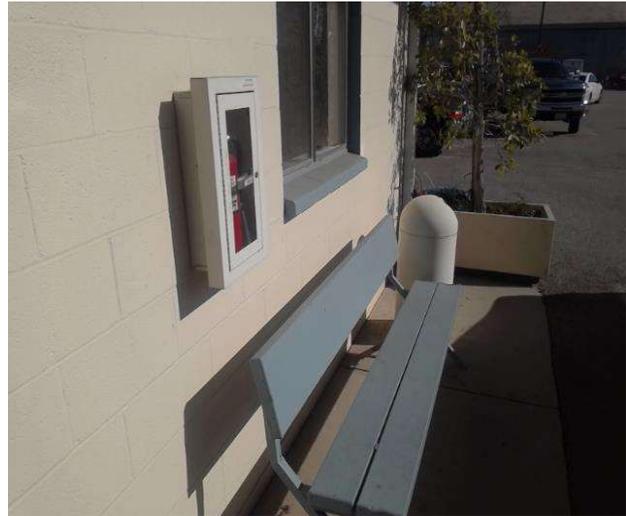
Code Reference ADA 307, 307.2, CA 11B-307.2

Recommendation Up to 4.00 inches

Install wing walls or relocate object \$1,920

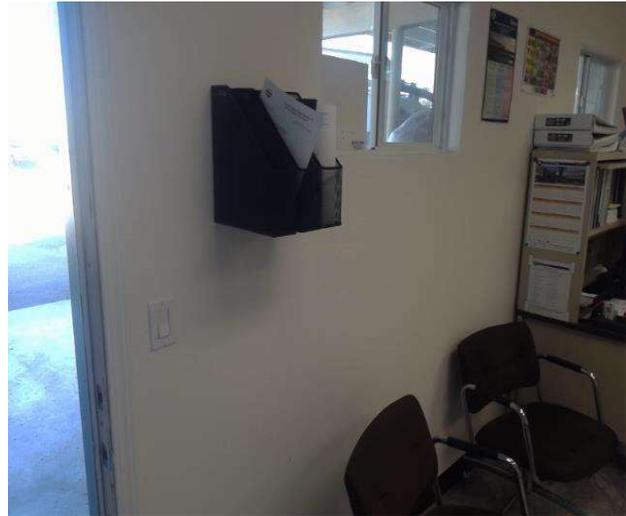
Code Reference ADA 307, 307.2, CA 11B-307.2

Recommendation Up to 4.00 inches

Install wing walls or relocate object \$640

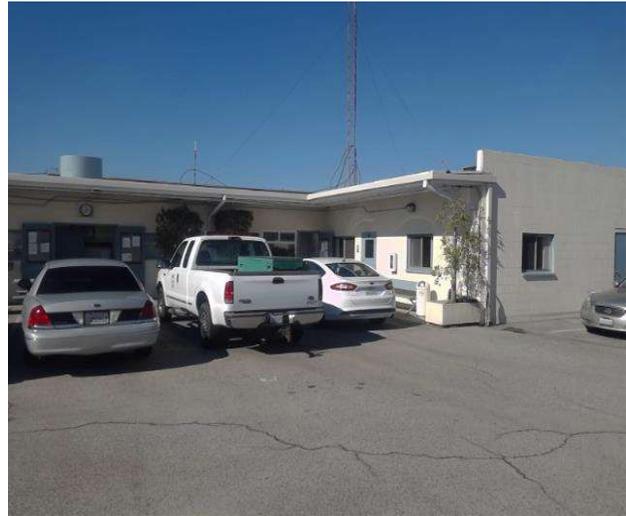
On-Site Finding None Found

Code Reference CA 11B-502.8

Install post mounted sign \$250

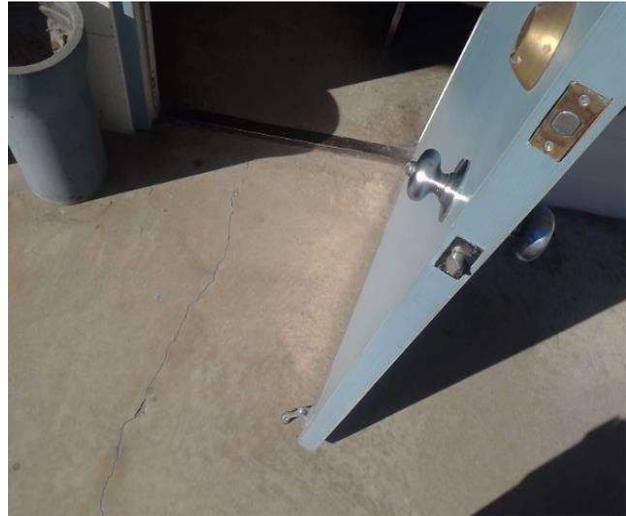
On-Site Finding Found

Code Reference ADA 404, 404.2.10, CA 11B-404.2.10

Remove door stop \$50

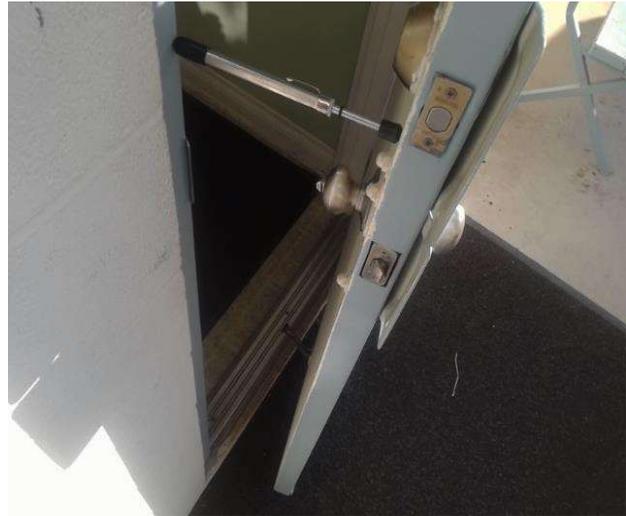
Code Reference ADA 404.2.9,CA 11B-404.2.9

Recommendation Up to 5.00 pounds

Adjust door closer pressure \$25

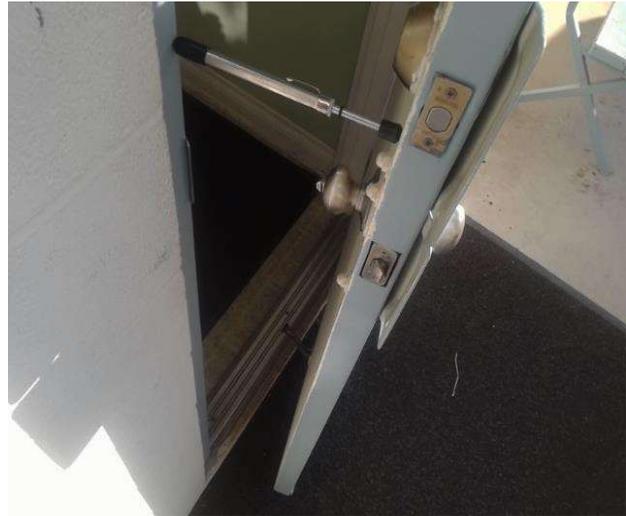
On-Site Finding Found

Code Reference ADA 404, 404.2.10,CA 11B-404.2.10

Remove door stop \$50

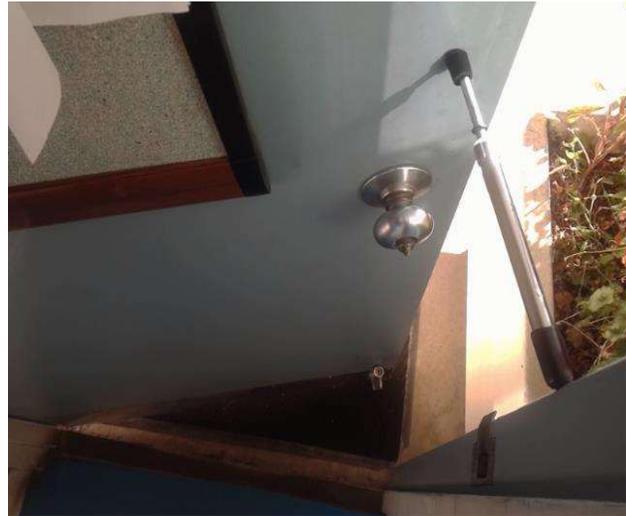
Code Reference ADA 404.2.9,CA 11B-404.2.9

Recommendation Up to 5.00 pounds

Adjust door closer pressure \$25

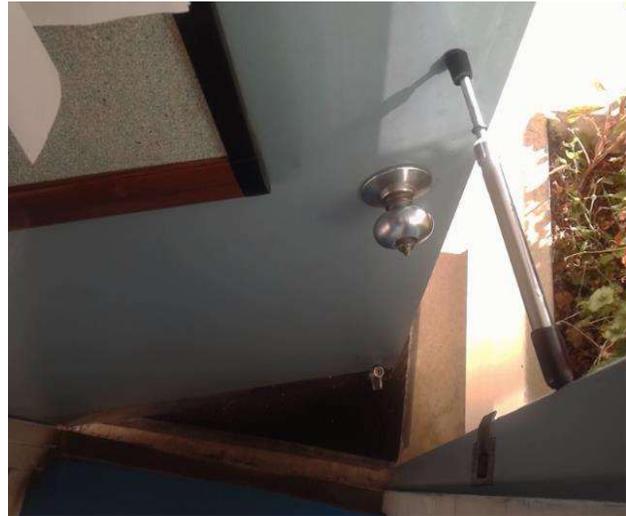
On-Site Finding Found

Code Reference ADA 404, 404.2.10,CA 11B-404.2.10

Remove door stop \$50

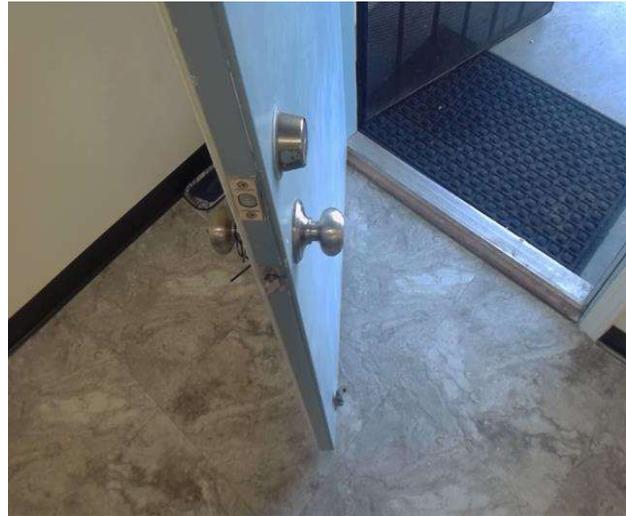
On-Site Finding Found

Code Reference ADA 404, 404.2.10,CA 11B-404.2.10

Remove door stop \$50

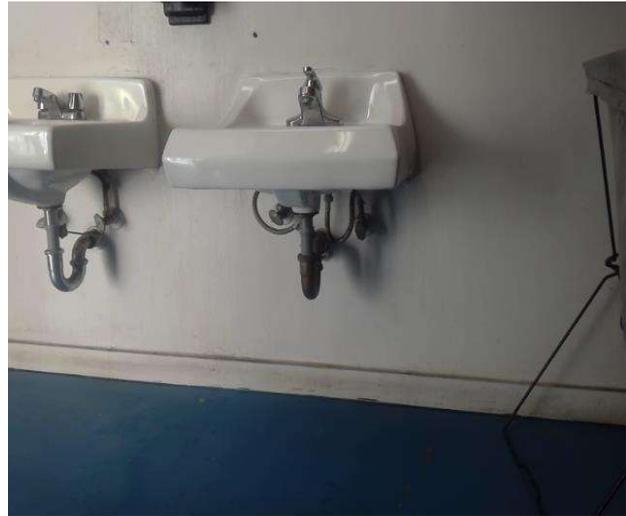
Code Reference ADA 213, 606, 606.5, CA 11B-606.5

Wrap pipes \$149

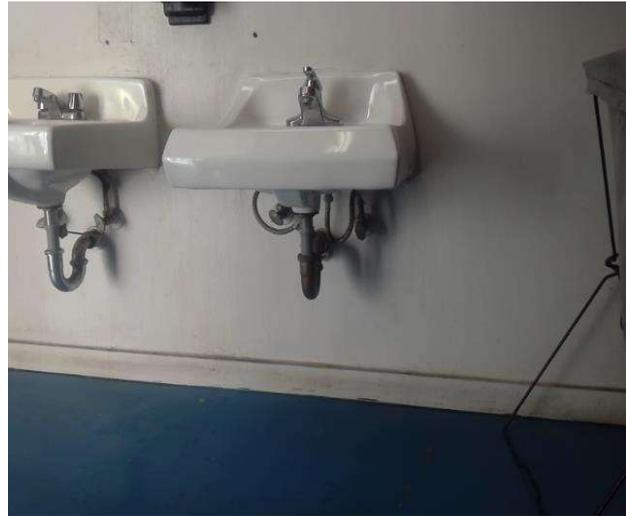
Code Reference ADA 213, 606, 606.5, CA 11B-606.5

Wrap supply lines \$149

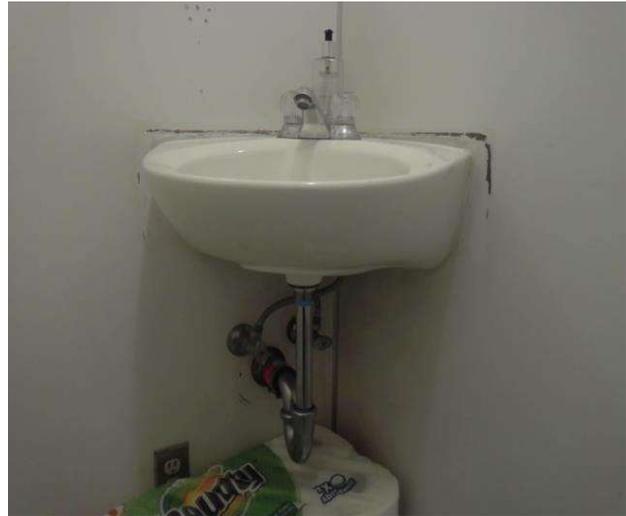
Code Reference ADA 213, 606, 606.5, CA 11B-606.5

Wrap pipes \$149

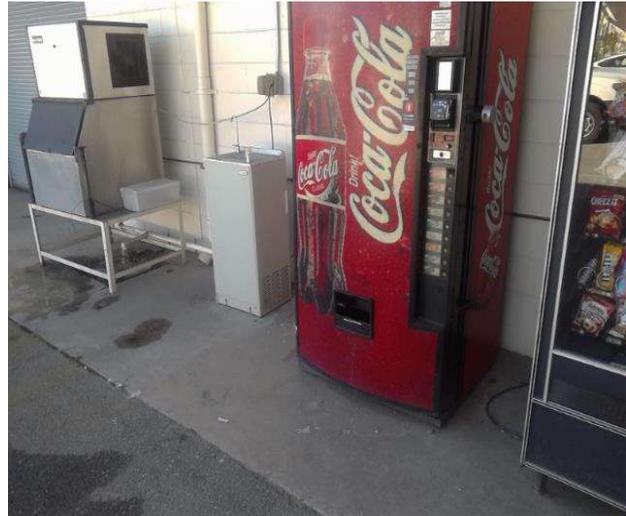
Code Reference ADA 309, 308

Recommendation Up to 48.00 inches

Review options for relocating Unassigned

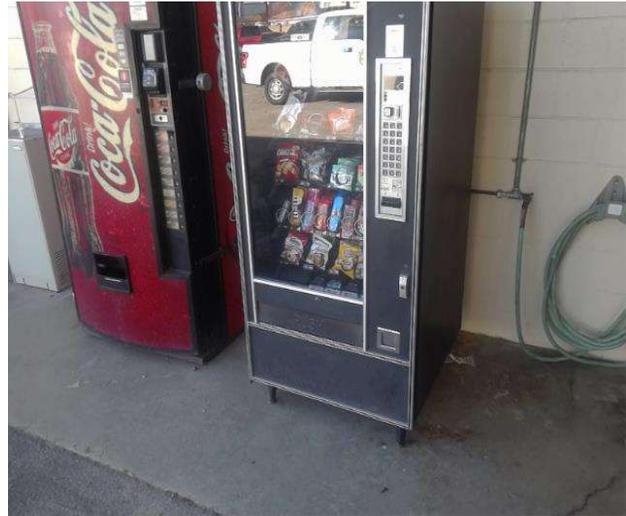
Code Reference ADA 309, 308

Recommendation Up to 48.00 inches

Review options for relocating Unassigned

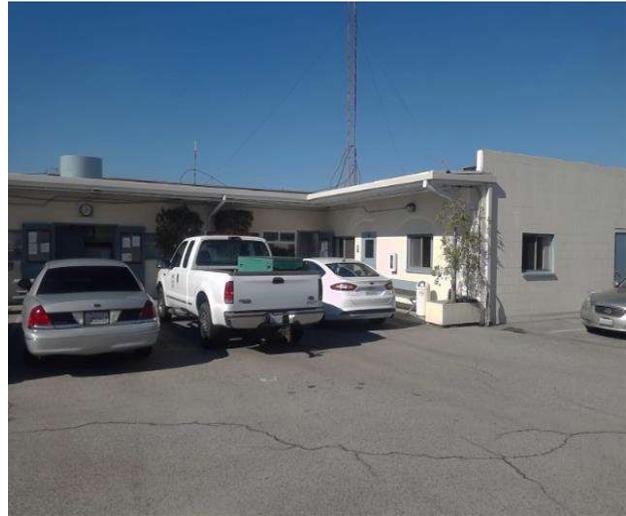
On-Site Finding None Found

Code Reference ADA 208, 208.2,CA 11B-208.2,CA 11B-502

Paint ground markings and install a post mounted sign \$370

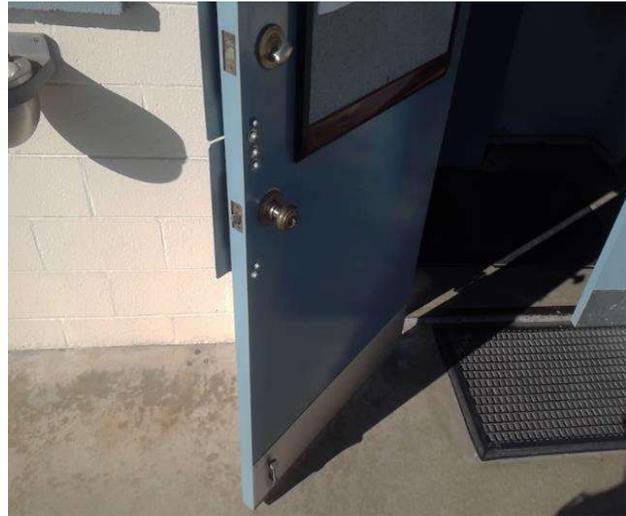
Code Reference ADA 404, 404.2.7,CA 11B-404.2.7

Mount the door hardware at the recommended height.

Recommendation 34.00 - 44.00 inches

Replace door hardware \$280

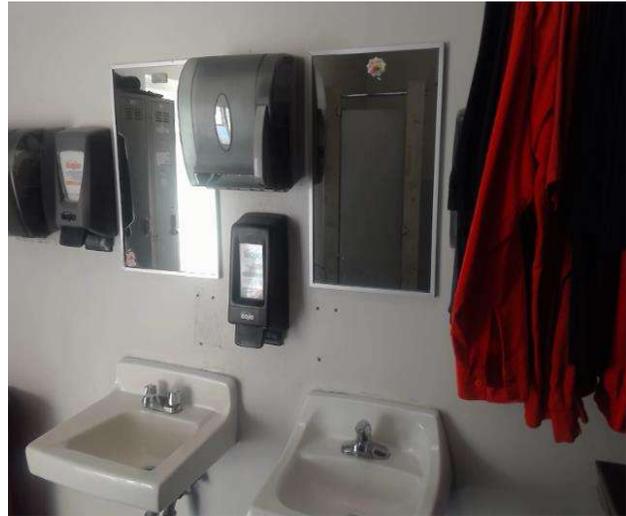
Code Reference ADA 603, 213, 603.3, CA 11B-603.3

Lower the mirror so the bottom edge of the reflective surface is no higher than recommended above the finished floor.

Recommendation Up to 40.00 inches

Lower mirror \$300

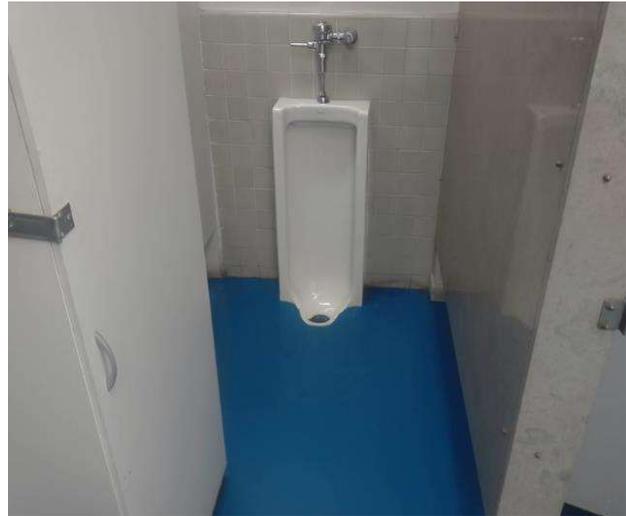
Code Reference ADA 605, 605.3, 305.7, CA 11B-605.3, CA 11B-305.7

Modify or replace the urinal shields in the restroom to provide the required clearance between the shields for the urinal designated as accessible.

Recommendation At least 36.00 inches

Modify urinal \$1,800

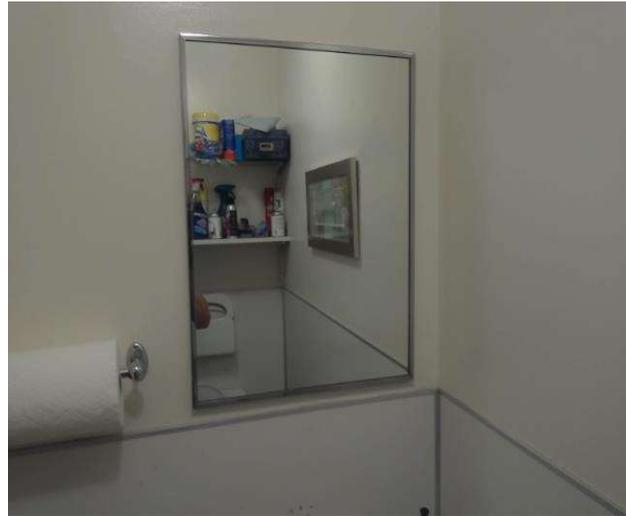
Code Reference ADA 603, 213, 603.3, CA 11B-603.3

Lower the mirror so the bottom edge of the reflective surface is no higher than recommended above the finished floor.

Recommendation Up to 40.00 inches

Lower mirror \$300

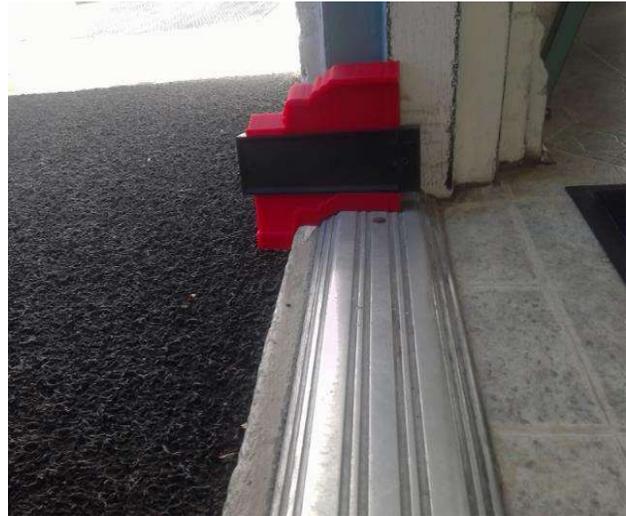
Code Reference ADA 404, 404.2.5, CA 11B-404.2.5

Modify or replace the threshold to provide the recommended height.

Recommendation Up to 0.50 inches

Provide smooth transition \$436

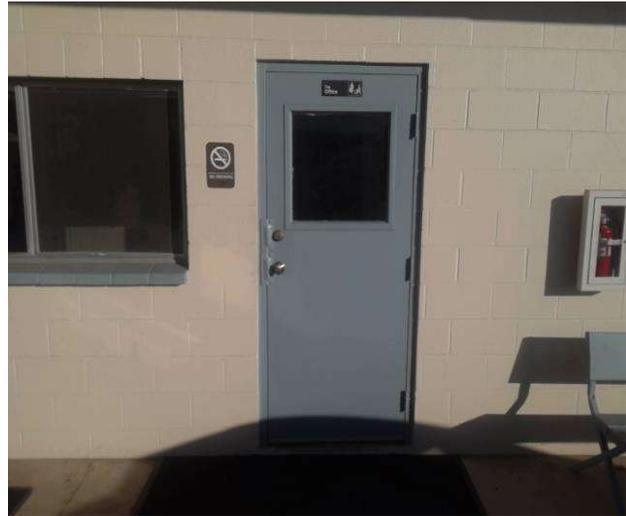
Code Reference ADA 404, 404.2.3,CA 11B-404.2.3

Replace the door closing device with a device that fits above the door casing and does not protrude into the primary path of travel.

Recommendation At least 78.00 inches

Install new door opener \$250

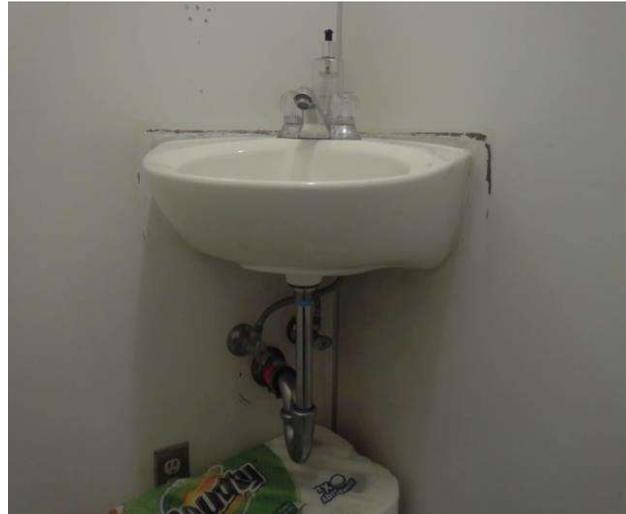
ADA 213, 606, 309.4, CA 11B-309.4, CA 11B-213, CA 11B-606

Replace knob faucets with paddle faucets \$392
