Accessibility Survey

Parking Structure

2nd Street and La Reina Avenue
Downey, CA 90240

Date of Inspection
12/21/2016

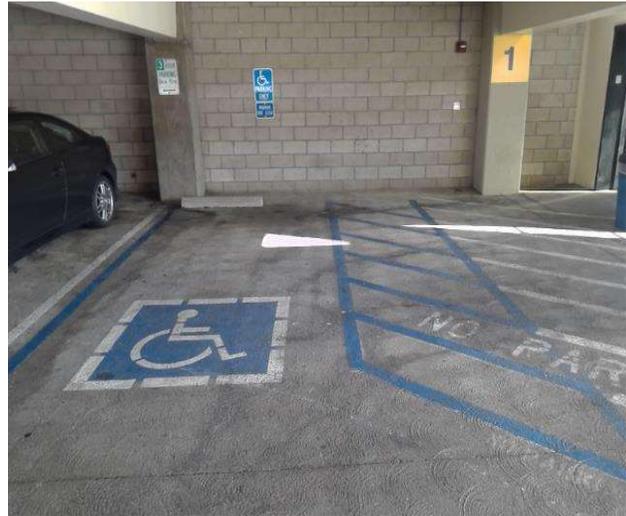
1st Floor, Accessible Space Next to Elevator

The bottom edge of the wall-mounted signage designating accessible parking is not at the required height.

On-Site Finding 42.62 inches

Code Reference ADA 502, 502.6, CA 11B-502.6

Remount the wall-mounted signage designating the accessible parking space so that it is installed at the required height. The sign shall be located so that it cannot be obscured by a vehicle parked in the space.

Recommendation At least 60.00 inches

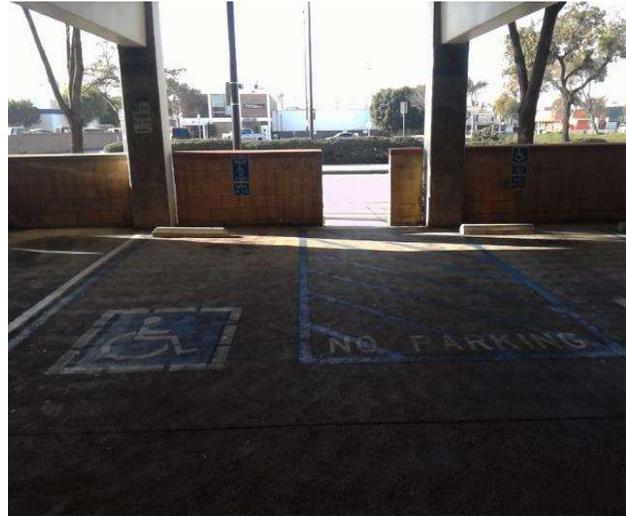
1st Floor, South Wall, 1st Accessible Space From Left

The bottom edge of the wall-mounted signage designating accessible parking is not at the required height.

On-Site Finding 19.50 inches

Code Reference ADA 502, 502.6, CA 11B-502.6

Remount the wall-mounted signage designating the accessible parking space so that it is installed at the required height. The sign shall be located so that it cannot be obscured by a vehicle parked in the space.

Recommendation At least 60.00 inches

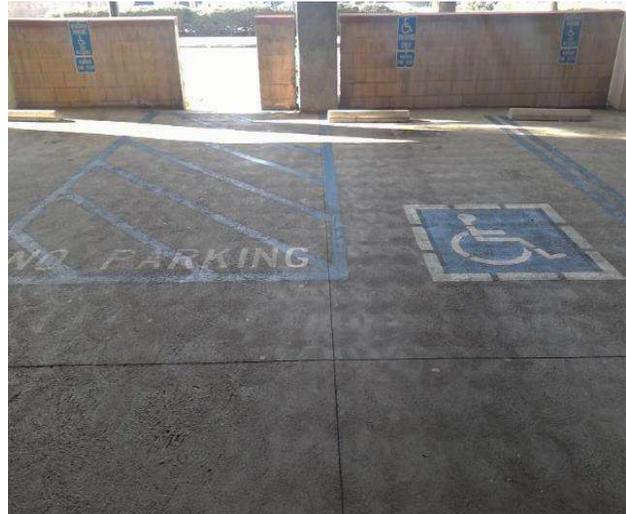
1st Floor, South Wall, 2nd Accessible Space From Left

The bottom edge of the wall-mounted signage designating accessible parking is not at the required height.

On-Site Finding 23.00 inches

Code Reference ADA 502, 502.6, CA 11B-502.6

Remount the wall-mounted signage designating the accessible parking space so that it is installed at the required height. The sign shall be located so that it cannot be obscured by a vehicle parked in the space.

Recommendation At least 60.00 inches

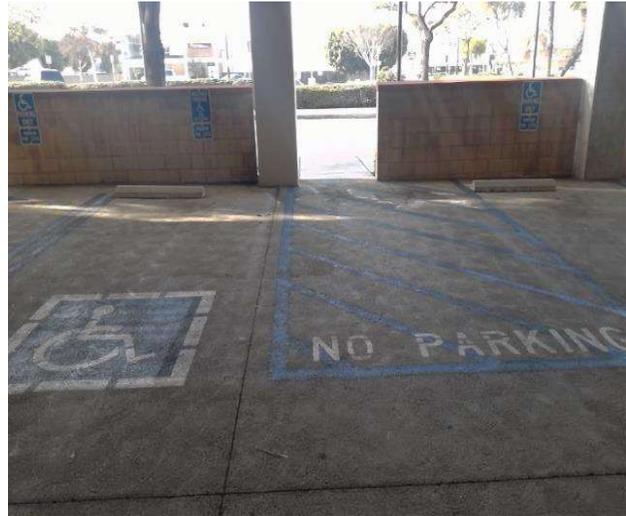
1st Floor, South Wall, 3rd Accessible Space From Left

The bottom edge of the wall-mounted signage designating accessible parking is not at the required height.

On-Site Finding 24.75 inches

Code Reference ADA 502, 502.6, CA 11B-502.6

Remount the wall-mounted signage designating the accessible parking space so that it is installed at the required height. The sign shall be located so that it cannot be obscured by a vehicle parked in the space.

Recommendation At least 60.00 inches

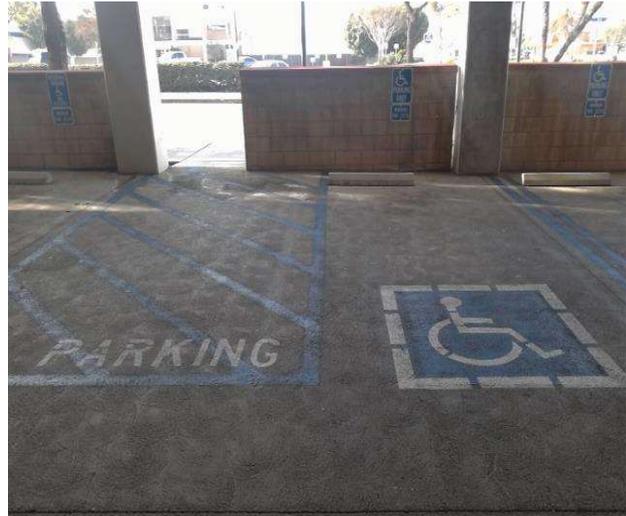
1st Floor, South Wall, 4th Accessible Space From Left

The bottom edge of the wall-mounted signage designating accessible parking is not at the required height.

On-Site Finding 27.50 inches

Code Reference ADA 502, 502.6, CA 11B-502.6

Remount the wall-mounted signage designating the accessible parking space so that it is installed at the required height. The sign shall be located so that it cannot be obscured by a vehicle parked in the space.

Recommendation At least 60.00 inches

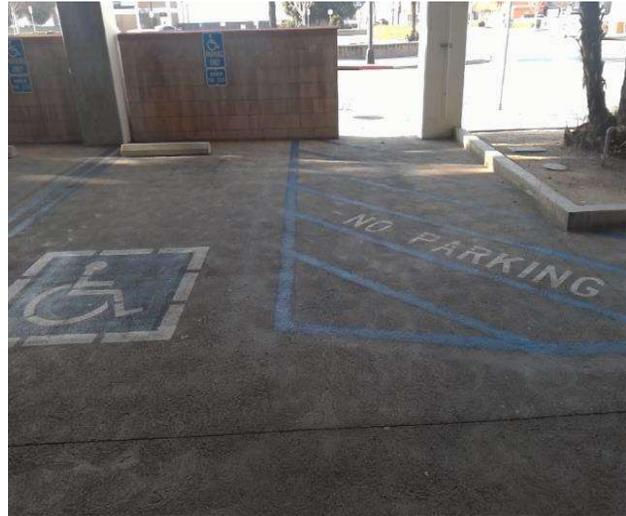
1st Floor, South Wall, 5th Accessible Space From Left

The bottom edge of the wall-mounted signage designating accessible parking is not at the required height.

On-Site Finding 29.62 inches

Code Reference ADA 502, 502.6, CA 11B-502.6

Remount the wall-mounted signage designating the accessible parking space so that it is installed at the required height. The sign shall be located so that it cannot be obscured by a vehicle parked in the space.

Recommendation At least 60.00 inches

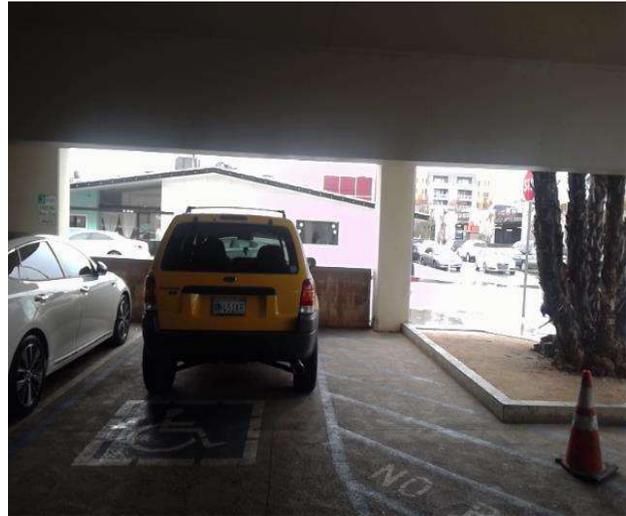
1st Floor, Southeast Corner Left Accessible Space

The bottom edge of the wall-mounted signage designating accessible parking is not at the required height.

On-Site Finding 12.00 inches

Code Reference ADA 502, 502.6, CA 11B-502.6

Remount the wall-mounted signage designating the accessible parking space so that it is installed at the required height. The sign shall be located so that it cannot be obscured by a vehicle parked in the space.

Recommendation At least 60.00 inches

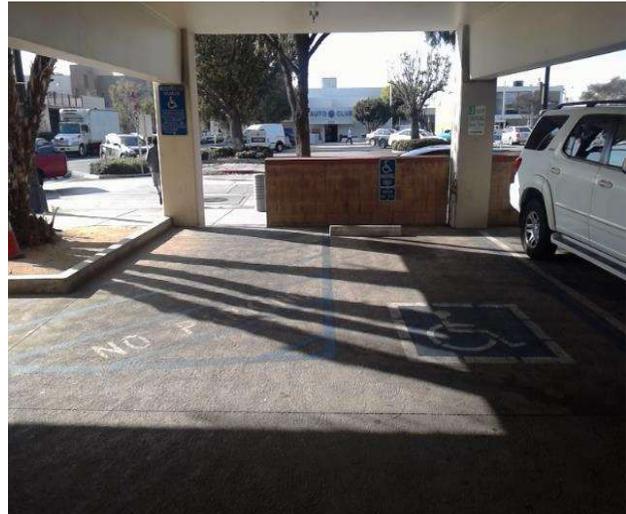
1st Floor, Southeast Corner Right Accessible Space

The bottom edge of the wall-mounted signage designating accessible parking is not at the required height.

On-Site Finding 16.00 inches

Code Reference ADA 502, 502.6, CA 11B-502.6

Remount the wall-mounted signage designating the accessible parking space so that it is installed at the required height. The sign shall be located so that it cannot be obscured by a vehicle parked in the space.

Recommendation At least 60.00 inches

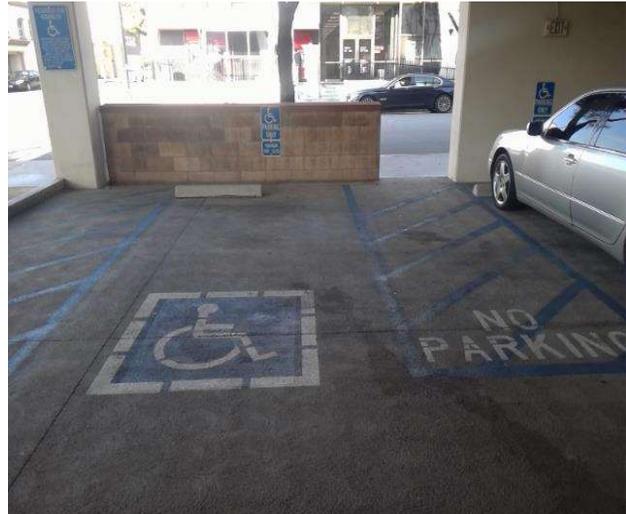
1st Floor, West Wall, Left Accessible Space

The bottom edge of the wall-mounted signage designating accessible parking is not at the required height.

On-Site Finding 15.00 inches

Code Reference ADA 502, 502.6, CA 11B-502.6

Remount the wall-mounted signage designating the accessible parking space so that it is installed at the required height. The sign shall be located so that it cannot be obscured by a vehicle parked in the space.

Recommendation At least 60.00 inches

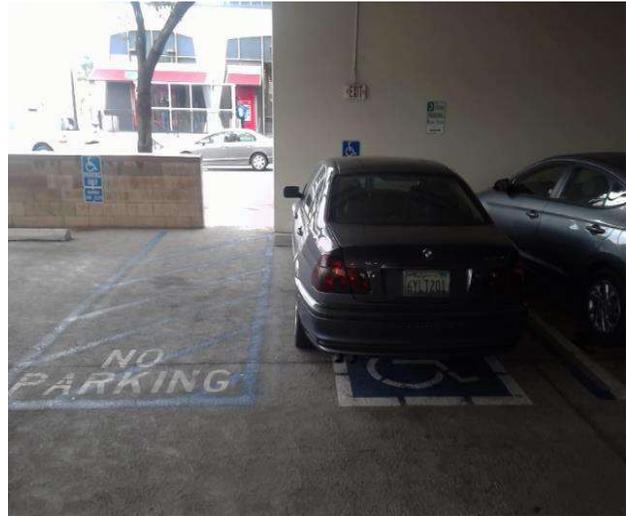
1st Floor, West Wall, Right Accessible Space

Code Reference ADA 502, 502.6, CA 11B-502.6

Recommendation At least 60.00 inches

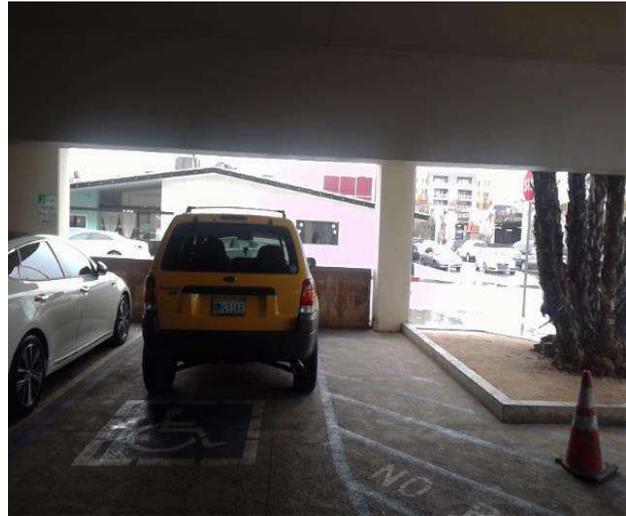
Parking Lot , Parking Space : Access Aisle is Faded or Damaged

The access aisle markings are faded, damaged, or otherwise not viewable.

Code Reference ADA 502.3, 502.3.3, CA 11B-502.3

Re-stripe existing parking space \$250

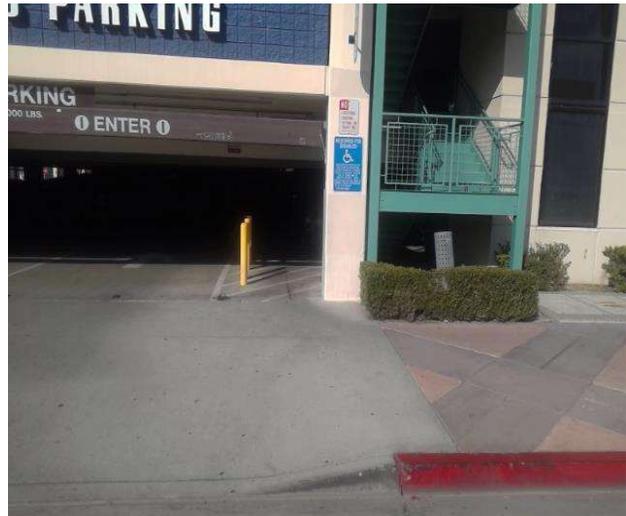
Path Of Travel , Vehicular Traffic : Cross Walks and Detectable Warnings

Code Reference ADA 705,CA 11B-705.1.2.5,CA 11B-247.1.2.5

Notes : Walking surface leads to driveway entrance.

Install compliant detectable warnings \$190
