# Accessibility Survey

## Furman Park

10419 Rives Avenue  
Downey, CA 90241

Date of Inspection  
4/27/2017

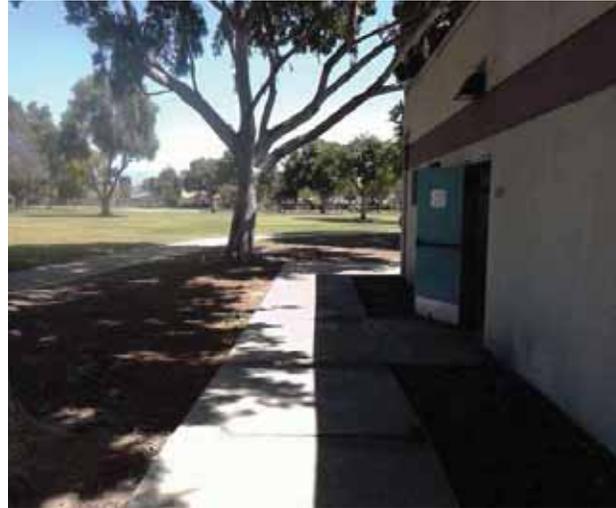
**Sidewalk around Building 2**

**Change In Level**

There is a change in elevation greater than recommended value.

**On-Site Finding** 0.50 inches

**Code Reference** ADA 303, 403.4, 303.2,CA 11B-303,CA 11B-403.4

Ensure that the change in elevation is within the recommended value.

Recommendation Up to 0.25 inches

Provide smooth surface \$150

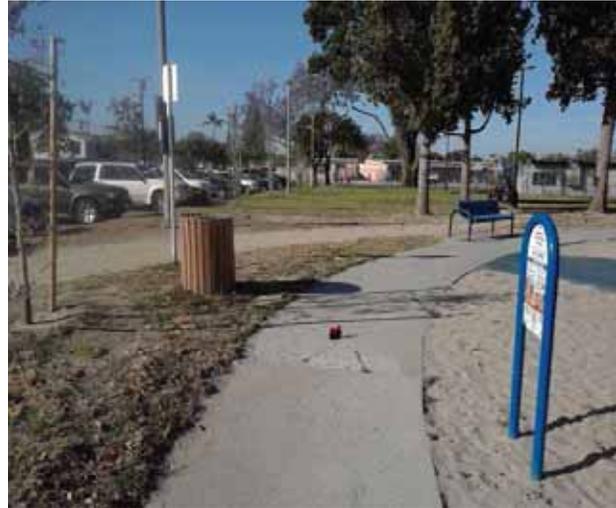
There is a change in elevation greater than recommended value.

**Code Reference** ADA 303, 403.4, 303.2,CA 11B-303,CA 11B-403.4

Ensure that the change in elevation is within the recommended value.

Recommendation Up to 0.25 inches

Provide smooth surface \$150

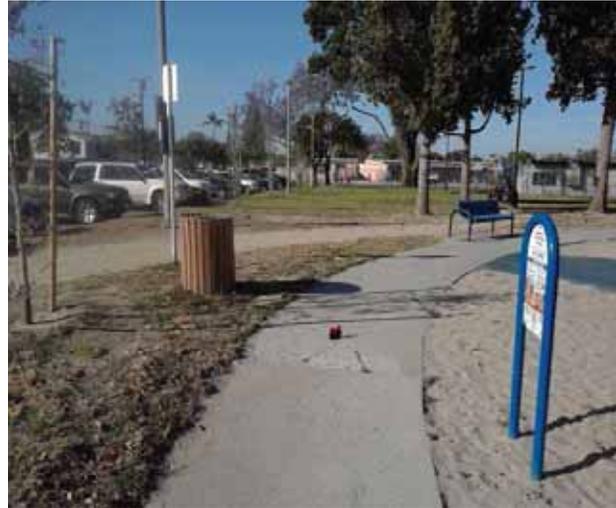
There is a change in elevation greater than recommended value.

**Code Reference** ADA 303, 403.4, 303.2,CA 11B-303,CA 11B-403.4

Ensure that the change in elevation is within the recommended value.

Recommendation Up to 0.25 inches

Provide smooth surface \$150

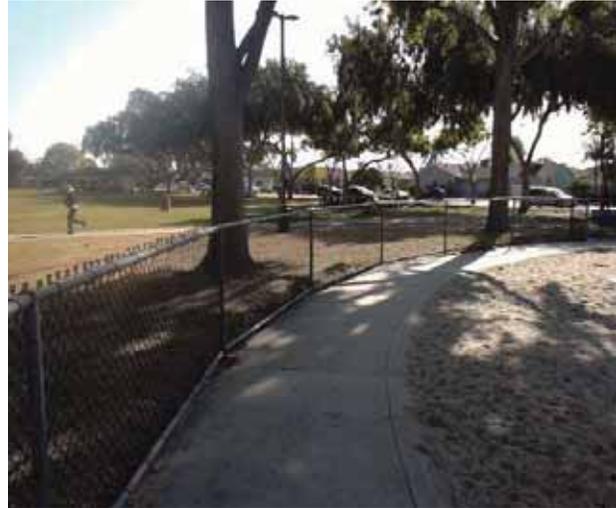
There is a change in elevation greater than recommended value.

**Code Reference** ADA 303, 403.4, 303.2,CA 11B-303,CA 11B-403.4

Ensure that the change in elevation is within the recommended value.

Recommendation Up to 0.25 inches

Provide smooth surface \$600

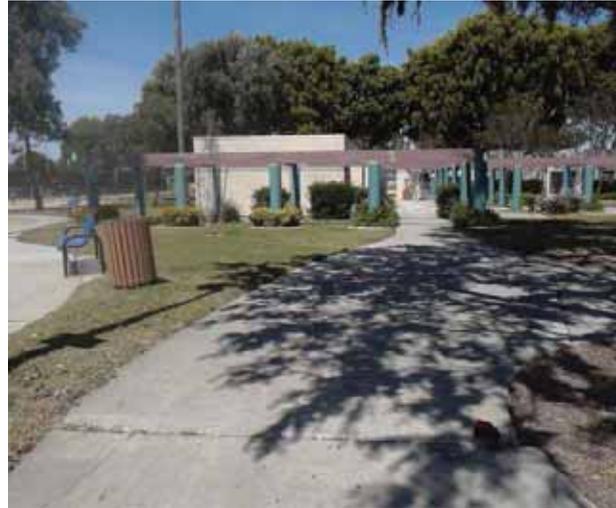
There is a change in elevation greater than recommended value.

**Code Reference** ADA 303, 403.4, 303.2,CA 11B-303,CA 11B-403.4

Ensure that the change in elevation is within the recommended value.

Recommendation Up to 0.25 inches

Provide smooth surface \$300

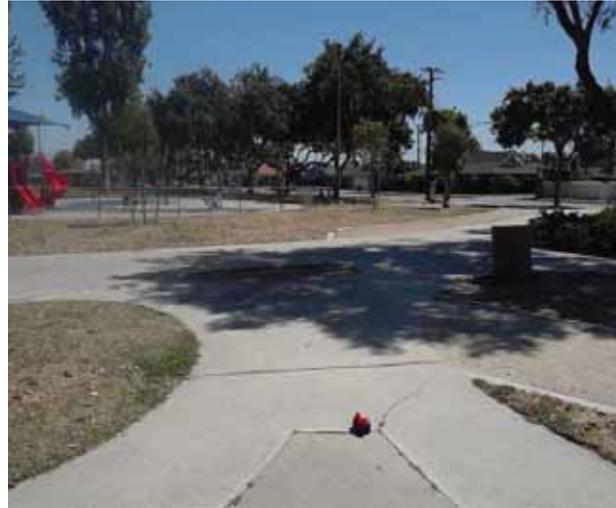
There is a change in elevation greater than recommended value.

**Code Reference** ADA 303, 403.4, 303.2, CA 11B-303, CA 11B-403.4

Ensure that the change in elevation is within the recommended value.

Recommendation Up to 0.25 inches

Provide smooth surface \$150

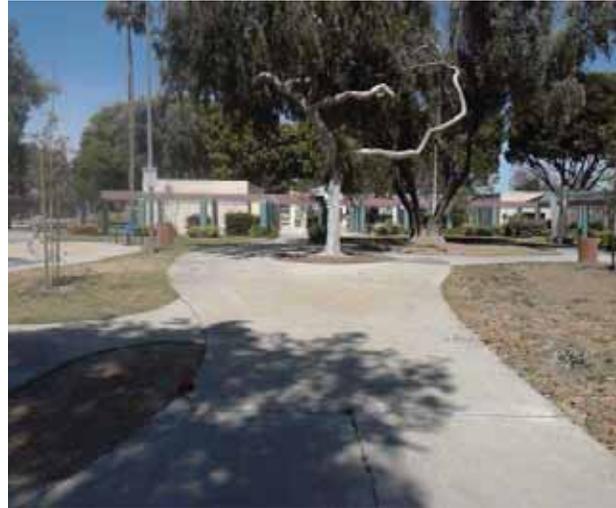
There is a change in elevation greater than recommended value.

**Code Reference** ADA 303, 403.4, 303.2, CA 11B-303, CA 11B-403.4

Ensure that the change in elevation is within the recommended value.

Recommendation Up to 0.25 inches

Provide smooth surface \$150

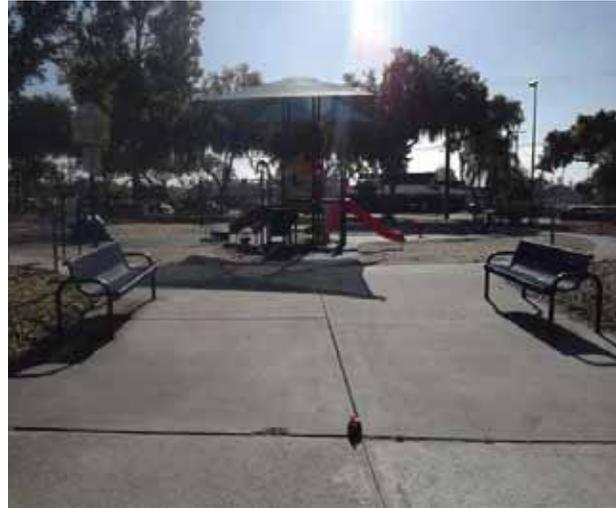
There is a change in elevation greater than recommended value.

**Code Reference** ADA 303, 403.4, 303.2,CA 11B-303,CA 11B-403.4

Ensure that the change in elevation is within the recommended value.

Recommendation Up to 0.25 inches

Provide smooth surface \$300

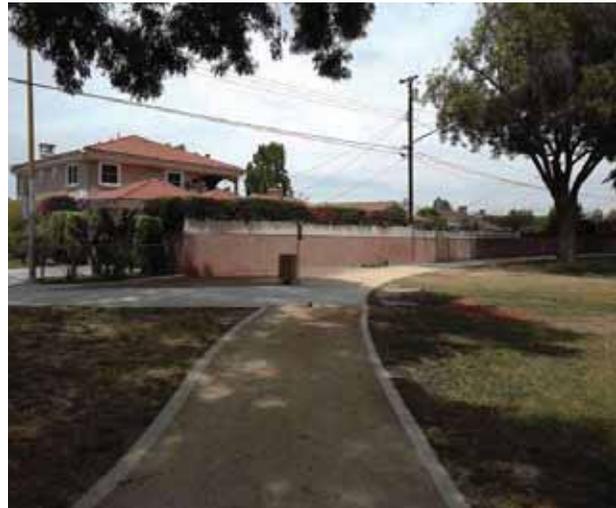
There is a change in elevation greater than recommended value.

**Code Reference** ADA 303, 403.4, 303.2, CA 11B-303, CA 11B-403.4

Ensure that the change in elevation is within the recommended value.

Recommendation Up to 0.25 inches

Provide smooth surface \$150

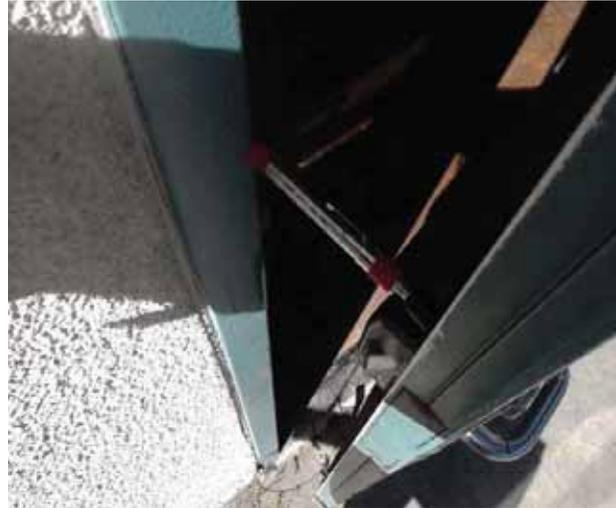
**Code Reference** ADA 404.2.9,CA 11B-404.2.9

Recommendation Up to 5.00 pounds

Adjust door closer pressure \$25

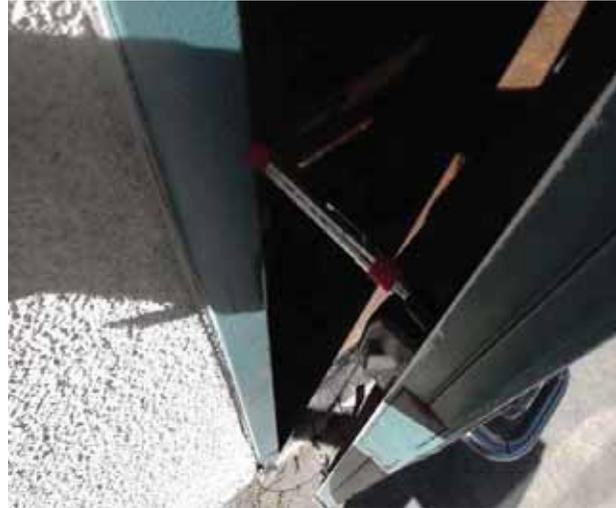
**On-Site Finding** Found

**Code Reference** ADA 404, 404.2.10,CA 11B-404.2.10

Remove door stop \$50

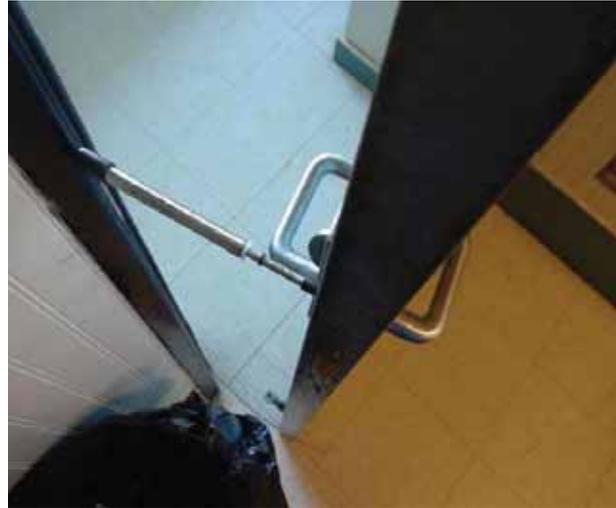
**Code Reference** ADA 404.2.9,CA 11B-404.2.9

Recommendation Up to 5.00 pounds

Adjust door closer pressure \$25

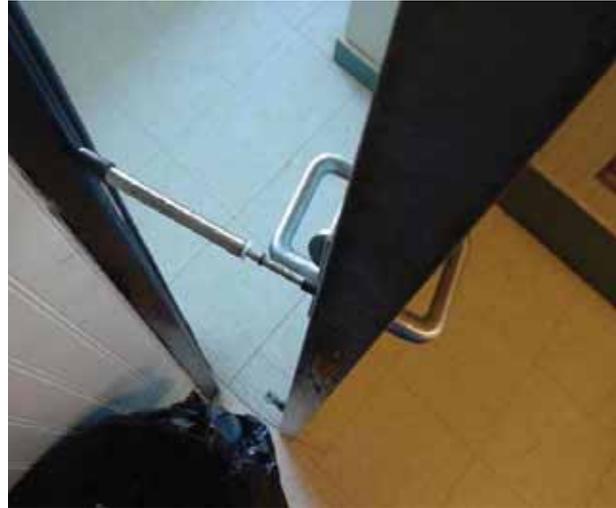
**On-Site Finding** Found

**Code Reference** ADA 404, 404.2.10,CA 11B-404.2.10

Remove door stop \$50

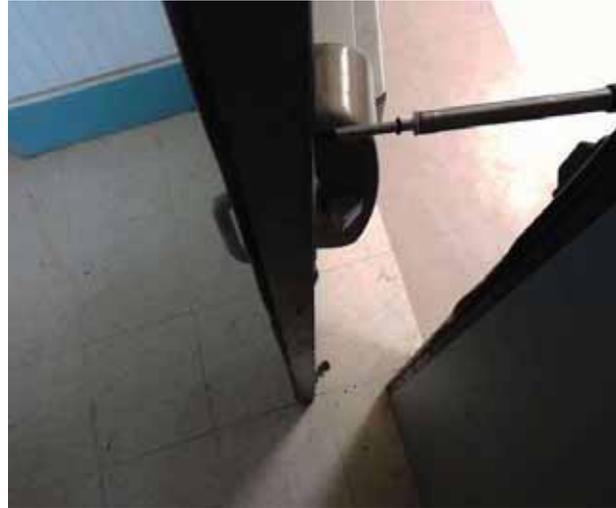
**Code Reference** ADA 404.2.9,CA 11B-404.2.9

Recommendation Up to 5.00 pounds

Adjust door closer pressure \$25

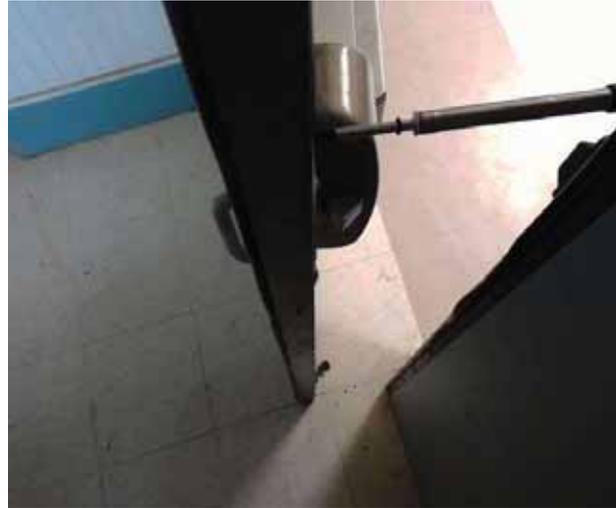
**On-Site Finding** Found

**Code Reference** ADA 404, 404.2.10,CA 11B-404.2.10

Remove door stop \$50

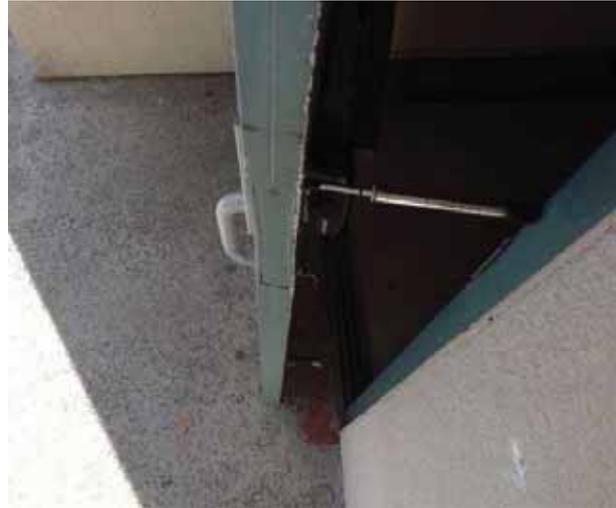
**On-Site Finding** Found

**Code Reference** ADA 404, 404.2.10,CA 11B-404.2.10

Remove door stop \$50

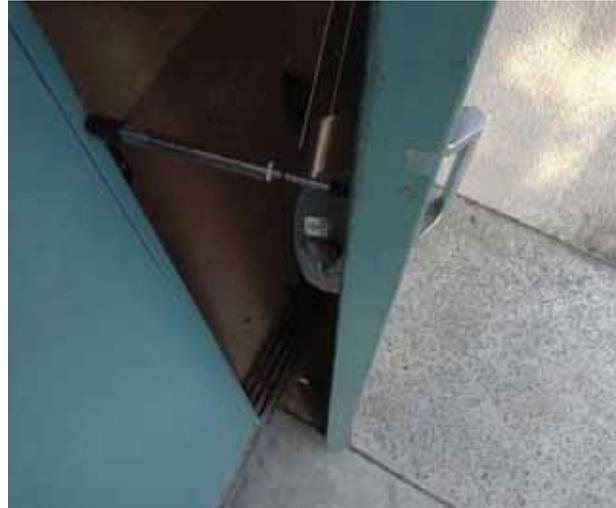
**Code Reference** ADA 404.2.9,CA 11B-404.2.9

Recommendation Up to 5.00 pounds

Adjust door closer pressure \$25

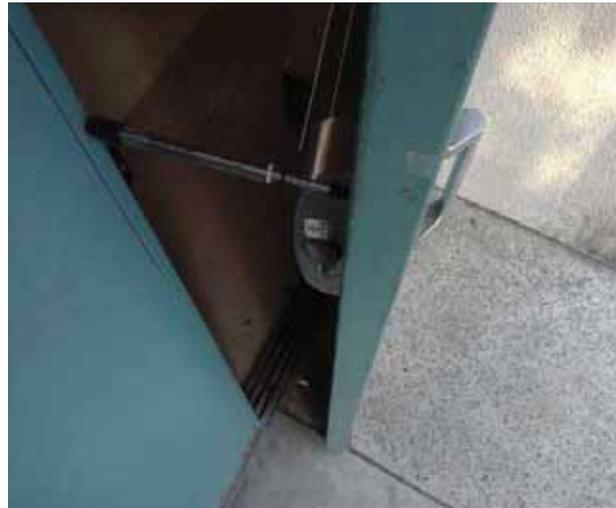
**On-Site Finding** Found

**Code Reference** ADA 404, 404.2.10,CA 11B-404.2.10

Remove door stop \$50

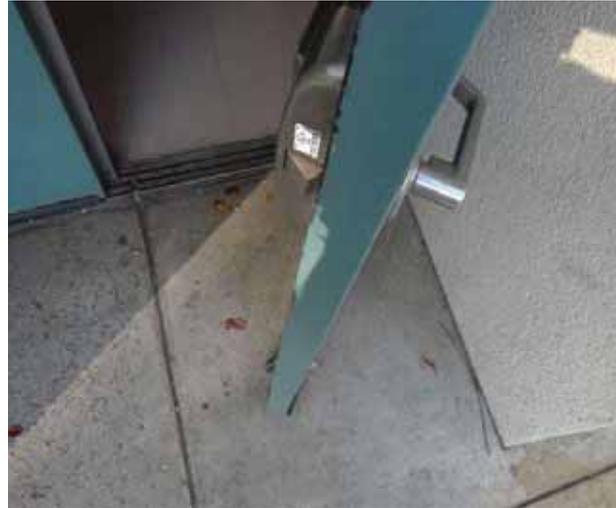
**On-Site Finding** Found

**Code Reference** ADA 404, 404.2.10,CA 11B-404.2.10

Remove door stop \$50

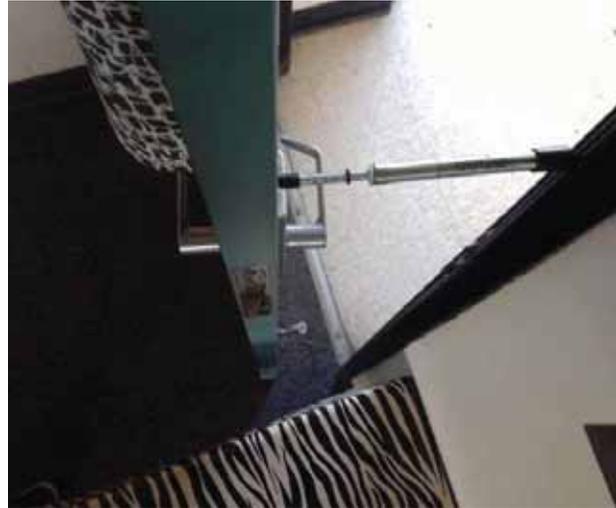
**Code Reference** ADA 404.2.9,CA 11B-404.2.9

Recommendation Up to 5.00 pounds

Adjust door closer pressure \$25

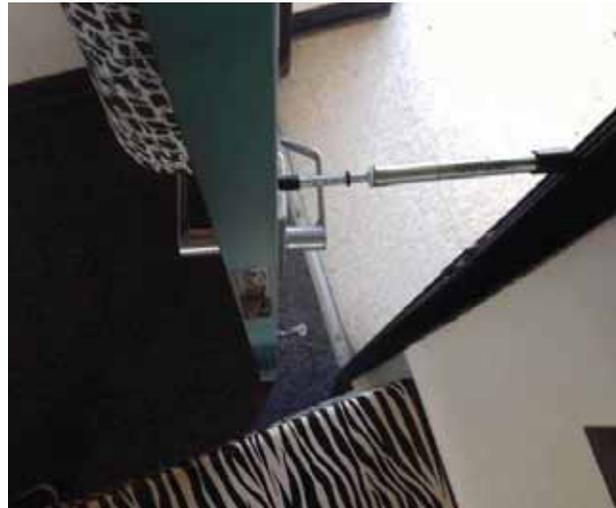
**On-Site Finding** Found

**Code Reference** ADA 404, 404.2.10,CA 11B-404.2.10

Remove door stop \$50

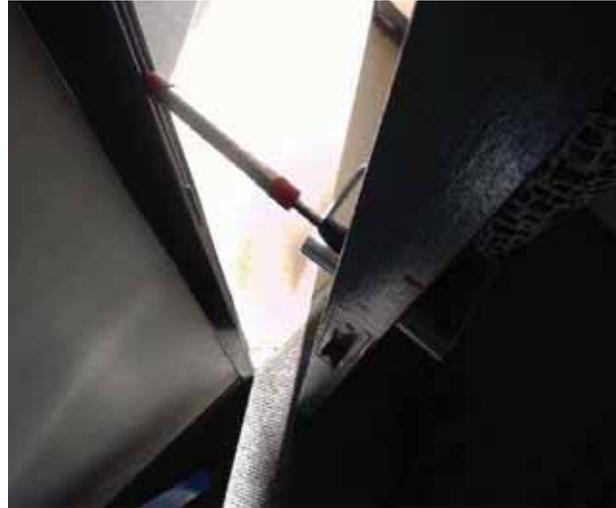
**Code Reference** ADA 404.2.9,CA 11B-404.2.9

Recommendation Up to 5.00 pounds

Adjust door closer pressure \$25

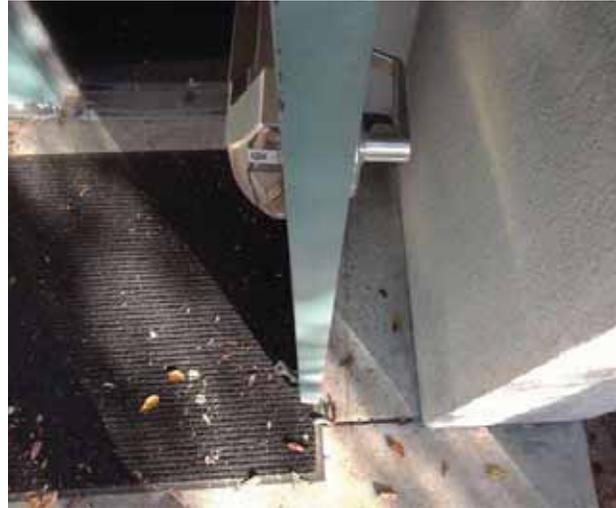
**On-Site Finding** Found

**Code Reference** ADA 404, 404.2.10,CA 11B-404.2.10

Remove door stop \$50

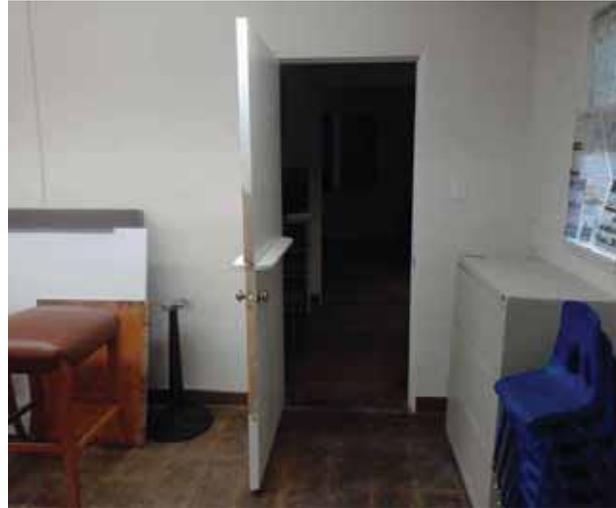
**Code Reference** ADA 404, 404.2.4,CA 11B-404.2.4

Notes : Cabinet obstructs clear floor space length.

Provide the recommended clear floor space on the pull side of the door.

Recommendation At least 60.00 inches

Install automatic door opener \$2,921

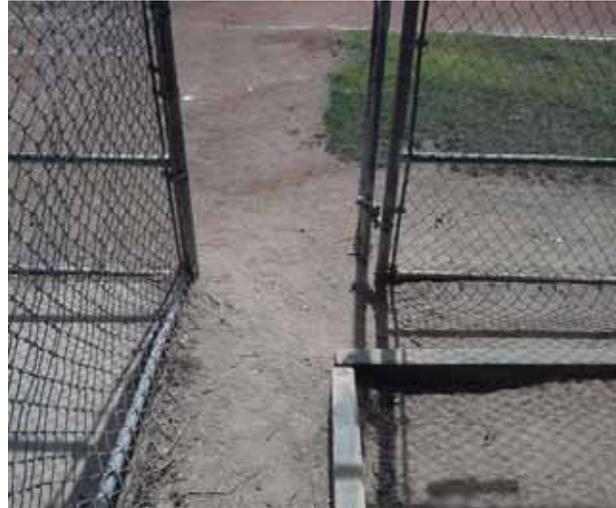
**Code Reference** ADA 404, 404.2.4,CA 11B-404.2.4.1

Notes : Pitchers mound obstructs clear floor space length.

Provide the recommended clear floor space on the push side of the door.

Recommendation At least 48.00 inches

Install automatic door opener \$4,000

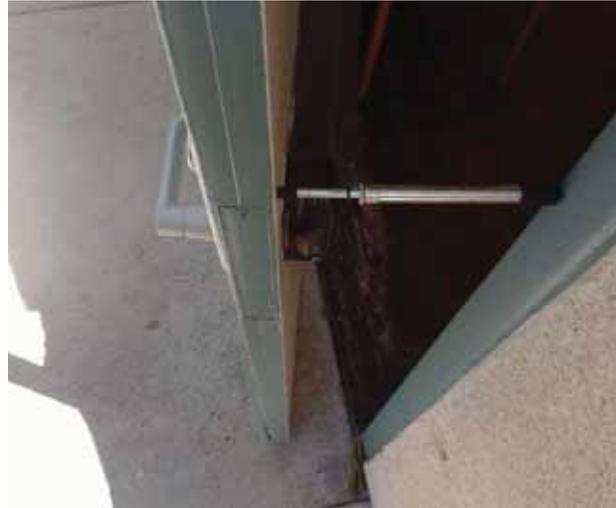
**Code Reference** ADA 404.2.9,CA 11B-404.2.9

Recommendation Up to 5.00 pounds

Adjust door closer pressure \$25

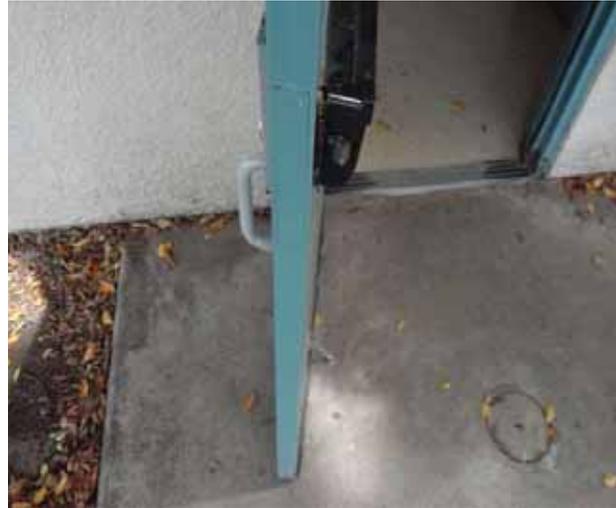
**On-Site Finding** Found

**Code Reference** ADA 404, 404.2.10,CA 11B-404.2.10

Remove door stop \$50

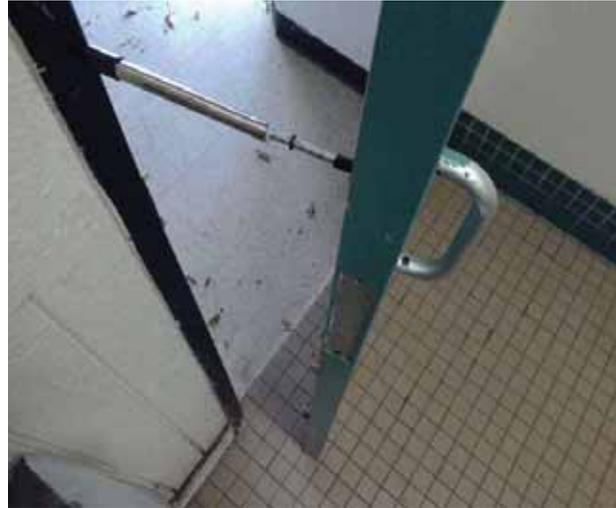
**Code Reference** ADA 404.2.9,CA 11B-404.2.9

Notes : Door scrapes and catches along the floor.

Recommendation Up to 5.00 pounds

Adjust door closer pressure \$25

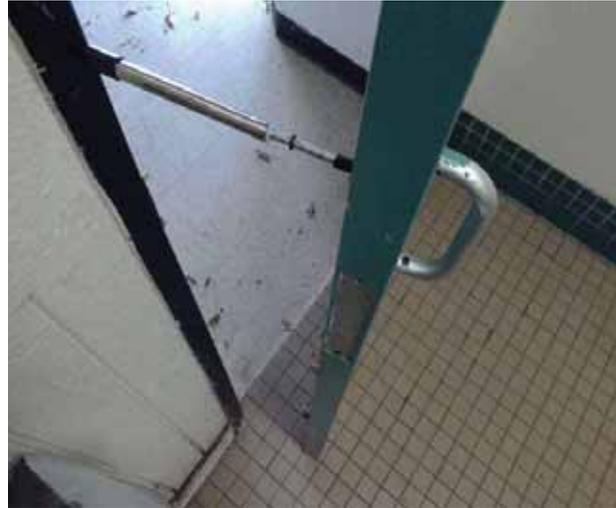
**On-Site Finding** Found

**Code Reference** ADA 404, 404.2.10,CA 11B-404.2.10

Notes : Door scrapes and catches along the floor.

Remove door stop \$50

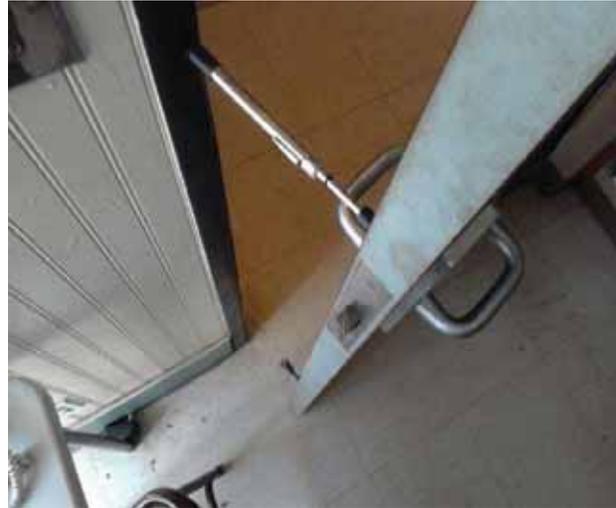
**Code Reference** ADA 404.2.9,CA 11B-404.2.9

Recommendation Up to 5.00 pounds

Adjust door closer pressure \$25

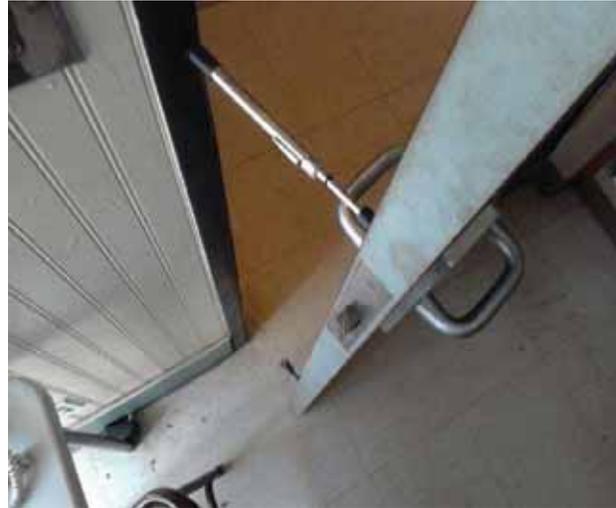
**On-Site Finding** Found

**Code Reference** ADA 404, 404.2.10,CA 11B-404.2.10

Remove door stop \$50

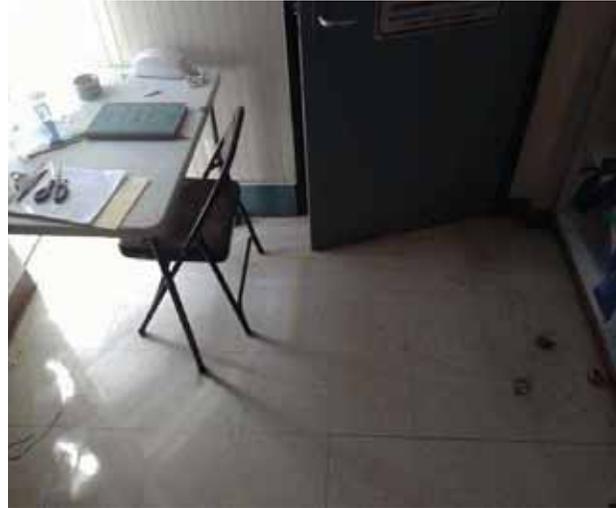
**Code Reference** ADA 404, 404.2.4,CA 11B-404.2.4.1

Notes : Table obstructs latch side clearance.

Recommendation At least 18.00 inches

Install automatic door opener \$4,000

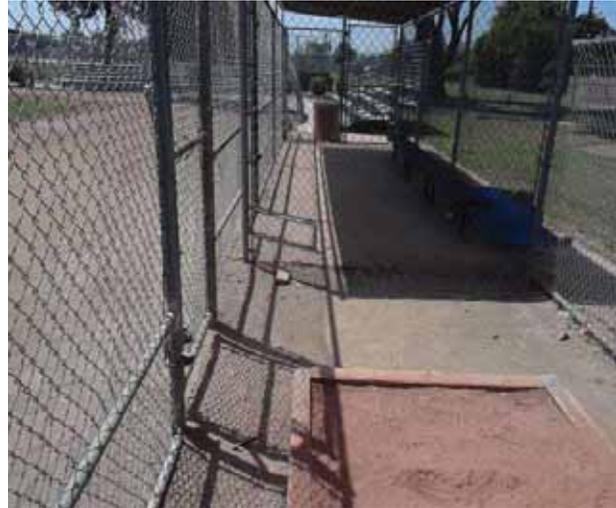
**Code Reference** ADA 404, 404.2.4,CA 11B-404.2.4.1

Notes : Pitchers mound obstructs clear floor space length.

Provide the recommended clear floor space on the push side of the door.

Recommendation At least 48.00 inches

Install automatic door opener \$8,000

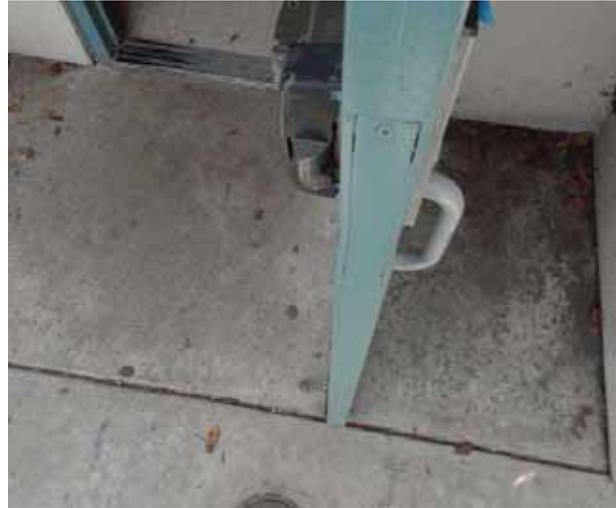
**On-Site Finding** Found

**Code Reference** ADA 404, 404.2.10,CA 11B-404.2.10

Remove door stop \$50

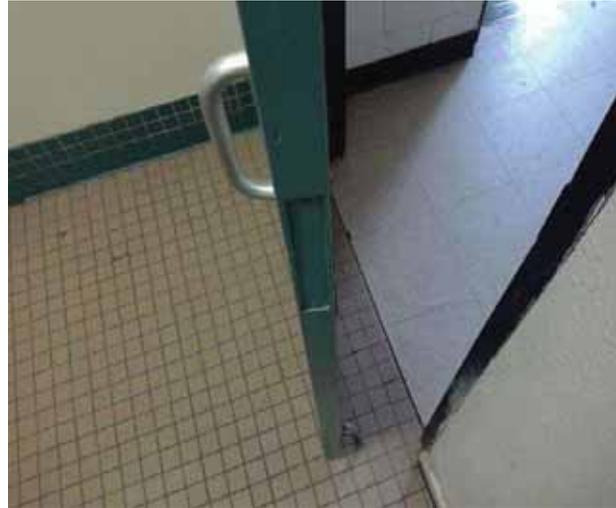
**On-Site Finding** Found

**Code Reference** ADA 404, 404.2.10,CA 11B-404.2.10

Remove door stop \$50

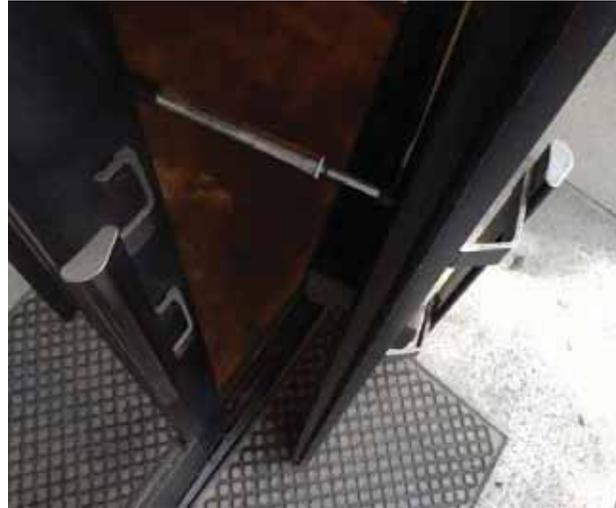
**Code Reference** ADA 404.2.9,CA 11B-404.2.9

Recommendation Up to 5.00 pounds

Adjust door closer pressure \$25

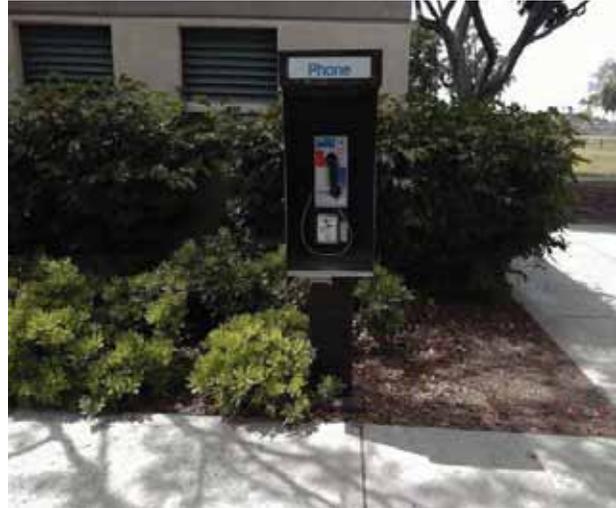
**Code Reference** ADA 309, 205, 704, 309.3, 704.2.2, CA 11B-309, CA 11B-704.2.2

Recommendation 15.00 - 48.00 inches

Lower public telephones \$458

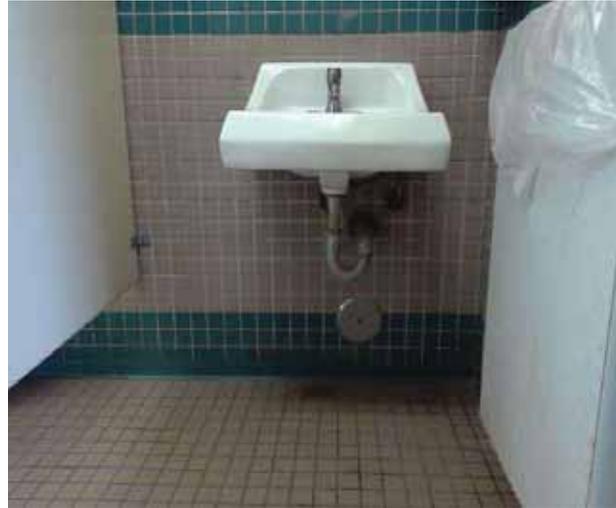
**Code Reference** ADA 213, 606, 606.5, CA 11B-606.5

Wrap pipes \$149

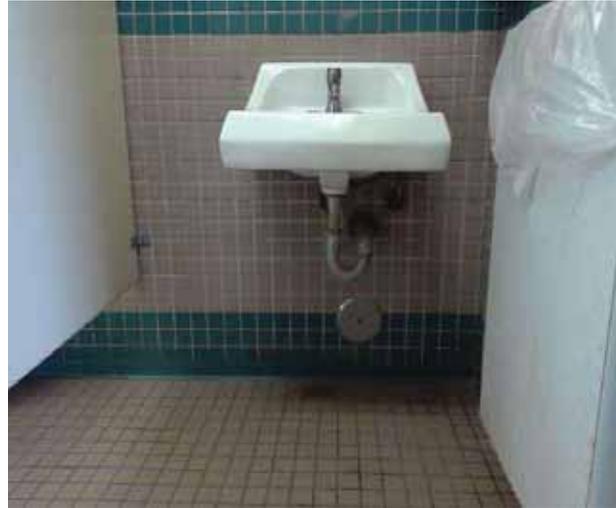
**Code Reference** ADA 213, 606, 606.5, CA 11B-606.5

Wrap supply lines \$149

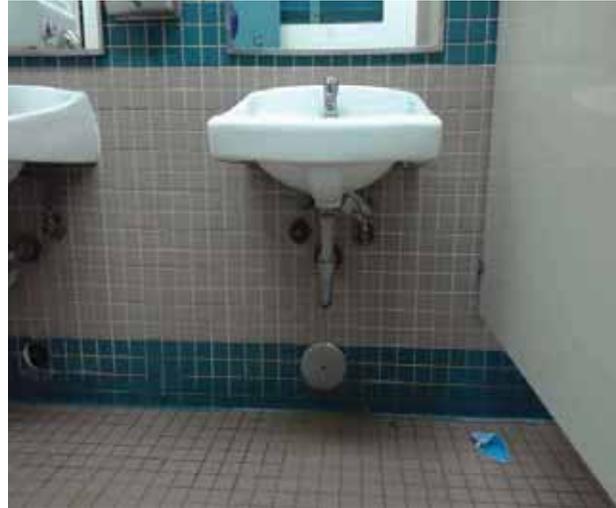
**Code Reference** ADA 213, 606, 606.5,CA 11B-606.5

Wrap pipes \$149

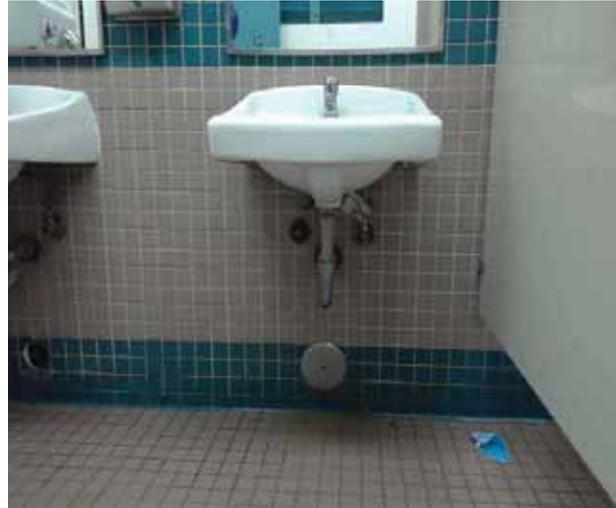
**Code Reference** ADA 213, 606, 606.5,CA 11B-606.5

Wrap supply lines \$149

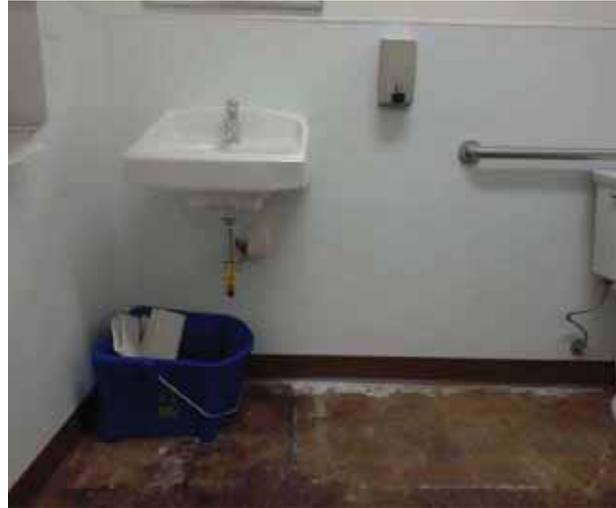
**Code Reference** ADA 213, 606, 606.5,CA 11B-606.5

Wrap pipes \$149

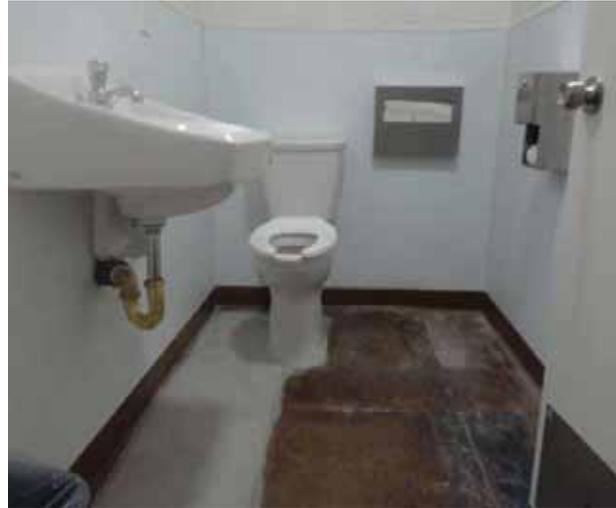
**Code Reference** ADA 213, 606, 606.5,CA 11B-606.5

Wrap pipes \$149

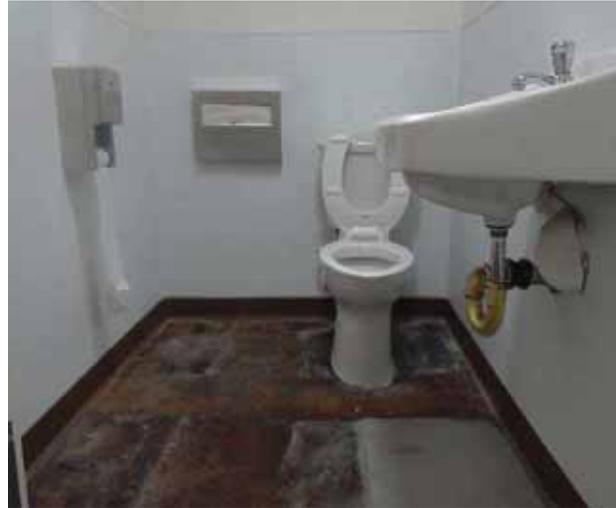
**Code Reference** ADA 213, 606, 606.5,CA 11B-606.5

Wrap pipes \$149

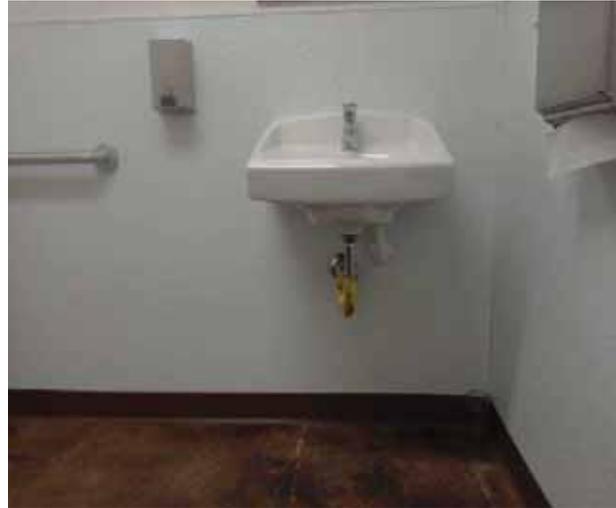
**Code Reference** ADA 213, 606, 606.5,CA 11B-606.5

Wrap pipes \$149

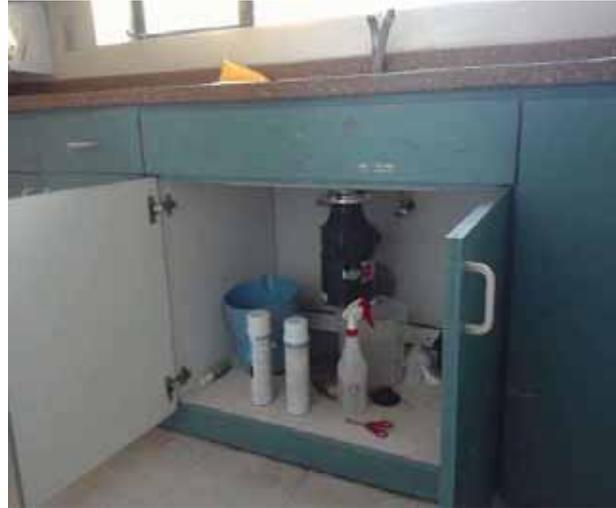
**Code Reference** ADA 309, 205, 308, 228, 606.5, CA 11B-606.5

Notes : Refrigerator obstructs clear floor space length.

Wrap pipes \$149

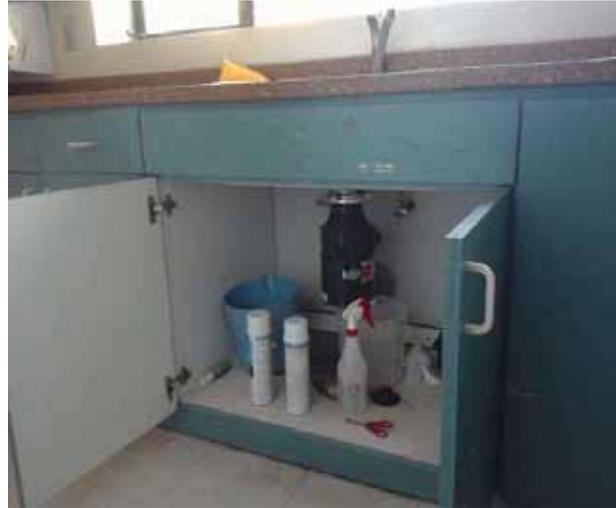
**Code Reference** ADA 606.5, CA 11B-606.5

Notes : Refrigerator obstructs clear floor space length.

Wrap pipes \$149

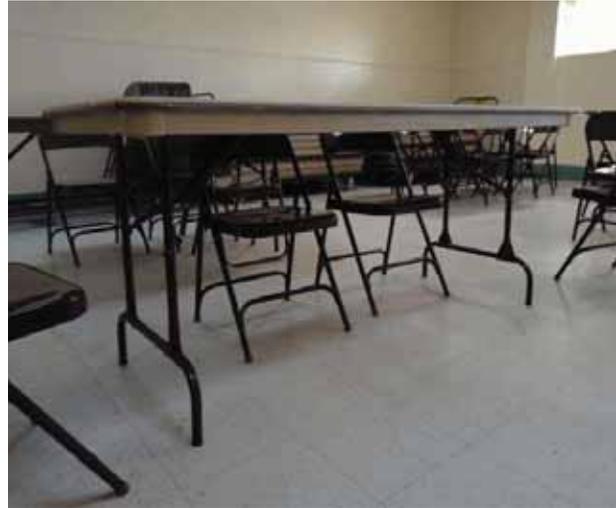
**Code Reference** ADA 309, 205, 308, 228, CA 11B-902.2, CA 11B-306

Recommendation At least 27.00 inches

Adjust/Replace Table \$500

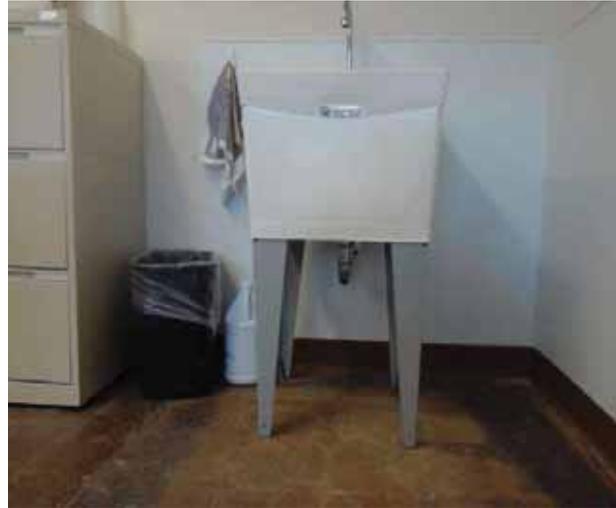
**Code Reference** ADA 309, 205, 308, 228, 606.5, CA 11B-606.5

Wrap pipes \$149

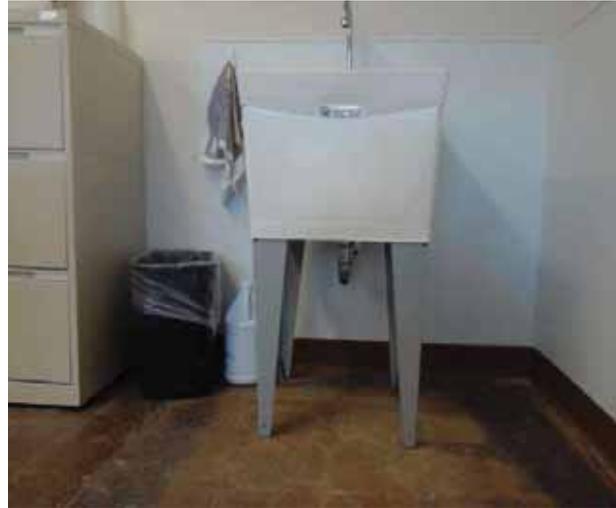
**Code Reference** ADA 606.5, CA 11B-606.5

Wrap pipes \$149

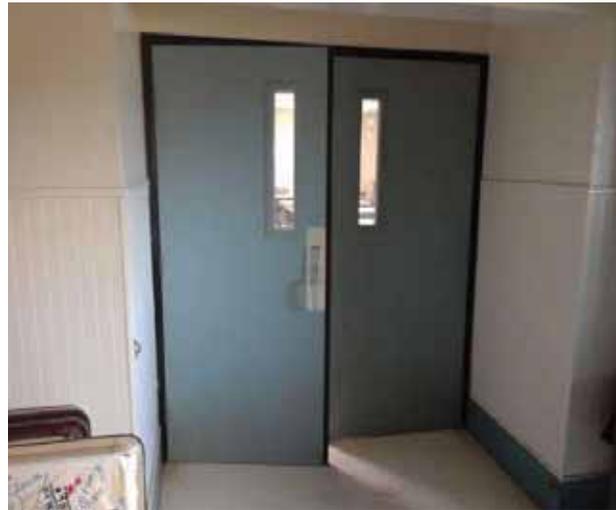
**On-Site Finding** None Found

**Code Reference** ADA 703, 216, 216.2, CA 11B-216.2

Install signage \$158

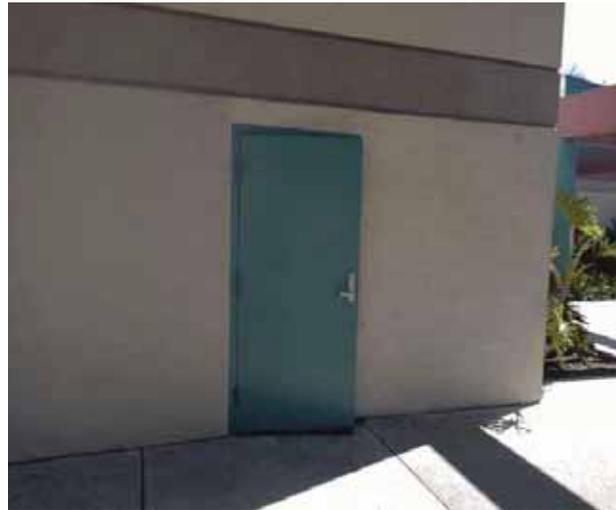
**On-Site Finding** None Found

**Code Reference** ADA 703, 216, 216.2,CA 11B-216.2

Install signage \$158

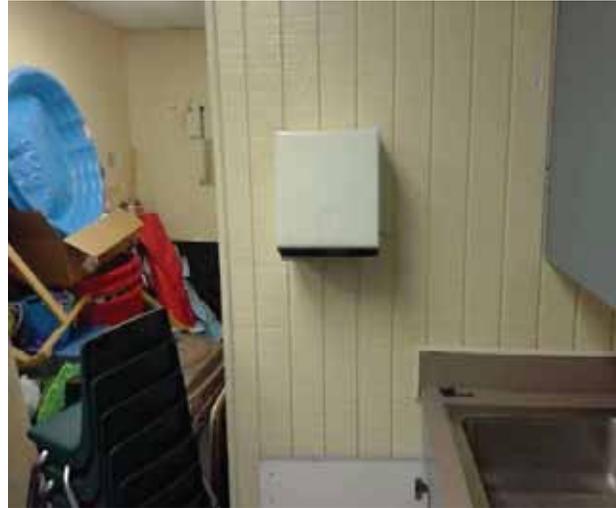
**Code Reference** ADA 309, 205, 308, 606, CA 11B-603.5

Recommendation Up to 40.00 inches

Replace dispenser \$180

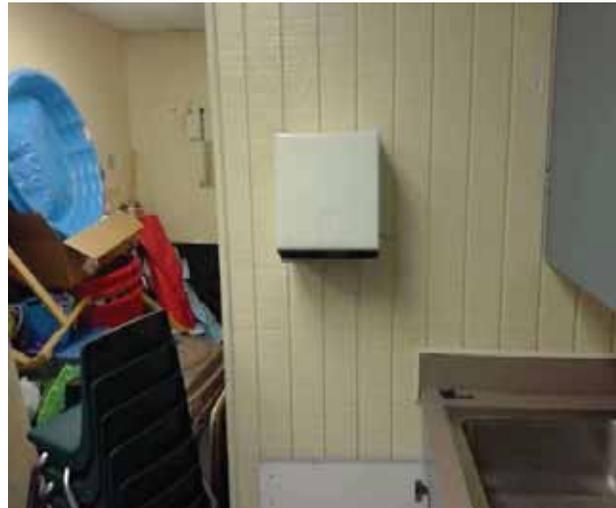
**Code Reference** ADA 309,CA 11B-309.4

Replace dispenser with one that allows operation with one hand and does not require tight grasping, pinching, or twisting of the wrist. The force required to activate operable parts shall be 5 pounds. Consider installing automatic dispensers.

Replace dispenser \$980

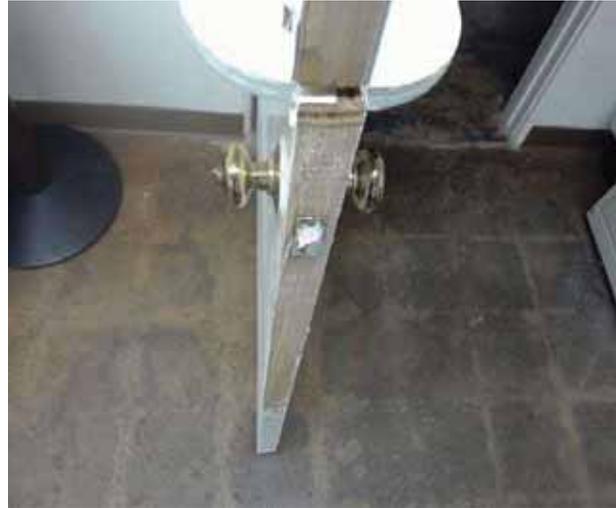
**Code Reference** ADA 404.2.7, 309.4,CA 11B-404.2.7

Replace existing lock set with lever handled lock set \$800

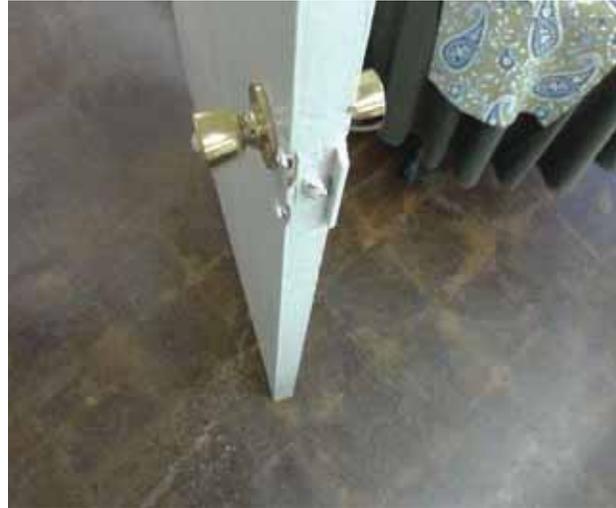
**Code Reference** ADA 404.2.7, 309.4,CA 11B-404.2.7

Replace existing lock set with lever handled lock set \$800

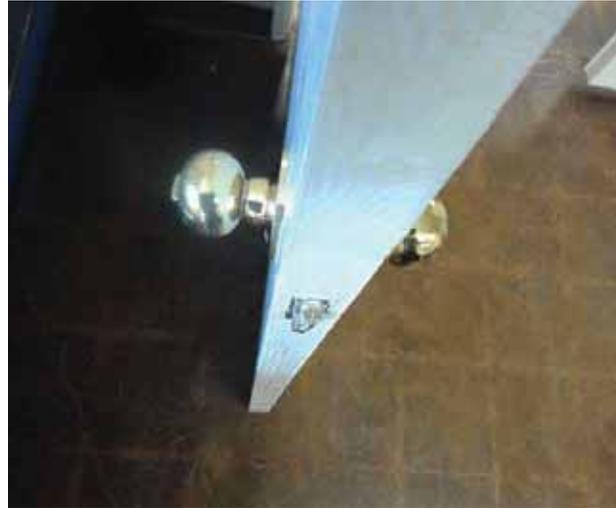
**Code Reference** ADA 404.2.7, 309.4,CA 11B-404.2.7

Replace existing lock set with lever handled lock set \$800

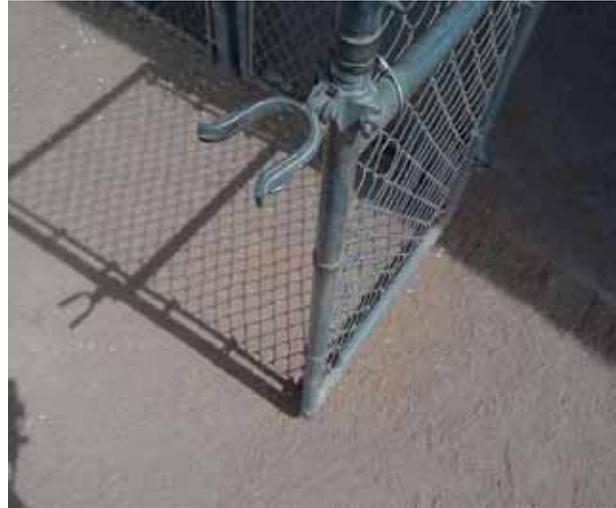
**Code Reference** ADA 404, 404.2.7,CA 11B-404.2.7

Replace door hardware \$560

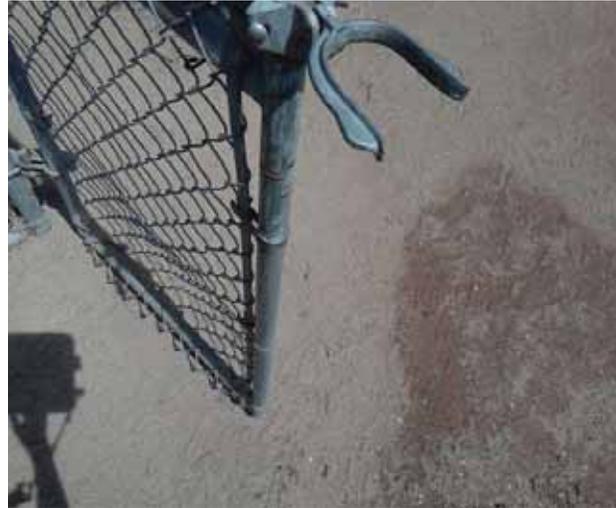
**Code Reference** ADA 404, 404.2.7,CA 11B-404.2.7

Replace door hardware \$280

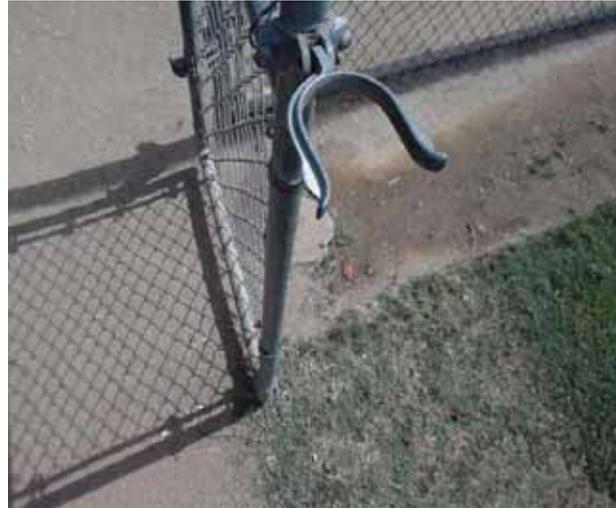
**Code Reference** ADA 404, 404.2.7,CA 11B-404.2.7

Replace door hardware \$280

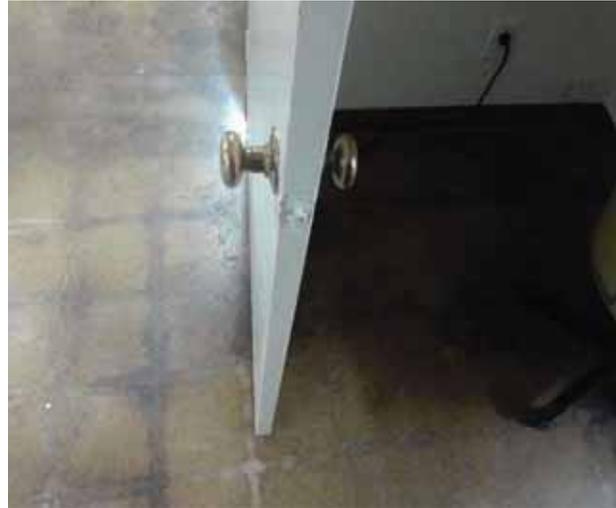
**Code Reference** ADA 404.2.7, 309.4,CA 11B-404.2.7

Replace existing lock set with \$800  
lever handled lock set

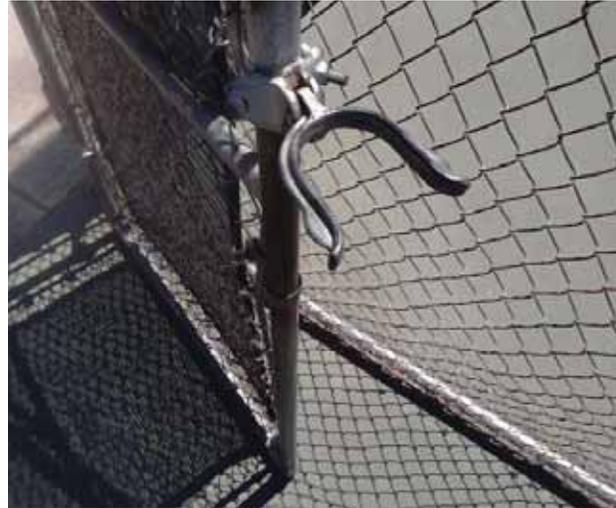
**Code Reference** ADA 404, 404.2.7,CA 11B-404.2.7

Replace door hardware \$840

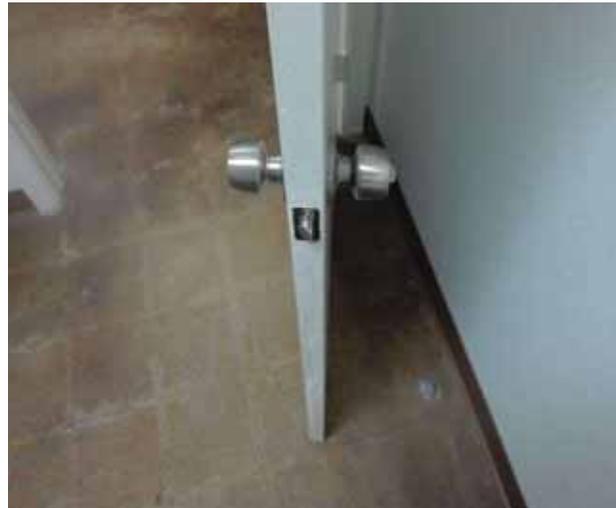
**Code Reference** ADA 404.2.7, 309.4,CA 11B-404.2.7

Replace existing lock set with lever handled lock set \$800

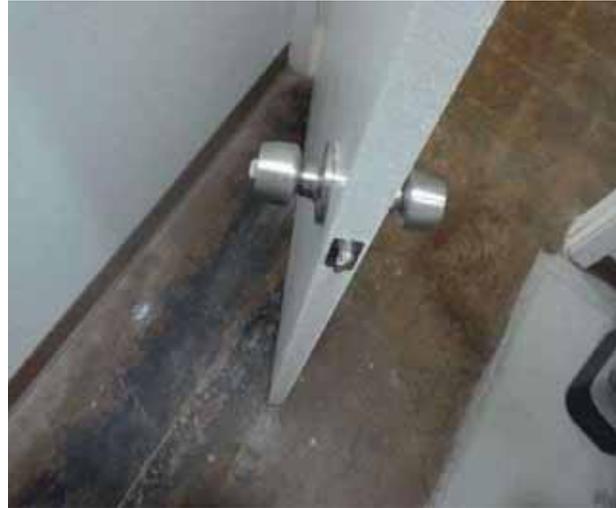
**Code Reference** ADA 404.2.7, 309.4,CA 11B-404.2.7

Replace existing lock set with lever handled lock set \$800

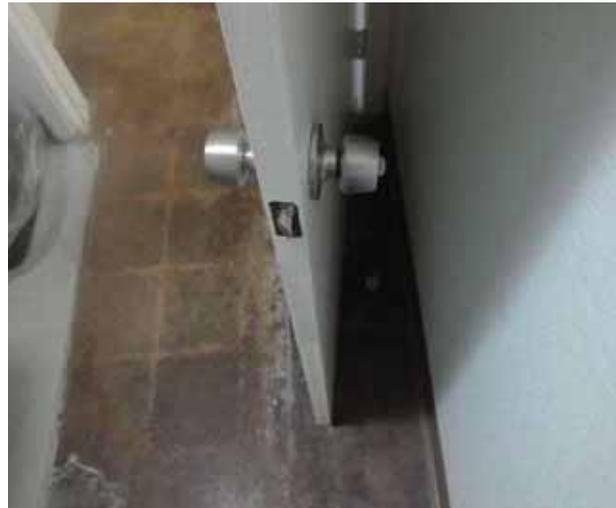
**Code Reference** ADA 404.2.7, 309.4,CA 11B-404.2.7

Replace existing lock set with lever handled lock set \$800
