# Accessibility Survey

## Furman Park

10419 Rives Avenue  
Downey, CA 90241

Date of Inspection  
4/27/2017

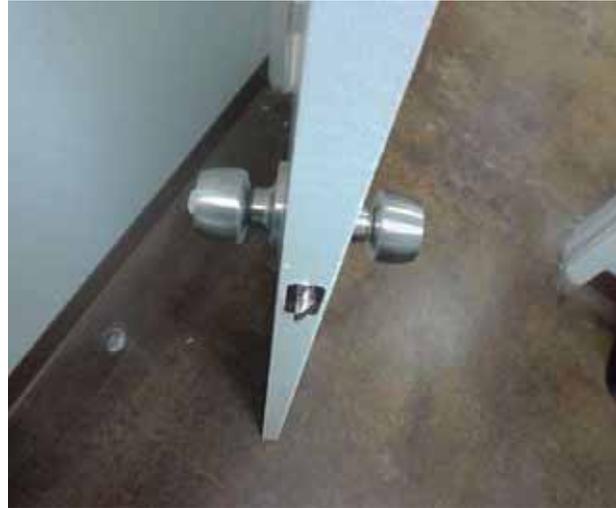
**Code Reference** ADA 404.2.7, 309.4,CA 11B-404.2.7

Replace existing lock set with lever handled lock set \$800

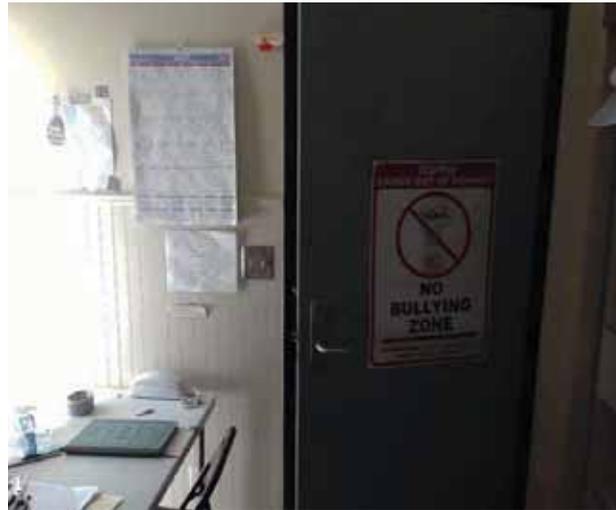
**Code Reference** ADA 404, 404.2.3, CA 11B-404.2.3

Install new door opener \$250

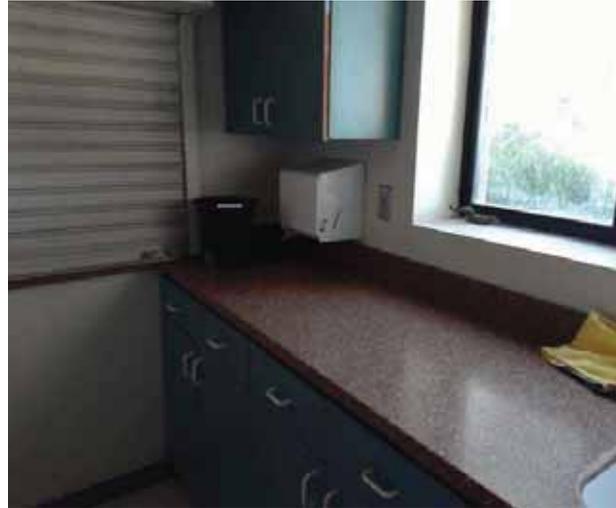
**Code Reference** ADA 205,CA 11B-309.4

Replace dispenser \$220
