Accessibility Survey

Rio San Gabriel Park

9612 Ardine Street
Downey, CA 90240

Date of Inspection
1/17/2017

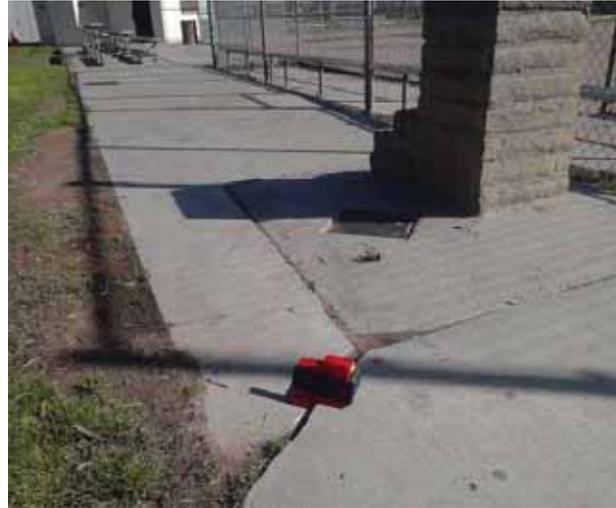
Northwest Softball Field

There is a change in elevation greater than recommended value.

On-Site Finding 0.87 inches

Code Reference ADA 303, 403.4, 303.2,CA 11B-303,CA 11B-403.4

Ensure that the change in elevation is within the recommended value.

Recommendation Up to 0.25 inches

Provide smooth surface \$150

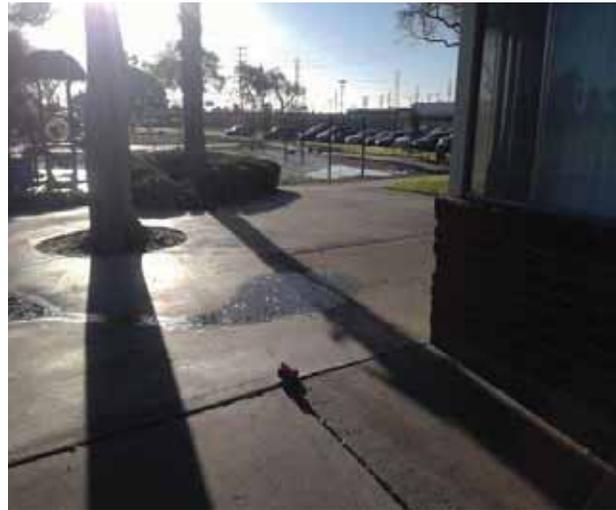
Path Of Travel From Recreation Center To Play Areas

There is a change in elevation greater than recommended value.

Code Reference ADA 303, 403.4, 303.2, CA 11B-303, CA 11B-403.4

Ensure that the change in elevation is within the recommended value.

Recommendation Up to 0.25 inches

Provide smooth surface \$150

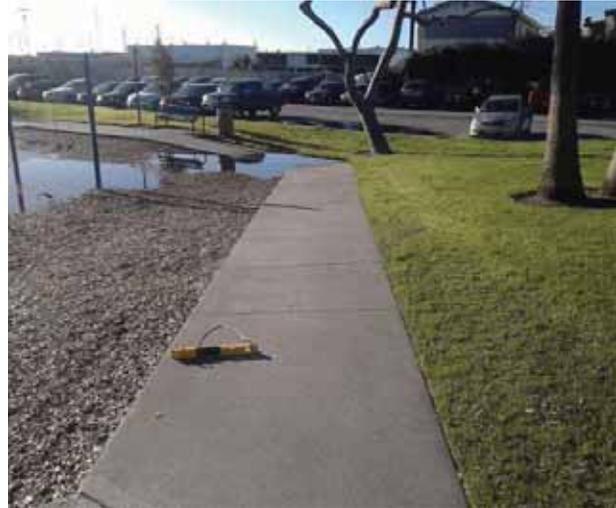
There is a change in elevation greater than recommended value.

Code Reference ADA 303, 403.4, CA 11B-303, CA 11B-403.4

Notes : Surface accumulates water for 10 feet.

Recommendation Up to 0.50 inches

Patch pathway \$480

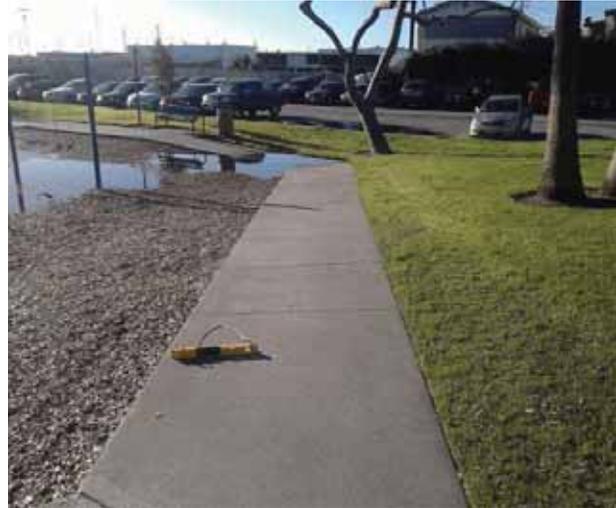
There is a change in elevation greater than recommended value.

Code Reference ADA 303, 403.4, CA 11B-303, CA 11B-403.4

Notes : Surface accumulates water for 10 feet.

Recommendation Up to 0.50 inches

Patch pathway \$480

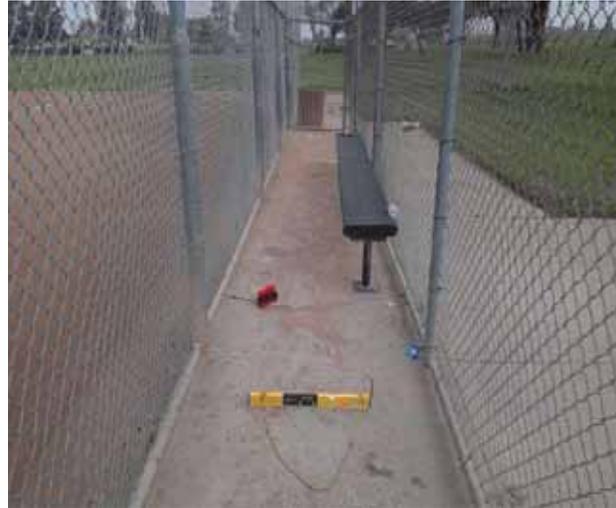
There is a change in elevation greater than recommended value.

Code Reference ADA 303, 403.4, 303.2, CA 11B-303, CA 11B-403.4

Ensure that the change in elevation is within the recommended value.

Recommendation Up to 0.25 inches

Provide smooth surface \$150

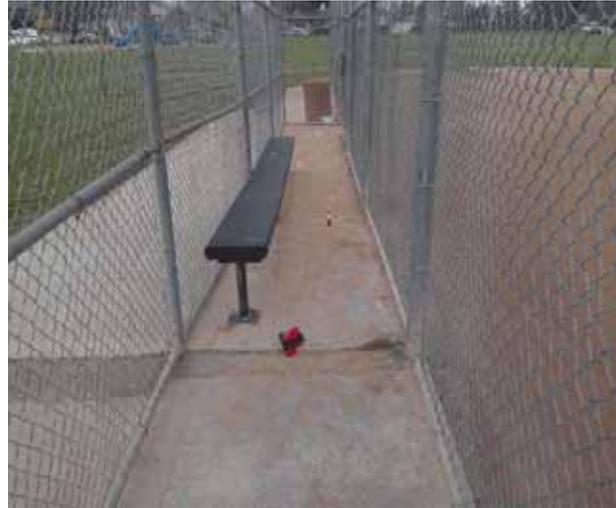
There is a change in elevation greater than recommended value.

Code Reference ADA 303, 403.4, 303.2, CA 11B-303, CA 11B-403.4

Ensure that the change in elevation is within the recommended value.

Recommendation Up to 0.25 inches

Provide smooth surface \$150

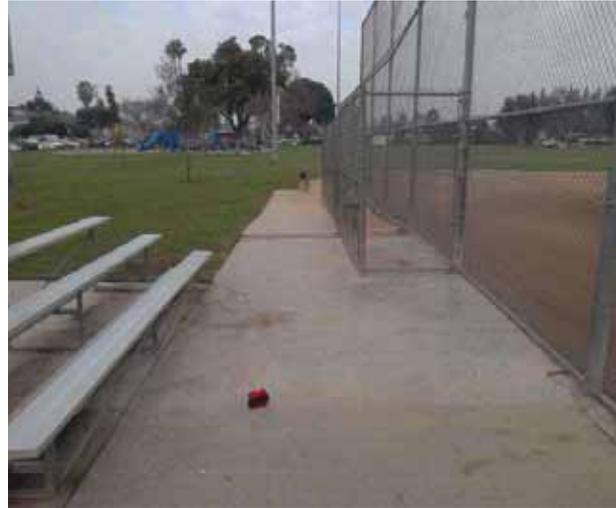
There is a change in elevation greater than recommended value.

Code Reference ADA 303, 403.4, 303.2, CA 11B-303, CA 11B-403.4

Ensure that the change in elevation is within the recommended value.

Recommendation Up to 0.25 inches

Provide smooth surface \$150

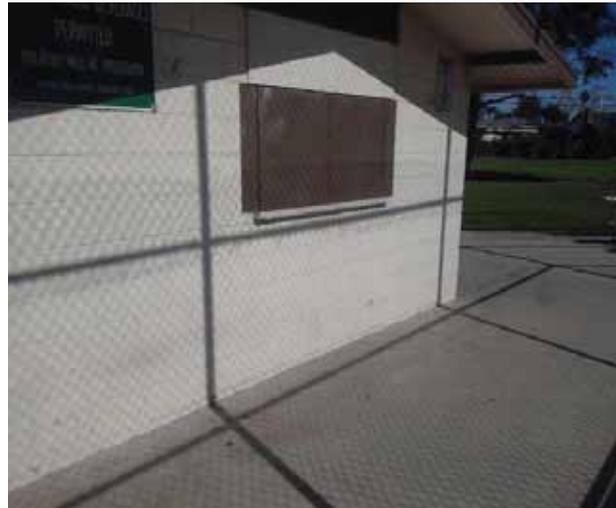
Code Reference ADA 904,CA 11B-904.4

Recommendation Up to 34.00 inches

Provide compliant counter \$329

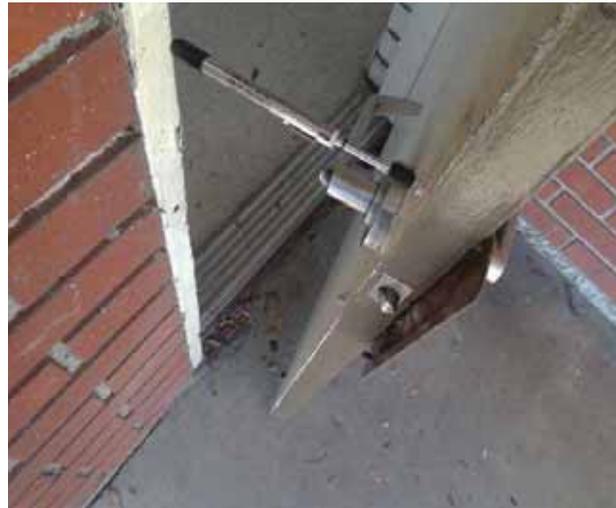
Code Reference ADA 404.2.9,CA 11B-404.2.9

Recommendation Up to 5.00 pounds

Adjust door closer pressure \$25

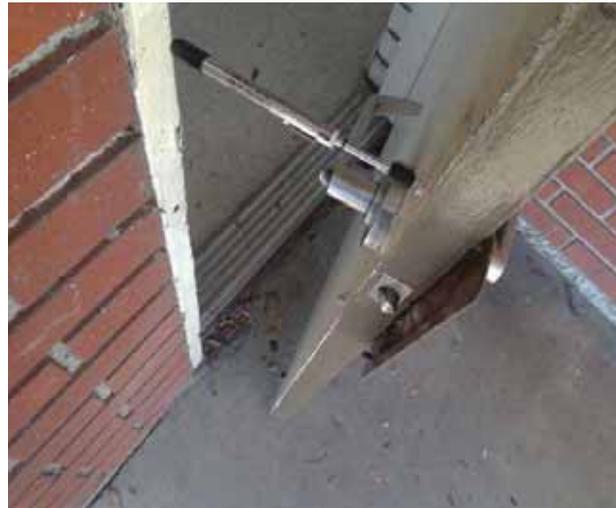
On-Site Finding Found

Code Reference ADA 404, 404.2.10,CA 11B-404.2.10

Remove door stop \$50

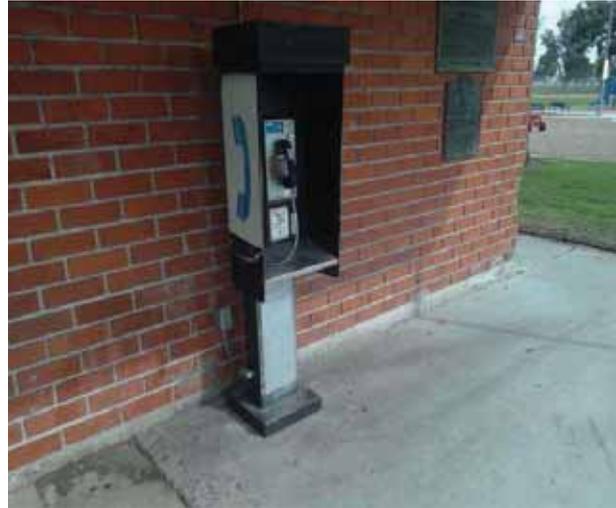
Code Reference ADA 309, 205, 704, 309.3, 704.2.2, CA 11B-309, CA 11B-704.2.2

Recommendation 15.00 - 48.00 inches

Lower public telephones \$458

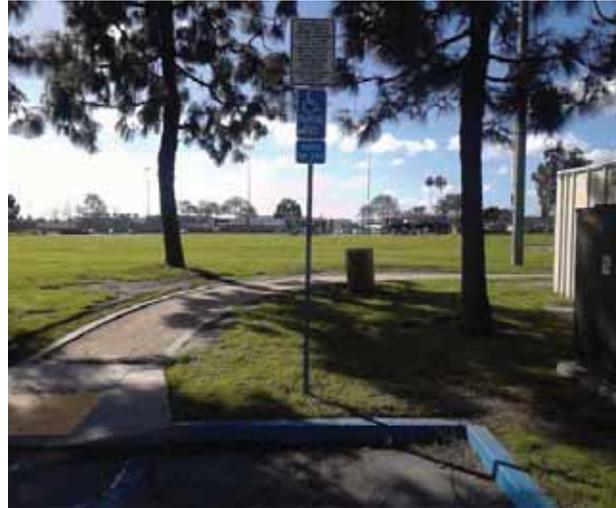
Code Reference CA 11B-502.8.2

Notes : Signage states: "Unauthorized vehicles...may be towed...".

Install signage \$300

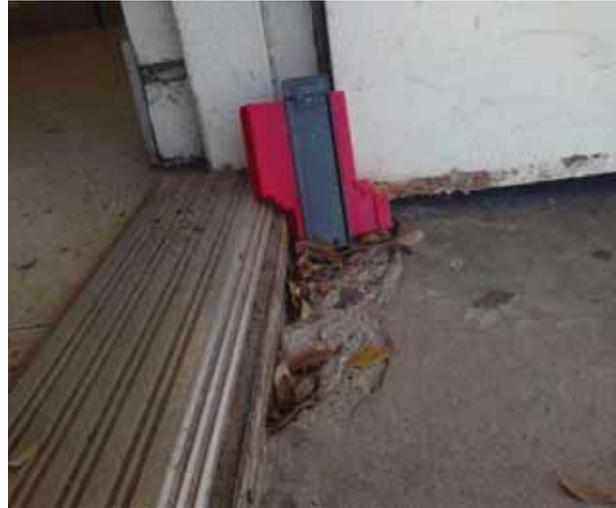
Code Reference ADA 404, 404.2.5,CA 11B-404.2.5

Modify or replace the threshold to provide the recommended height.

Recommendation Up to 0.50 inches

Provide smooth transition \$436

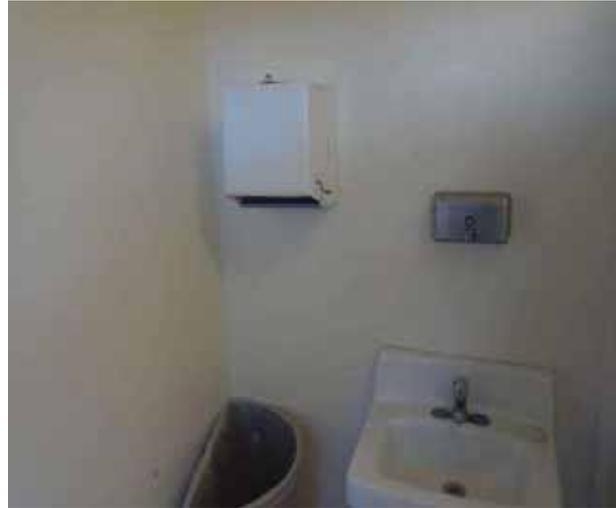
Code Reference ADA 309, 205, 309.4, CA 11B-603.5, CA 11B-309.4

Replace dispenser with one that allows operation with one hand and does not require tight grasping, pinching, or twisting of the wrist. The force required to activate operable parts shall be 5 pounds. Consider installing automatic dispensers.

Provide compliant dispenser \$277

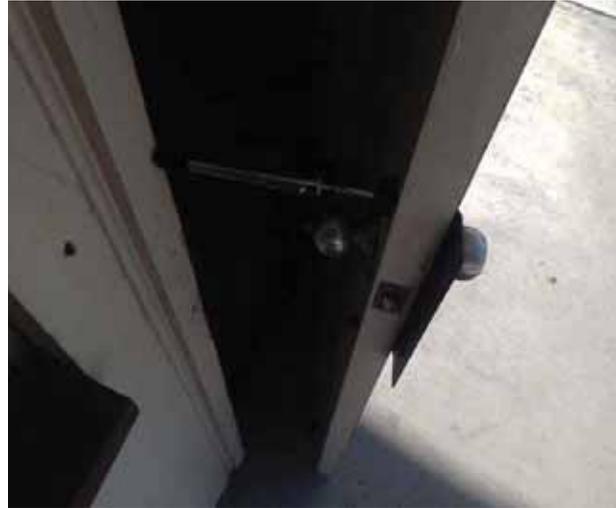
Code Reference ADA 404.2.7, 309.4,CA 11B-404.2.7

Replace existing lock set with lever handled lock set \$800

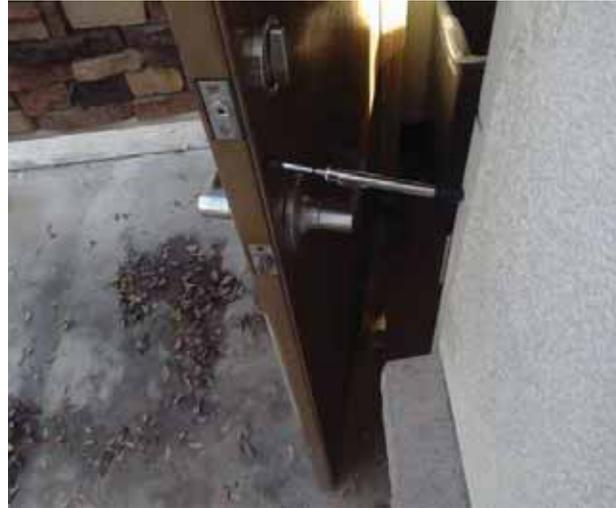
Code Reference ADA 404, 404.2.7,CA 11B-404.2.7

Mount the door hardware at the recommended height.

Recommendation 34.00 - 44.00 inches

Replace door hardware \$280
