Accessibility Survey

Barbara J Riley Community Center

7810 Quill Drive
Downey, CA 90240

Date of Inspection
1/5/2017

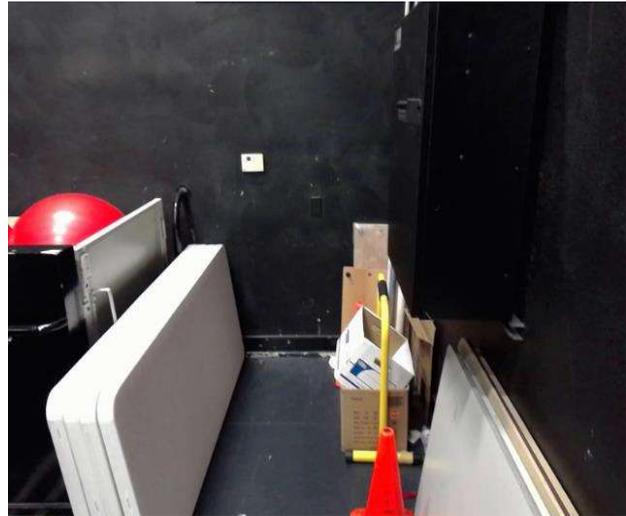
Lighting Control Panel

Path Of Travel , Protruding Objects : Protruding Objects - Protrusion Limit

The leading edge of the wall-mounted item is more than 4 inches from the wall. The item is greater than 27 inches, and less than 80 inches from the floor and protrudes into the primary path of travel.

On-Site Finding 14.00 inches

Install side extensions, modify, relocate, or lower the item so that the leading edge protrudes less than 4 inches from the wall, is less than 27 inches from the floor, or more than 80 inches from the floor.

Install wing walls or relocate object \$640

Code Reference ADA 307, 307.2,CA 11B-307.2

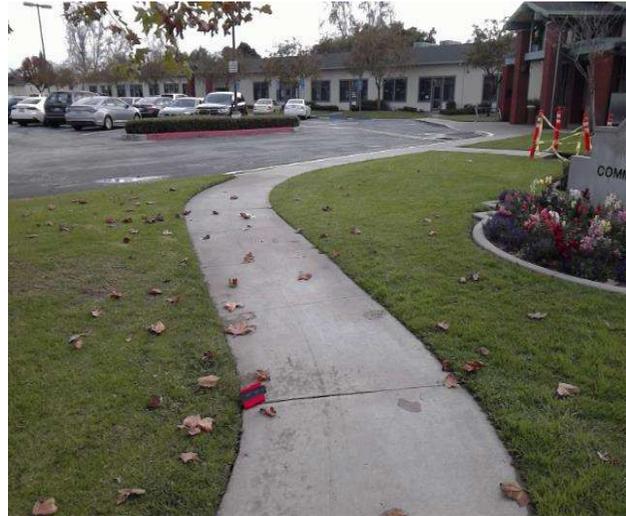
Sidewalk from Quill Drive to Main Entrance

Path Of Travel , Walking Surfaces : Change in Level

There is a change in elevation greater than recommended value.

Ensure that the change in elevation is within the recommended value.

Provide smooth surface \$300

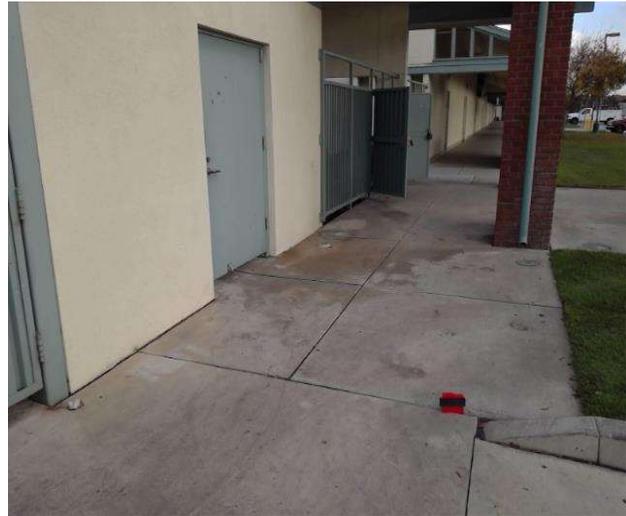
There is a change in elevation greater than recommended value.

Ensure that the change in elevation is within the recommended value.

Provide smooth surface \$150

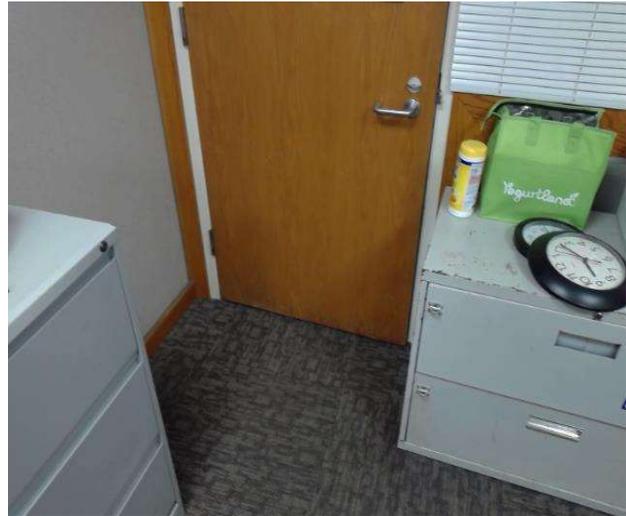
Notes : Cabinet obstruct latch side clearance & clear floor space length.

Install automatic door opener \$4,000

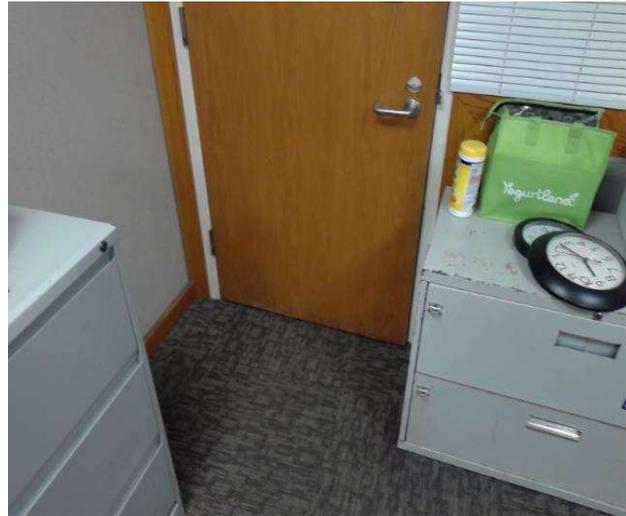
Notes : Cabinet obstruct latch side clearance & clear floor space length.

Provide the recommended clear floor space on the pull side of the door.

Install automatic door opener \$2,921

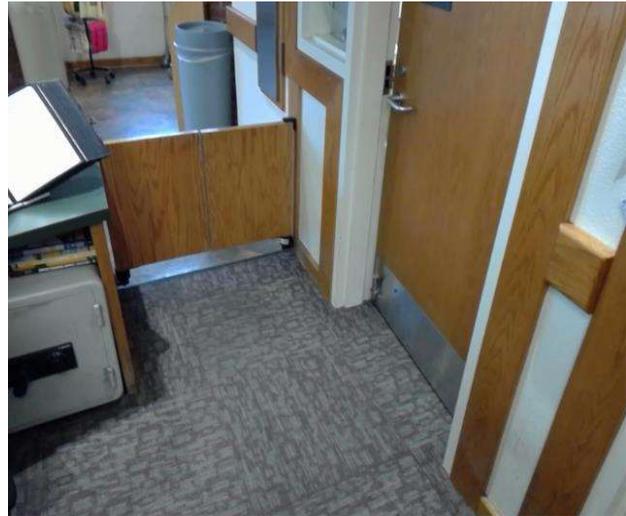
Notes : Counter obstructs clear floor space length.

Provide the recommended clear floor space on the push side of the door.

Install automatic door opener \$4,000

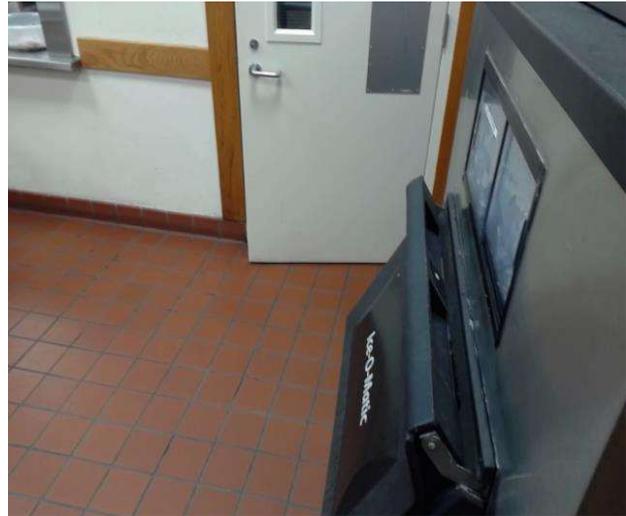
Notes : Ice machine obstructs clear floor space length.

Provide the recommended clear floor space on the pull side of the door.

Install automatic door opener \$2,921

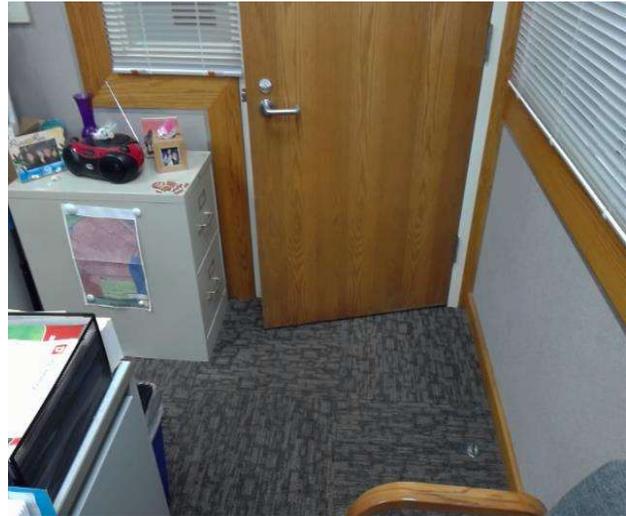
Notes : Cabinet obstructs latch side clearance.

Install automatic door opener \$12,000

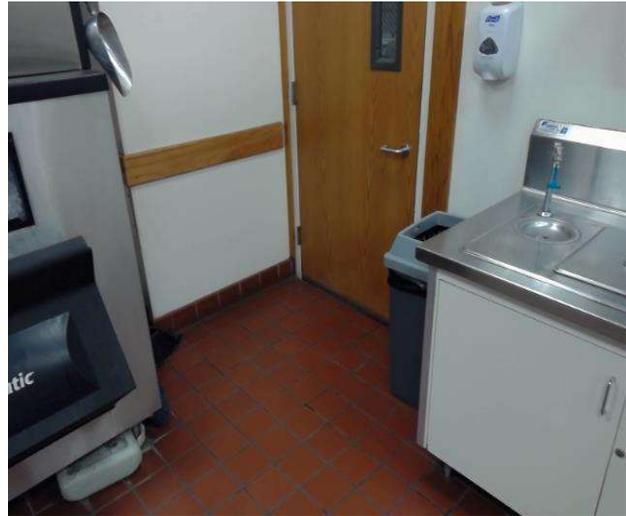
Notes : Ice machine obstructs clear floor space length.

Provide the recommended clear floor space on the pull side of the door.

Install automatic door opener \$2,921

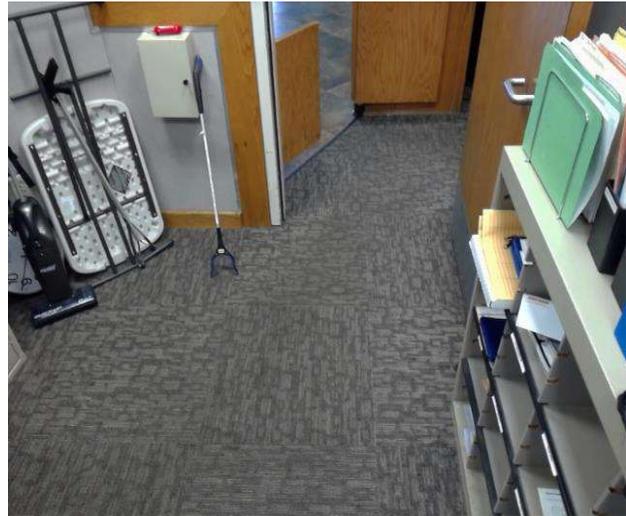
Notes : Cabinet obstructs clear floor space length.

Provide the recommended clear floor space on the pull side of the door.

Install automatic door opener \$2,921

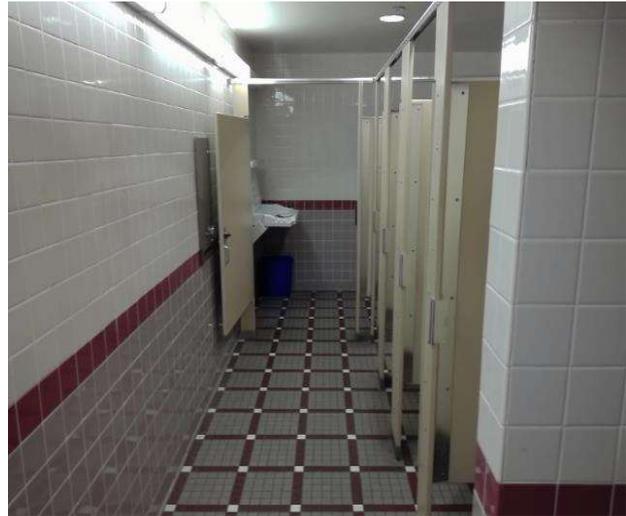
Notes : Waste receptacle obstructs turning space diameter.

Install single-use toilet room \$14,000

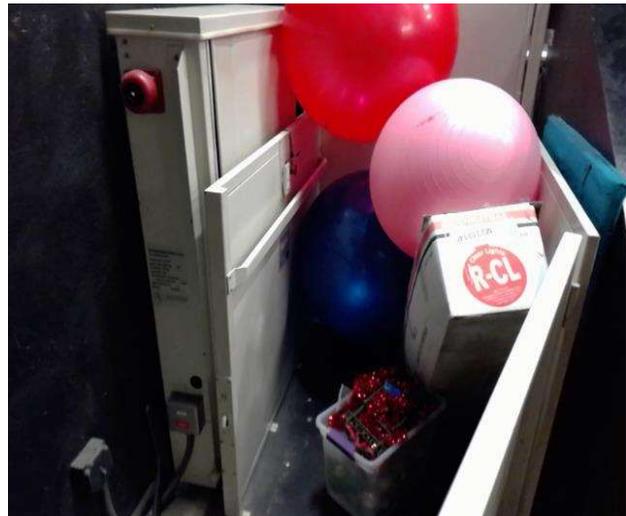
There is no ISA symbol found at the platform lift.

On-Site Finding None Found

Install ISA symbol \$58
