Accessibility Survey

Chamber of Commerce

11131 Brookshire Avenue
Downey, CA 90240

Date of Inspection
1/4/2017

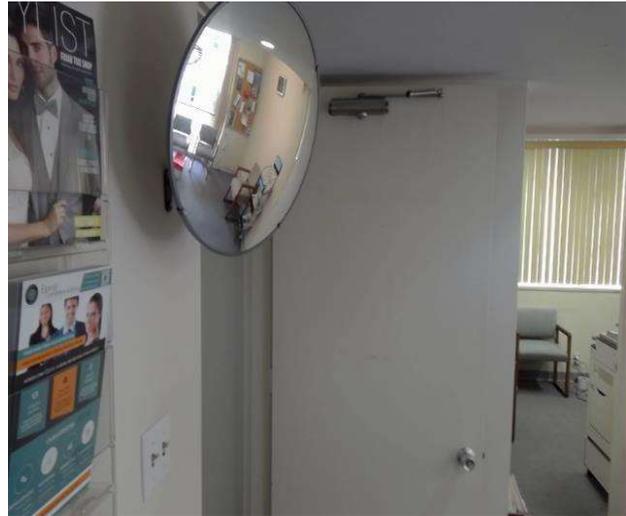
Hallway Door next to Restrooms

Mirror

Path Of Travel , Protruding Objects : Protruding Objects - Protrusion Limit

The leading edge of the wall-mounted item is more than 4 inches from the wall. The item is greater than 27 inches, and less than 80 inches from the floor and protrudes into the primary path of travel.

On-Site Finding 11.00 inches

Code Reference ADA 307, 307.2,CA 11B-307.2

Install side extensions, modify, relocate, or lower the item so that the leading edge protrudes less than 4 inches from the wall, is less than 27 inches from the floor, or more than 80 inches from the floor.

Recommendation Up to 4.00 inches

Install wing walls or relocate object \$640

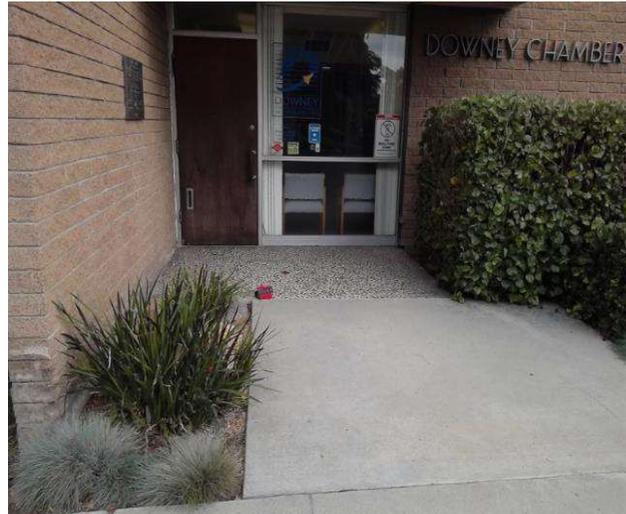
Sidewalk from 2nd Street to the Main Entrance

Change In Level

There is a change in elevation greater than recommended value.

On-Site Finding 0.50 inches

Code Reference ADA 303, 403.4, 303.2, CA 11B-303, CA 11B-403.4

Ensure that the change in elevation is within the recommended value.

Recommendation Up to 0.25 inches

Provide smooth surface \$150

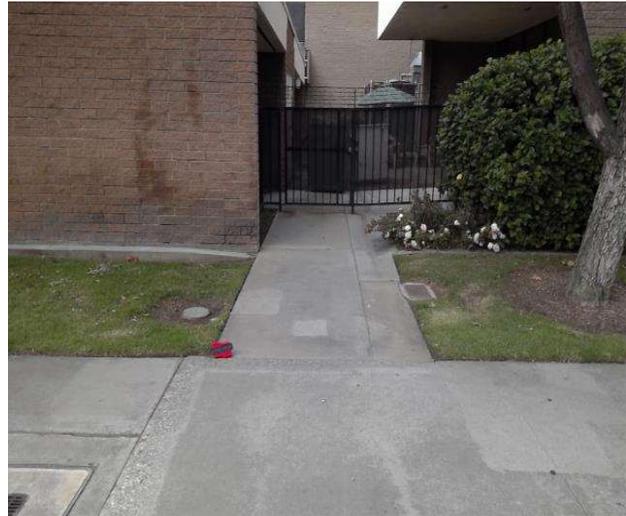
Sidewalk from Brookshire Avenue to Patio Entrance

Change In Level

There is a change in elevation greater than recommended value.

On-Site Finding 0.75 inches

Code Reference ADA 303, 403.4, 303.2, CA 11B-303, CA 11B-403.4

Ensure that the change in elevation is within the recommended value.

Recommendation Up to 0.25 inches

Provide smooth surface \$150

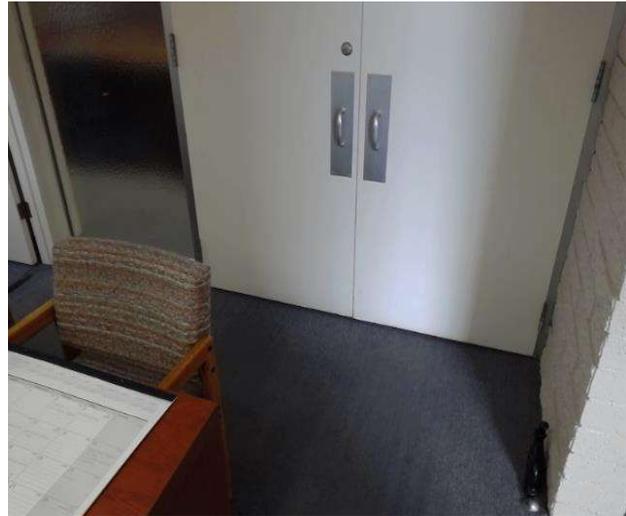
Pull Side

Code Reference ADA 404, 404.2.4, CA 11B-404.2.4

Notes : Desk obstructs clear floor space length.

Provide the recommended clear floor space on the pull side of the door.

Recommendation At least 60.00 inches

Install automatic door opener \$2,921

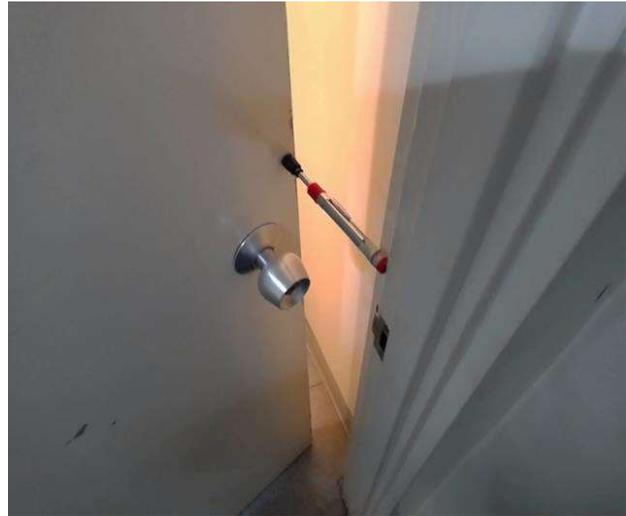
Code Reference ADA 404.2.9,CA 11B-404.2.9

Recommendation Up to 5.00 pounds

Adjust door closer pressure \$25

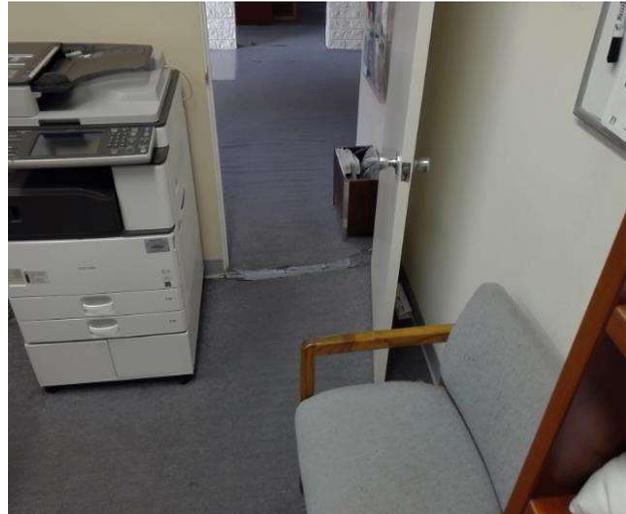
Code Reference ADA 404, 404.2.4,CA 11B-404.2.4.1

Notes : Copy machine obstructs latch side clearance.

Recommendation At least 18.00 inches

Install automatic door opener \$4,000

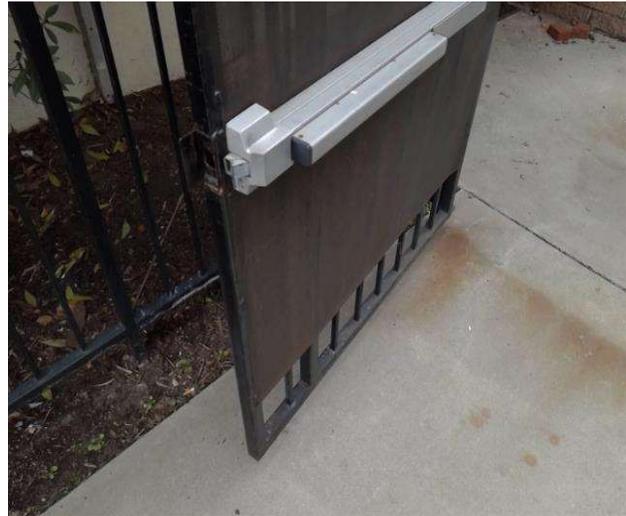
The bottom of the door does not provide a smooth, uninterrupted surface, or panel to allow the door to be opened by a wheelchair footrest without creating a trap or hazardous condition.

On-Site Finding None Found

Code Reference ADA 404, 404.2.10,CA 11B-404.2.10

Install a panel or replace the door to provide a smooth, uninterrupted surface at the bottom of the door.

Recommendation See Recommendation

Install compliant door \$2,000

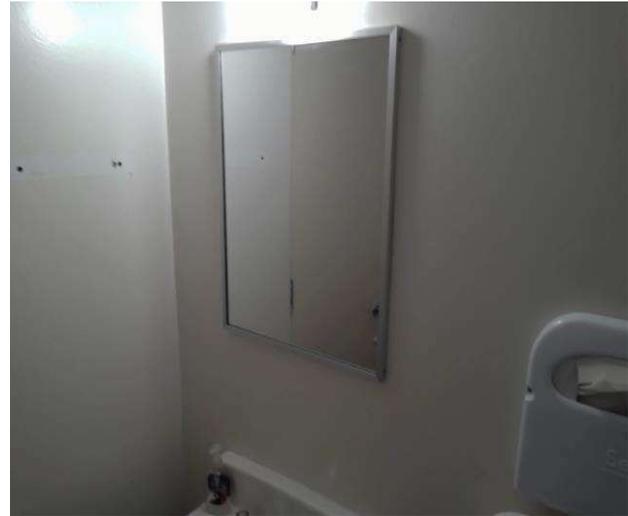
Code Reference ADA 603, 213, 603.3,CA 11B-603.3

Lower the mirror so the bottom edge of the reflective surface is no higher than recommended above the finished floor.

Recommendation Up to 40.00 inches

Lower mirror \$300

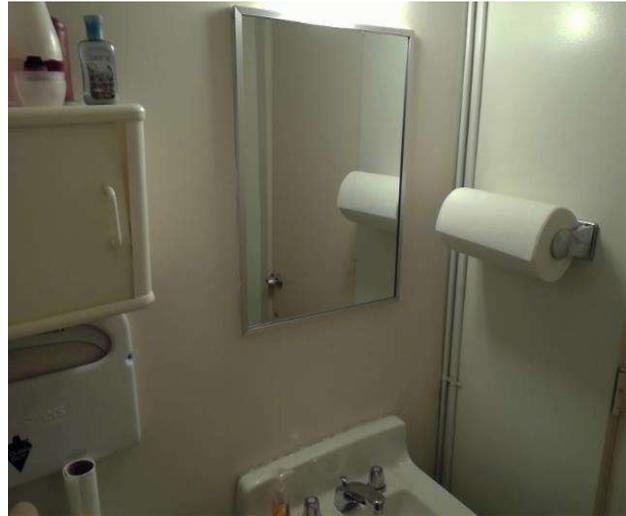
Code Reference ADA 603, 213, 603.3,CA 11B-603.3

Lower the mirror so the bottom edge of the reflective surface is no higher than recommended above the finished floor.

Recommendation Up to 40.00 inches

Lower mirror \$300

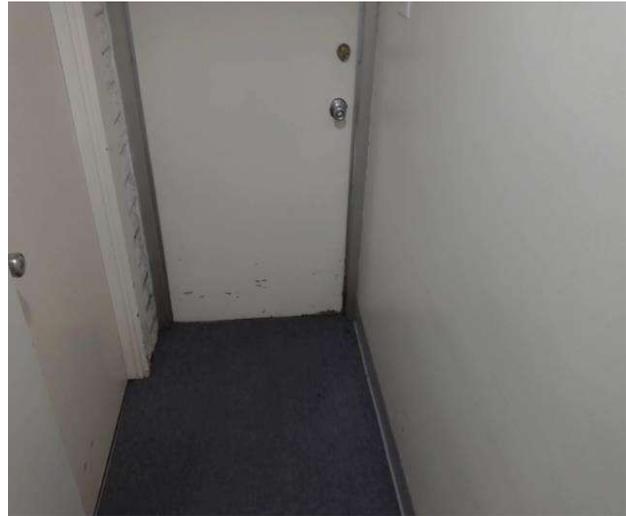
Code Reference ADA 404,CA 11B-404.2.4

Provide the recommended clear floor space on the push side of the door.

Recommendation At least 36.00 inches

Install automatic door opener \$8,000

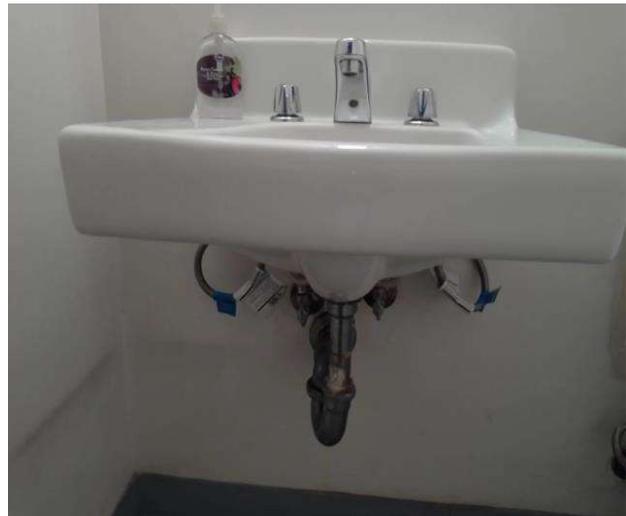
Code Reference ADA 213, 606, 306.3,CA 11B-306.3.3,CA 11B-606.2

Raise or replace the lavatory to provide the minimum required apron height.

Recommendation At least 29.00 inches

Provide compliant lavatory \$2,500

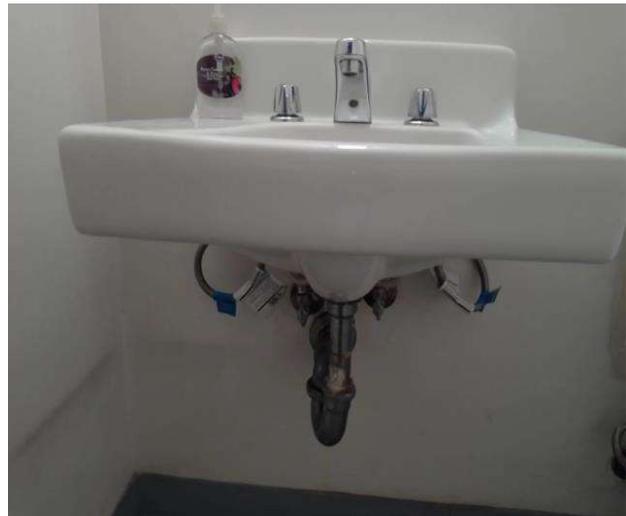
Code Reference CA 11B-606.6

Replace or remount lavatory to meet the minimum required distance to the center line of the fixture, when located adjacent to a side wall or partition.

Recommendation At least 18.00 inches on center

Install new sink, faucet and handles \$2,500

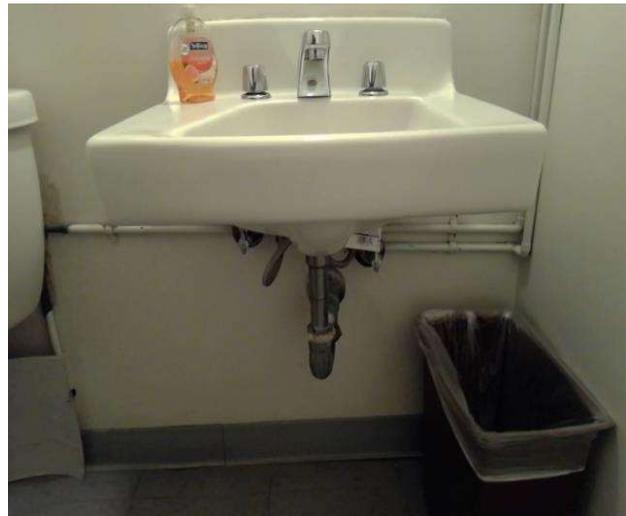
Code Reference CA 11B-606.6

Replace or remount lavatory to meet the minimum required distance to the center line of the fixture, when located adjacent to a side wall or partition.

Recommendation At least 18.00 inches on center

Install new sink, faucet and handles \$2,500
