Accessibility Survey

City Hall

11111 Brookshire Avenue
Downey, CA 90240

Date of Inspection
12/16/2016

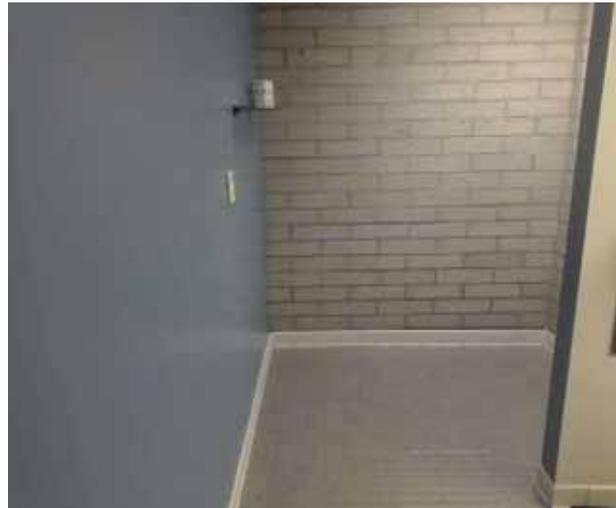
Mens Restroom Next To Council Office Shelf

Path of Travel - 3rd Floor : Path Of Travel , Protruding Objects

Path Of Travel , Protruding Objects : Protruding Objects - Protrusion Limit

The leading edge of the wall-mounted item is more than 4 inches from the wall. The item is greater than 27 inches, and less than 80 inches from the floor and protrudes into the primary path of travel.

On-Site Finding 8.00 inches

Install side extensions, modify, relocate, or lower the item so that the leading edge protrudes less than 4 inches from the wall, is less than 27 inches from the floor, or more than 80 inches from the floor.

Recommendation Up to 4.00 inches

Install wing walls or relocate object \$640

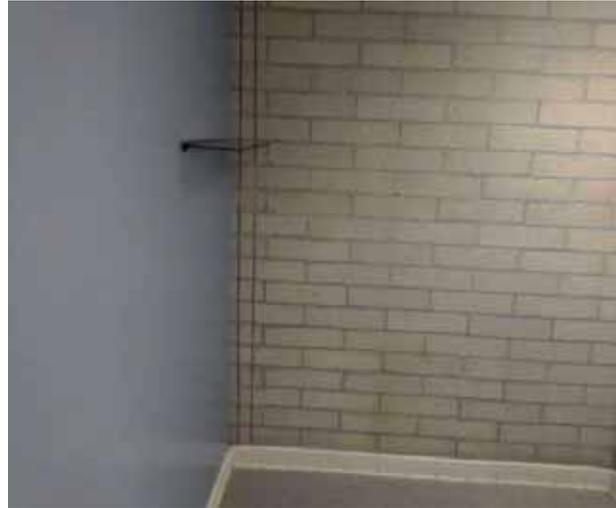
Mens Restroom Next To Credit Union Shelf

Path of Travel - 2nd Floor : Path Of Travel , Protruding Objects

Path Of Travel , Protruding Objects : Protruding Objects - Protrusion Limit

The leading edge of the wall-mounted item is more than 4 inches from the wall. The item is greater than 27 inches, and less than 80 inches from the floor and protrudes into the primary path of travel.

Recommendation Up to 4.00 inches

Install wing walls or relocate object \$640

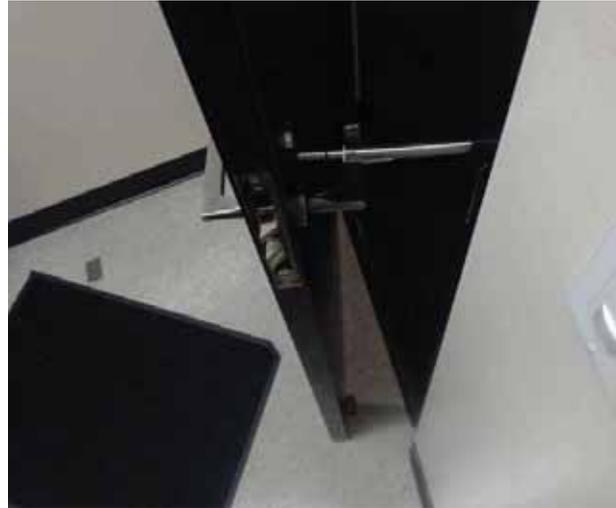
On-Site Finding Found

Recommendation See Recommendation

Remove door stop \$50
