Accessibility Survey

Crawford Park

7000 Dinwiddie Street
Downey, CA 90240

Date of Inspection
1/14/2017

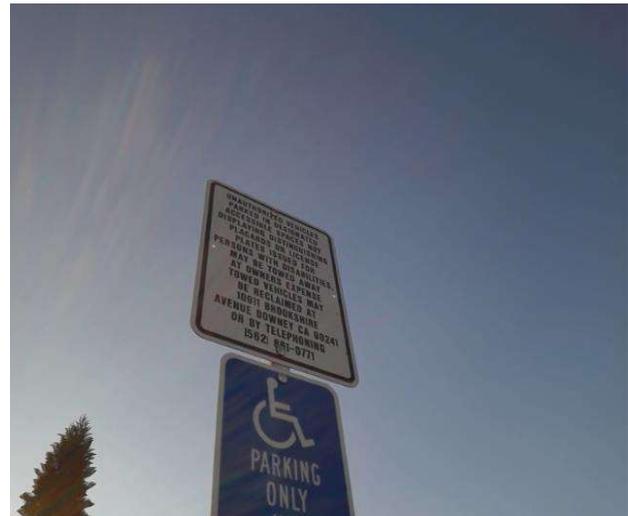
Parking Lot , Warning Signage : Parking Lot Warning Sign Wording Incorrect

There is warning signage posted regarding unauthorized use of accessible parking spaces in the parking lot, though the signage does not contain the correct wording and/or the blank spaces which should furnish the point of contact and telephone number for reclaiming towed vehicles have been left blank.

On-Site Finding Incorrect Wording

Notes : Signage states: "Unauthorized vehicles...may be towed...".

Provide a compliant warning sign regarding unauthorized use of accessible parking spaces in the parking lot. Fill in the blank spaces with are required to furnish point of contact and telephone number for reclaiming towed vehicles with the appropriate information as a permanent part of the sign and maintain the currency of the information.

Install signage \$300

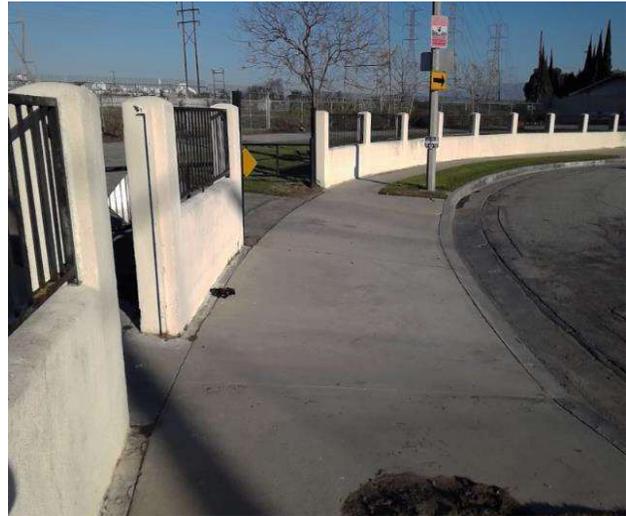
Signage , Signage : No Directional or Information Signage

There is no directional signage.

Install directional signage to each accessible element or room.

Install signage \$158

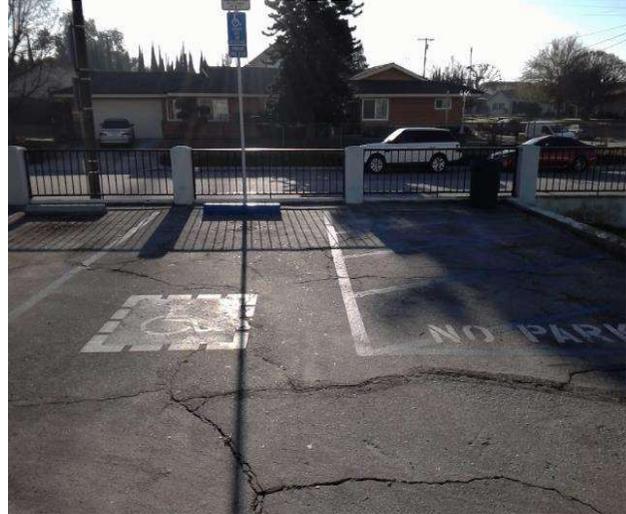
Parking Lot , Parking Space : Access Aisle Striping

The hatched lines are striped greater than 36" on center or are not painted a contrasting color.

On-Site Finding Not on 36" center

Re-stripe the hatched lines in a contrasting color up to 36" on center.

Re-stripe lines \$350

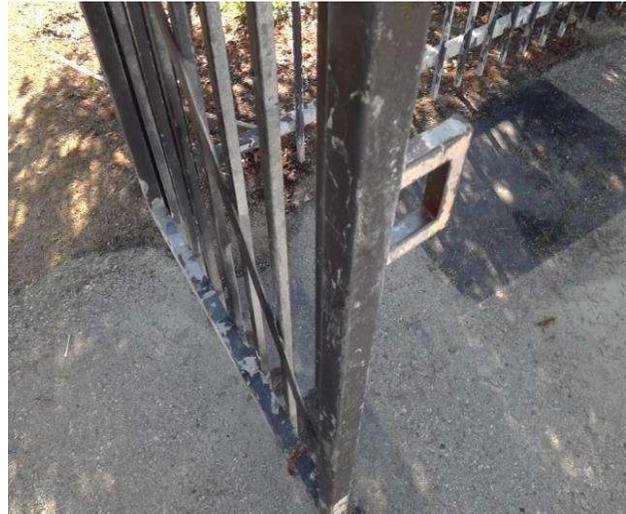
Door , Hardware : Bottom Door Panel

The bottom of the door does not provide a smooth, uninterrupted surface, or panel to allow the door to be opened by a wheelchair footrest without creating a trap or hazardous condition.

Install a panel or replace the door to provide a smooth, uninterrupted surface at the bottom of the door.

Install compliant door \$2,000

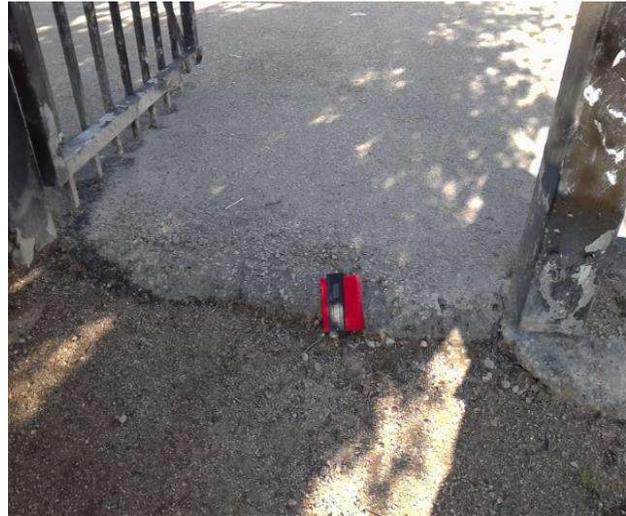
Door , Threshold : Door Threshold

The height of the threshold at the entrance door is greater than allowed.

On-Site Finding 3.00 inches

Modify or replace the threshold to provide the recommended height.

Recommendation Up to 0.50 inches

Provide smooth transition \$436

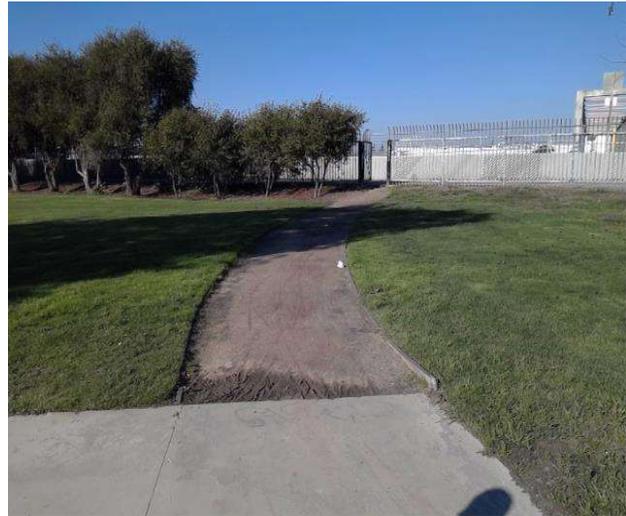
Path Of Travel , Walking Surfaces : Noncompliant Surface

The path of travel is grass, dirt, or gravel, preventing access to individuals with mobility impairments.

On-Site Finding Dirt, Grass or Gravel

Provide an accessible route.

Install pathway \$1,840

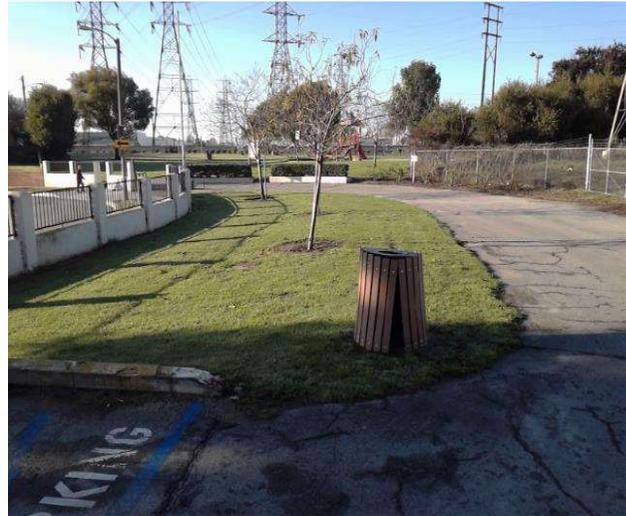
Path Of Travel , Walking Surfaces : Noncompliant Surface

The path of travel is grass, dirt, or gravel, preventing access to individuals with mobility impairments.

On-Site Finding Dirt, Grass or Gravel

Provide an accessible route.

Install pathway \$1,840

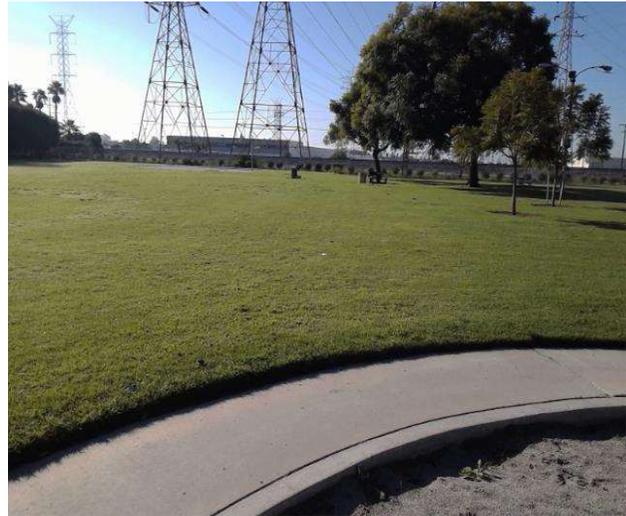
Path Of Travel , Walking Surfaces : Noncompliant Surface

The path of travel is grass, dirt, or gravel, preventing access to individuals with mobility impairments.

On-Site Finding Dirt, Grass or Gravel

Provide an accessible route.

Install pathway \$1,840

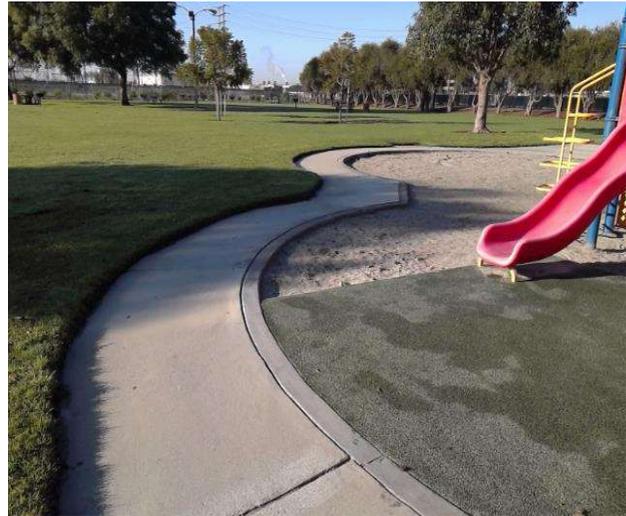
Path Of Travel , Walking Surfaces : Walking Surface Cross Slope

There are cross slopes greater than allowed on the primary path of travel.

On-Site Finding 5.00 percent for 163.00 feet

Provide a compliant path of travel.

Recommendation Up to 2.08 percent

Install pathway \$3,600

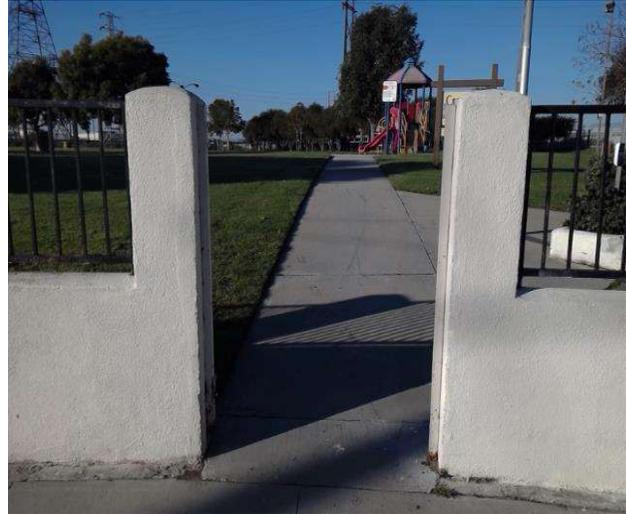
Path Of Travel , Walking Surfaces : Walking Surface Slope

There are slopes greater than allowed maximum slope on the primary path of travel.

On-Site Finding 11.60 percent for 25.00 feet

Provide a compliant path of travel.

Recommendation Up to 5.00 percent

Install pathway \$3,600

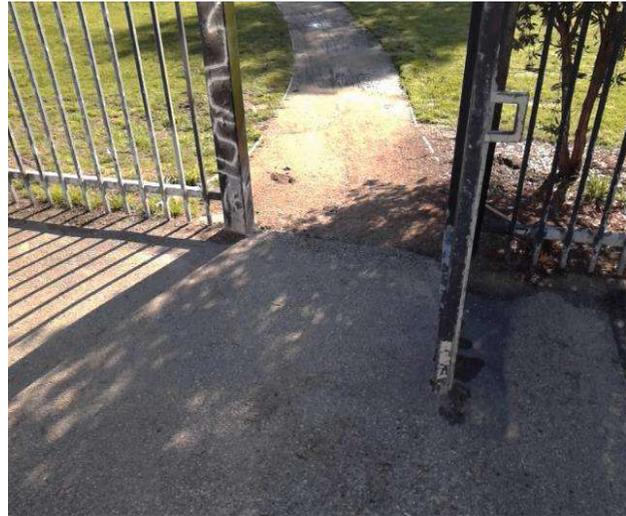
Door , Clear Floor Space : Floor Surface Slope

There is no level landing at this door.

On-Site Finding 3.70 percent

Provide a level landing.

Recommendation Up to 2.08 percent

Correct slopes \$1,500

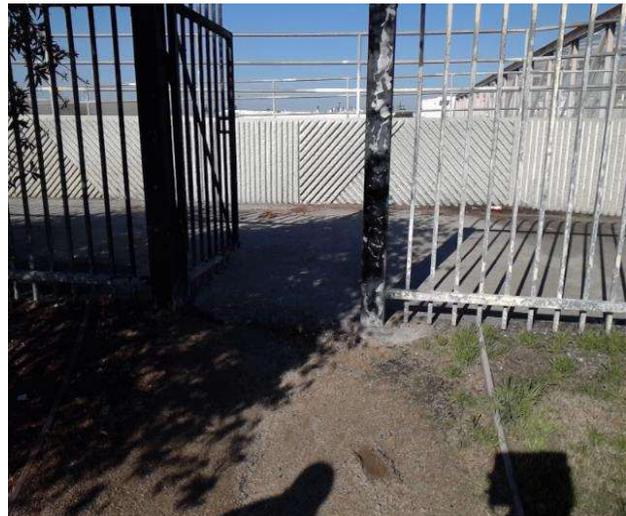
Door , Clear Floor Space : Floor Surface Slope

There is no level landing at this door.

On-Site Finding 13.30 percent

Notes : Landing is dirt/grass/gravel.

Provide a level landing.

Recommendation Up to 2.08 percent

Correct slopes \$1,500

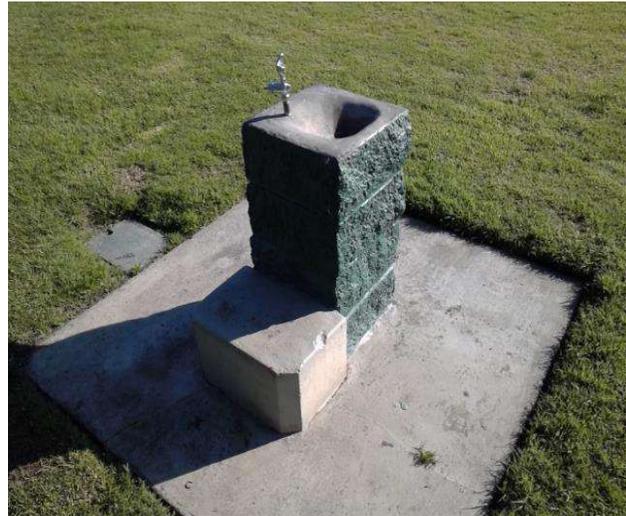
Drinking Fountain : Fountain Type

The provided drinking fountain is not a Hi-Low fountain.

On-Site Finding Fountain Not Compliant

Notes : Not operational at time of inspection.

Replace the drinking fountain with a compliant Hi-Low fountain.

Install new high/low fountain \$2,500

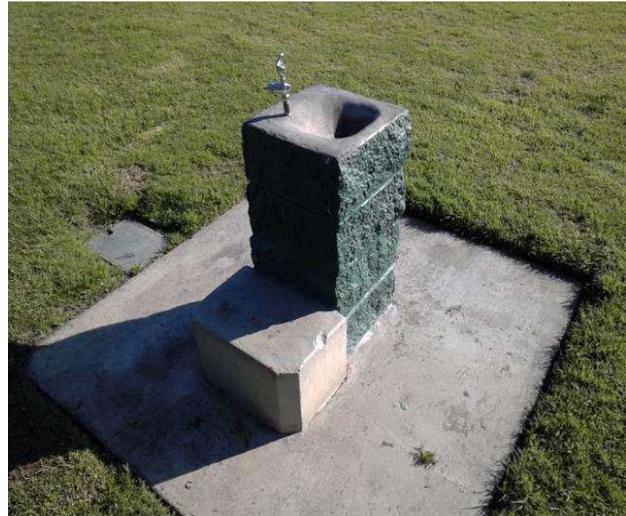
Drinking Fountain : Toe Clearance

The toe clearance is less than required.

On-Site Finding 0.00 inches

Provide a fountain with the required knee and toe clearances.

Recommendation At least 9.00 inches

Install new high/low fountain \$2,500

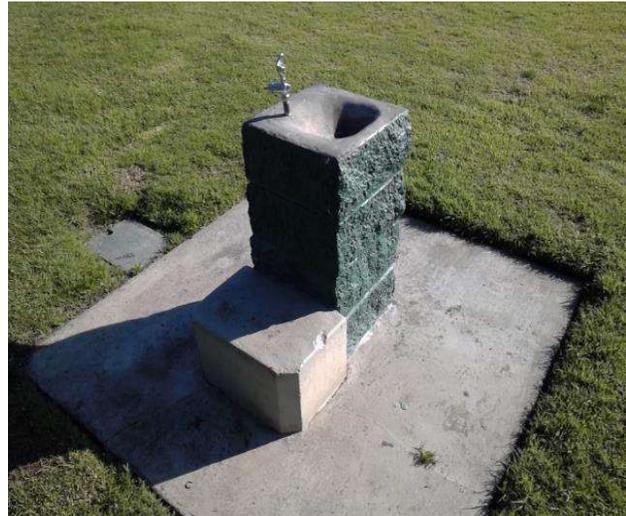
Drinking Fountains : Drinking Fountain

The drinking fountain is not on accessible route.

Make sure the drinking fountain is on an accessible route.

\$1,840

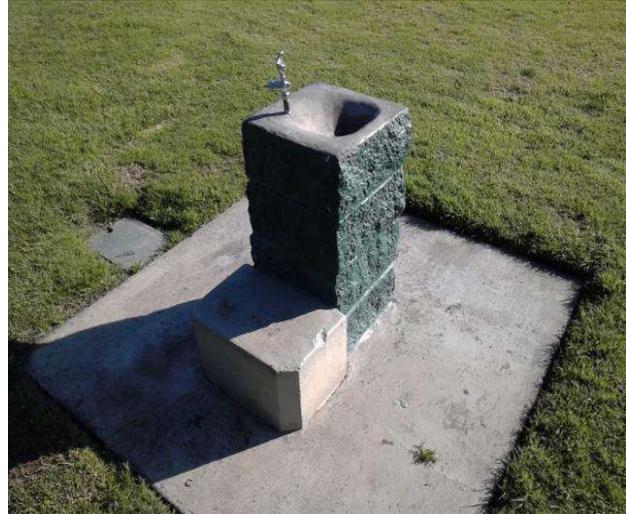
Drinking Fountain : Knee Clearance

There is less than the required minimum knee clearance height.

On-Site Finding 0.00 inches

Provide a fountain with the required knee and toe clearances.

Recommendation At least 27.00 inches

Install new high/low fountain \$2,500

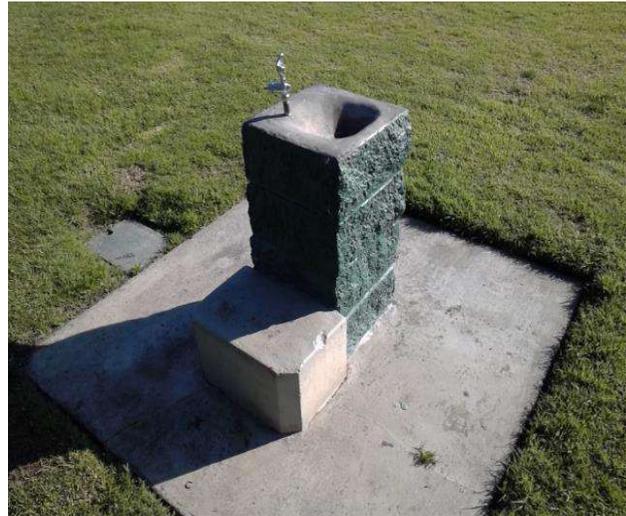
Drinking Fountain : Spout Height

The spout outlet height is greater than required.

On-Site Finding 39.00 inches

Provide a spout outlet that does not exceed the required height.

Recommendation Up to 36.00 inches

Install new wall-mounted fountain \$627

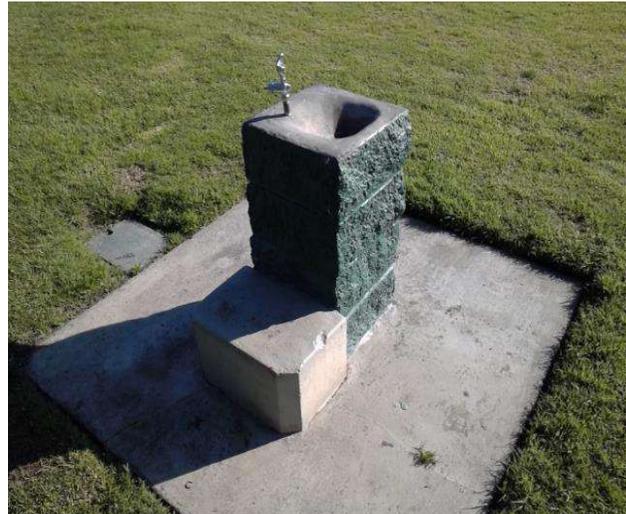
Drinking Fountain : Spout Distance to Front

The distance from the front edge of the unit (including bumpers) to the spout location, is greater than the allowed maximum distance.

On-Site Finding 5.50 inches

Make sure that the distance from the front of the fountain to the flow of the water is not greater than the allowed maximum distance.

Recommendation Up to 5.00 inches

Install new high/low fountain \$2,500

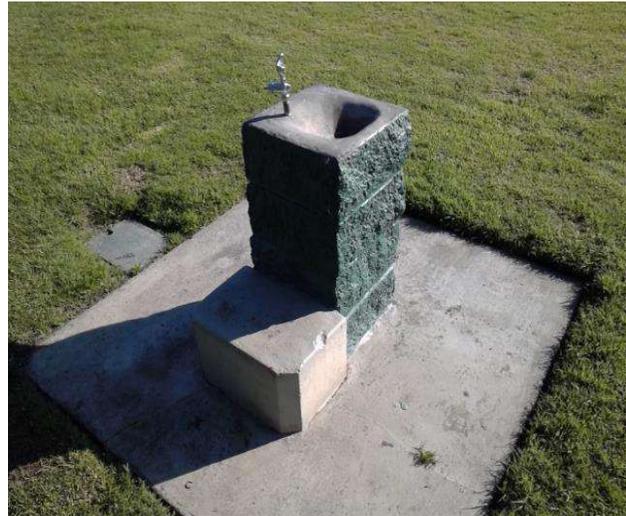
Drinking Fountain : Stream Height

The height of the water stream is less than required.

On-Site Finding 0.00 inches

Insure that the spout directs the water flow to the required height and in a trajectory that is parallel or nearly parallel to the front of the drinking fountain.

Recommendation At least 4.00 inches

Install new high/low fountain \$2,500

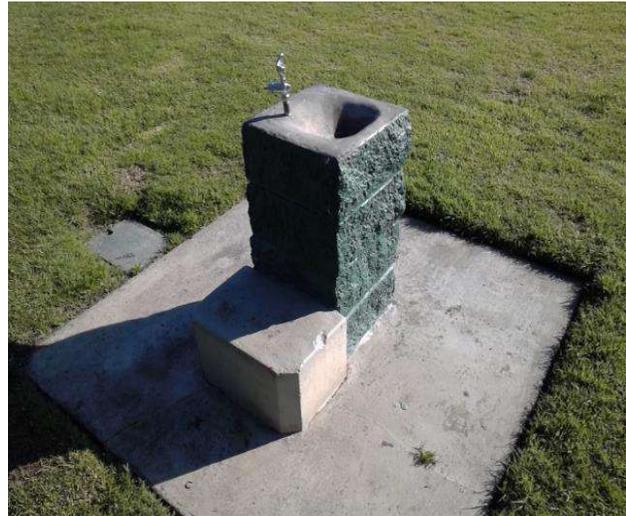
Drinking Fountain : Clear Floor Space Length

There is insufficient clear floor space in front of the drinking fountain.

On-Site Finding 15.50 inches

Provide the required clear floor space that is on a primary path of travel.

Recommendation At least 48.00 inches

Make aisles accessible \$660

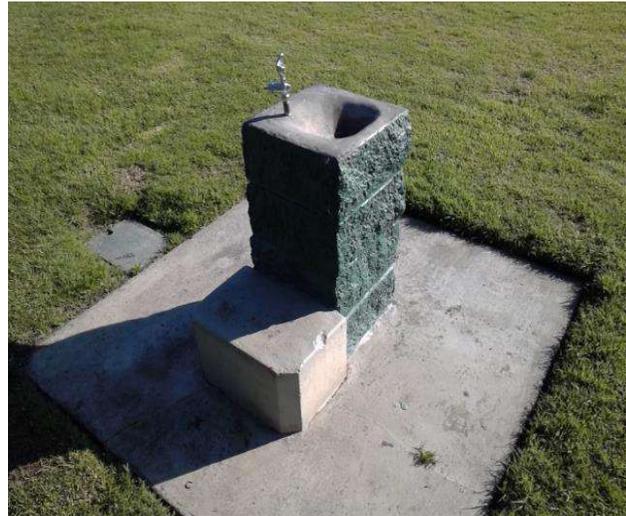
Drinking Fountain : Control Missing/Broken

The drinking fountain control is either missing or broken.

On-Site Finding Not Compliant

Provide compliant control for the drinking fountain.

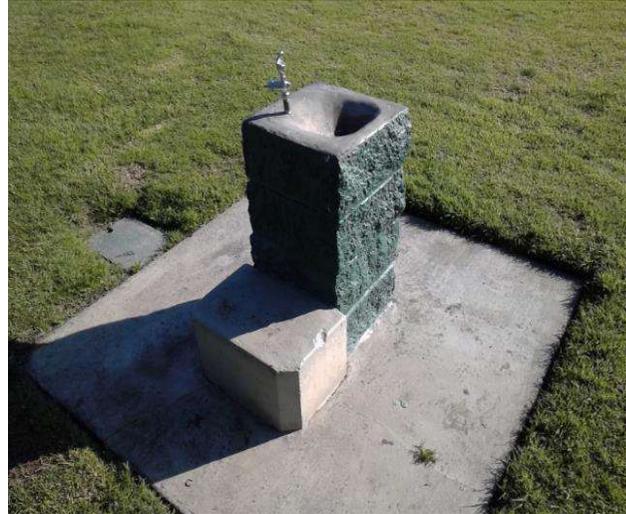
Drinking Fountain : Fountain Depth

Drinking fountain does not provide a required fountain depth.

On-Site Finding 16.75 inches

Install a drinking fountain the meets the required minimum depth.

Recommendation At least 18.00 inches

Install new wall-mounted fountain \$2,500

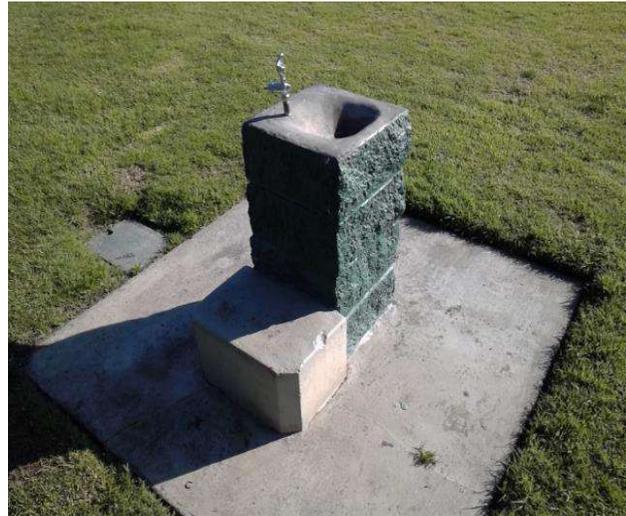
Drinking Fountain : No Detectable Warnings

The drinking fountain is not set entirely in an alcove.

If the drinking fountain is not set in an alcove it shall provide a side rail or wing wall next to each side of the fountain to prevent it from protruding into the primary path of travel.

Install wing walls or relocate object \$640

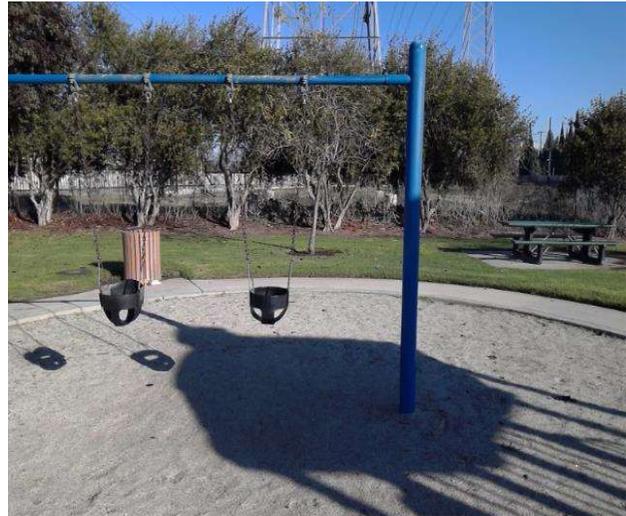
Play Area : Surface Type

The surface beneath the play area is non-accessible to individuals with mobility impairments.

On-Site Finding Not Accessible

The play area should be made an accessible play area for the facility. Provide a maneuvering space with an accessible resilient surface beneath the play components and adjacent to the play components where technically feasible.

Provide compliant and resilient surface \$500

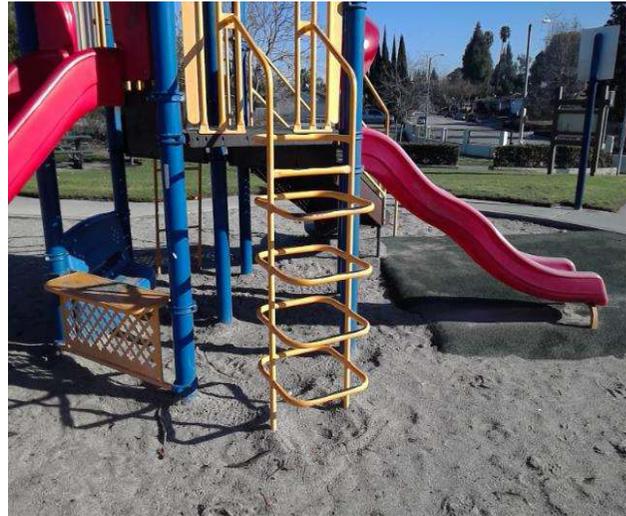
Play Area : Surface Type

The surface beneath the play area is non-accessible to individuals with mobility impairments.

On-Site Finding Not Accessible

Provide compliant and resilient surface \$500

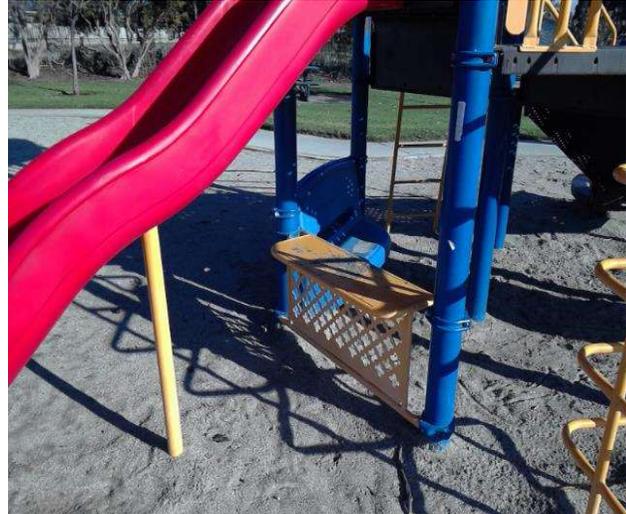
Play Area : Surface Type

Provide compliant and resilient surface \$500
