Accessibility Survey

Dennis The Menace Park

9125 Arrington Avenue
Downey, CA 90240

Date of Inspection
5/1/2017

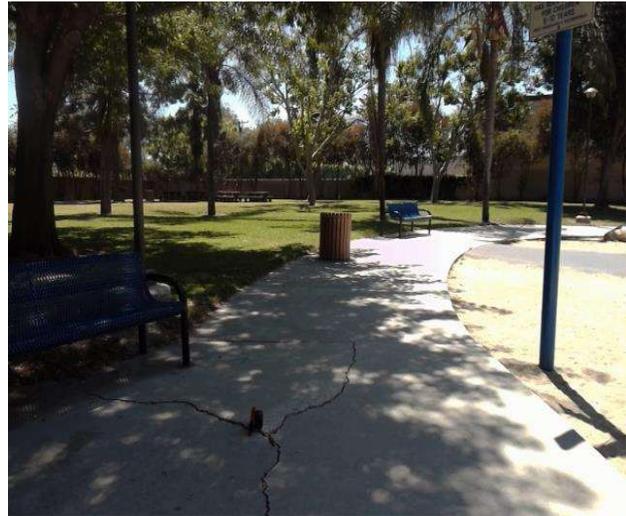
Sidewalk around Play Areas next to Restroom Building

Change In Level

There is a change in elevation greater than recommended value.

On-Site Finding 0.50 inches

Ensure that the change in elevation is within the recommended value.

Recommendation Up to 0.25 inches

Provide smooth surface \$450

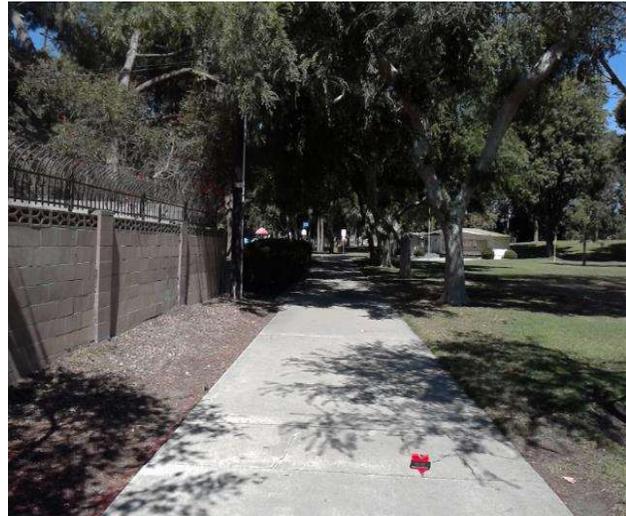
Sidewalk from the Accessible Spaces To Play Areas next to Restroom Building

Change In Level

There is a change in elevation greater than recommended value.

On-Site Finding 0.75 inches

Ensure that the change in elevation is within the recommended value.

Recommendation Up to 0.25 inches

Provide smooth surface \$300

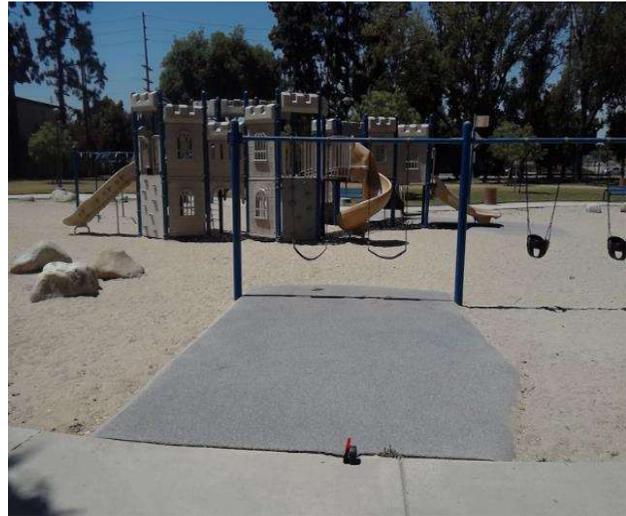
Change In Level

Recommendation Up to 0.25 inches

Provide smooth surface \$640

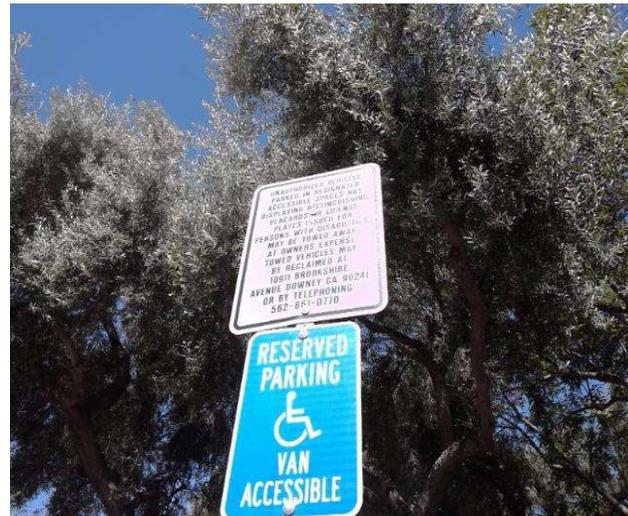
Notes : Signage states: "Unauthorized vehicles...may be towed...".

Install signage \$300

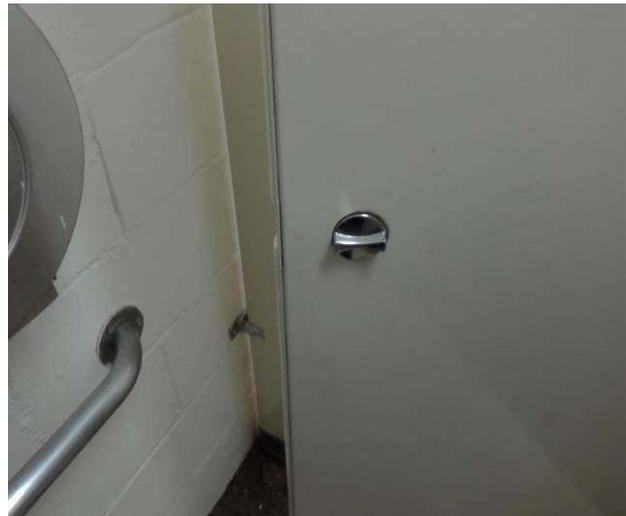
On-Site Finding Missing Hardware

Install accessible hardware on stall door \$269

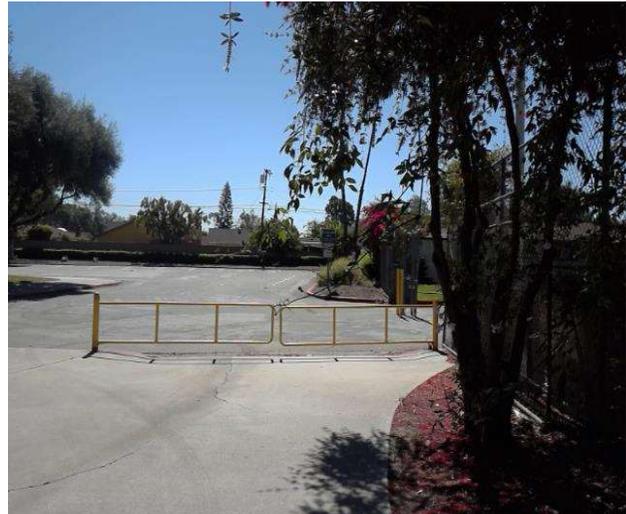
Path of Travel - Exterior : Path Of Travel , Vertical Hazards

Path Of Travel , Vertical Hazards : Protruding Objects - Vertical Clearance

Provide recommended vertical clearance.

Recommendation At least 80.00 inches

Provide recommended clearance \$108
