## Accessibility Survey

### Golden Park

8840 Golden Avenue  
Downey, CA 90240

Date of Inspection  
12/21/2016

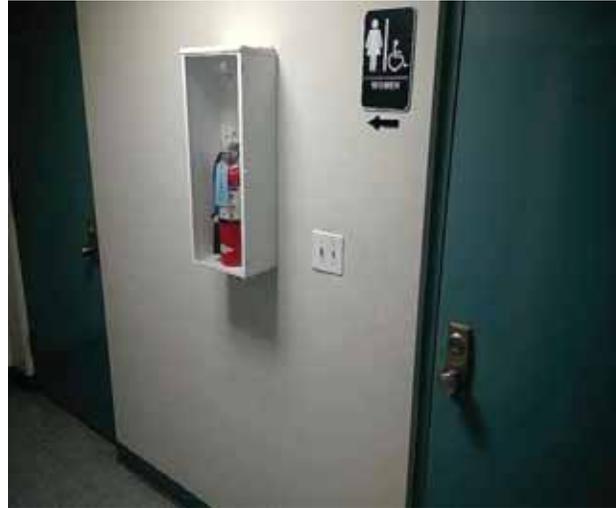
**Fire Extinguisher**

**Hallway to Womens Restroom**

Path Of Travel , Protruding Objects : Protruding Objects - Protrusion Limit

The leading edge of the wall-mounted item is more than 4 inches from the wall. The item is greater than 27 inches, and less than 80 inches from the floor and protrudes into the primary path of travel.

**On-Site Finding** 6.25 inches

Install side extensions, modify, relocate, or lower the item so that the leading edge protrudes less than 4 inches from the wall, is less than 27 inches from the floor, or more than 80 inches from the floor.

Recommendation Up to 4.00 inches

Install wing walls or relocate object \$640

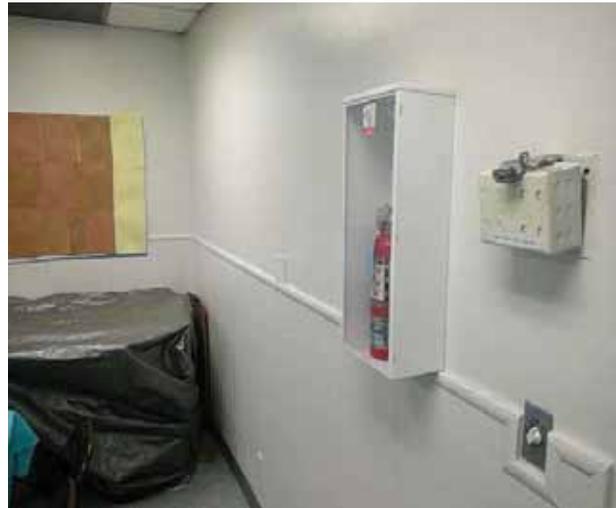
**Path of Travel - Activity Center : Path Of Travel , Protruding Objects**

**Recommendation**

Recommendation Up to 4.00 inches

Install wing walls or relocate object \$640

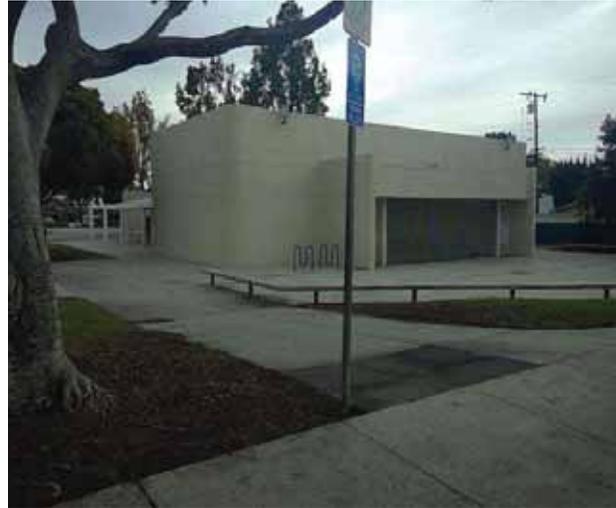
There is a change in elevation greater than recommended value.

Ensure that the change in elevation is within the recommended value.

Recommendation Up to 0.25 inches

Provide smooth surface \$150

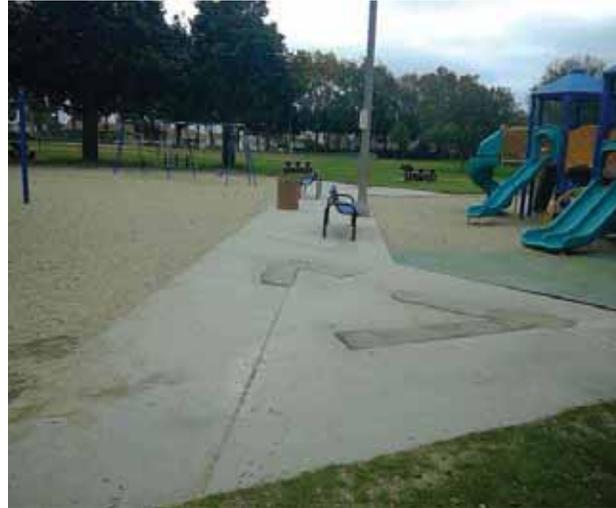
There is a change in elevation greater than recommended value.

Recommendation Up to 0.50 inches

Patch pathway \$480

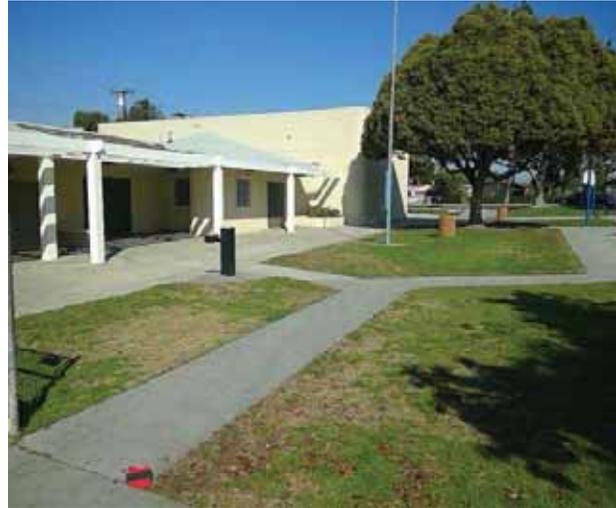
There is a change in elevation greater than recommended value.

Ensure that the change in elevation is within the recommended value.

Recommendation Up to 0.25 inches

Provide smooth surface \$150

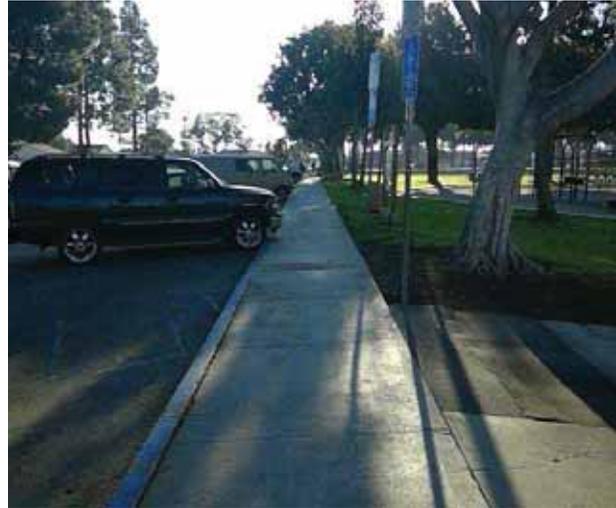
There is a change in elevation greater than recommended value.

Ensure that the change in elevation is within the recommended value.

Recommendation Up to 0.25 inches

Provide smooth surface \$150

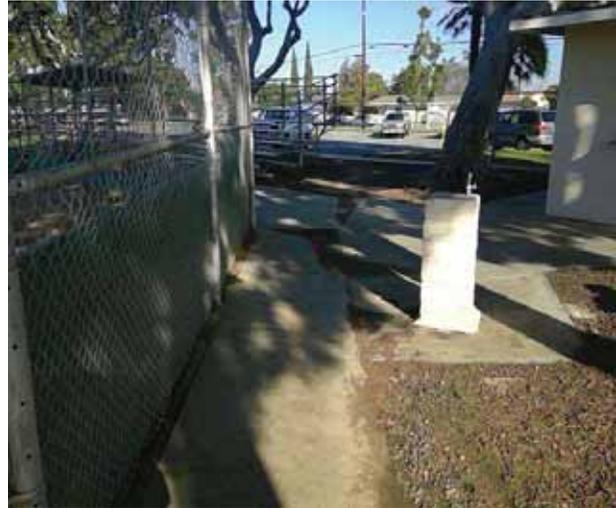
There is a change in elevation greater than recommended value.

Ensure that the change in elevation is within the recommended value.

Recommendation Up to 0.25 inches

Provide smooth surface \$450
