Accessibility Survey

Public Works Maintenance Yard

12324 Bellflower Boulevard
Downey, CA 90240

Date of Inspection
12/13/2016

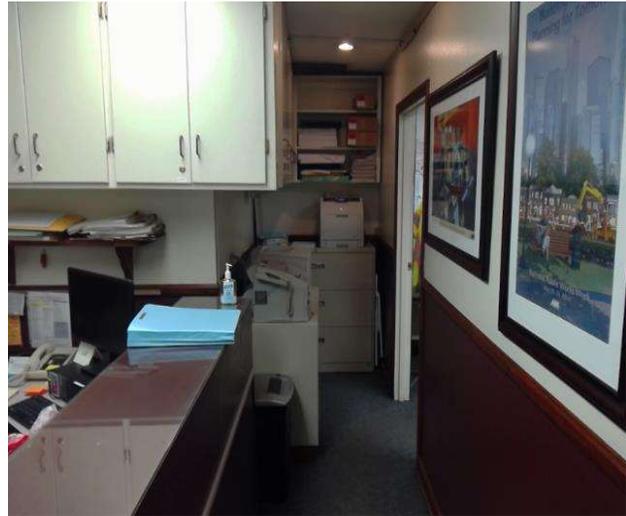
Path Of Travel , Vertical Hazards : Protruding Objects - Vertical Clearance

The vertical clearance height is less than required.

On-Site Finding 61.75 inches

Provide recommended vertical clearance.

Recommendation At least 80.00 inches

Provide recommended clearance \$108

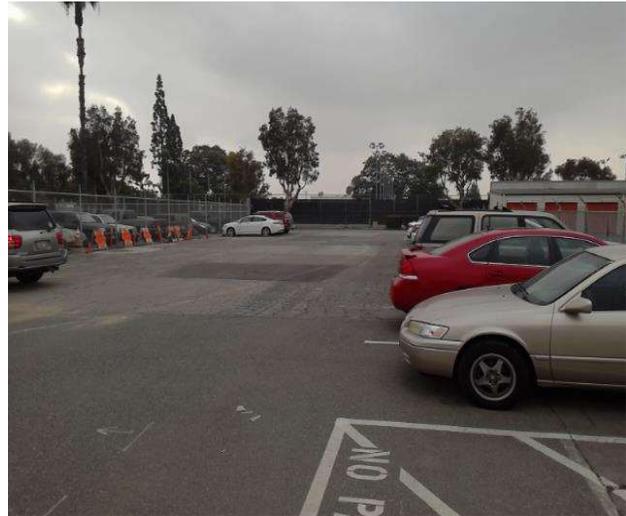
Parking Lot , Parking Space : No Accessible Parking Spaces Available

There are not enough accessible parking spaces marked in the parking lot and therefore does not meet the minimum number required.

On-Site Finding None Found

Re-stripe any existing parking spaces marked accessible and create additional accessible parking spaces. Designate one parking space as "van-accessible".

Paint ground markings and install a post mounted sign \$370

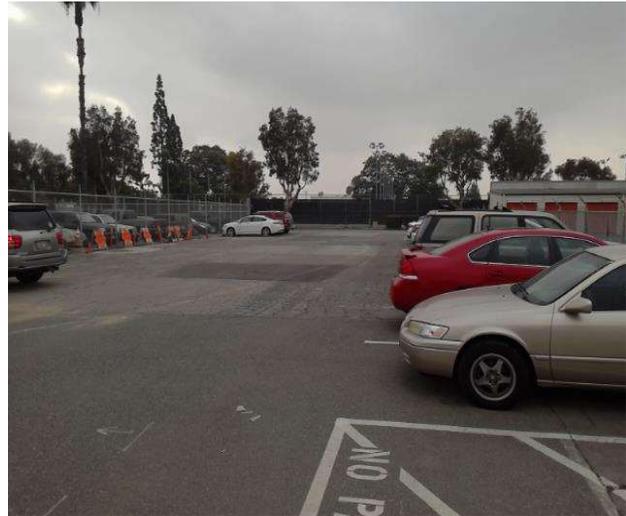
Parking Lot , Warning Signage : No Parking Lot Warning Sign

There is no warning signage posted regarding unauthorized use of accessible parking spaces in the parking lot.

On-Site Finding None Found

Post a sign in a conspicuous place to the entrance of the parking lot, or immediately adjacent to and visible from each accessible parking space. The warning sign shall measure at least 17 inches by 22 inches in size and consist of lettering at least 1 inch in height that clearly and conspicuously states the following; "Unauthorized vehicles parked in designated accessible spaces not displaying distinguishing placards or license plates issued for persons with disabilities will be towed away at owner's expense. Towed vehicles may be reclaimed at ____ or by telephoning ____ ." Fill in the blank spaces with appropriate information as a permanent part of the sign and maintain the currency of the information.

Install post mounted sign \$250
