Accessibility Survey

Transportation Depot Center

8150 Nance Avenue
Downey, CA 90240

Date of Inspection
10/22/2016

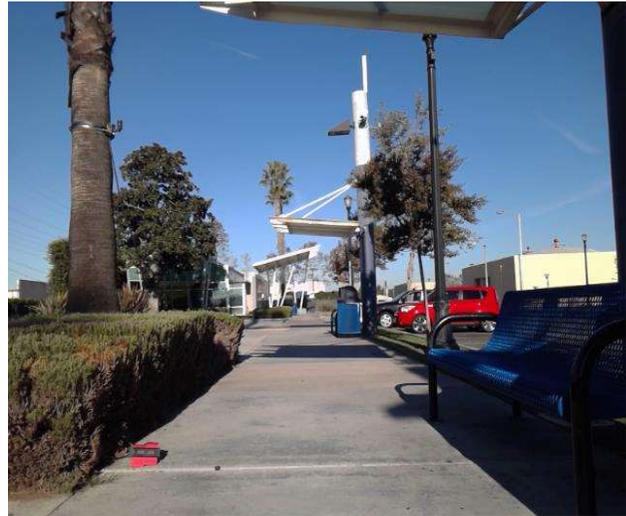
Sidewalk From Downey Avenue

Path Of Travel , Walking Surfaces : Change in Level

There is a change in elevation greater than recommended value.

On-Site Finding 0.50 inches

Notes : Cross slope greater than 2% continues for 360 feet.

Ensure that the change in elevation is within the recommended value.

Recommendation Up to 0.25 inches

Provide smooth surface \$150

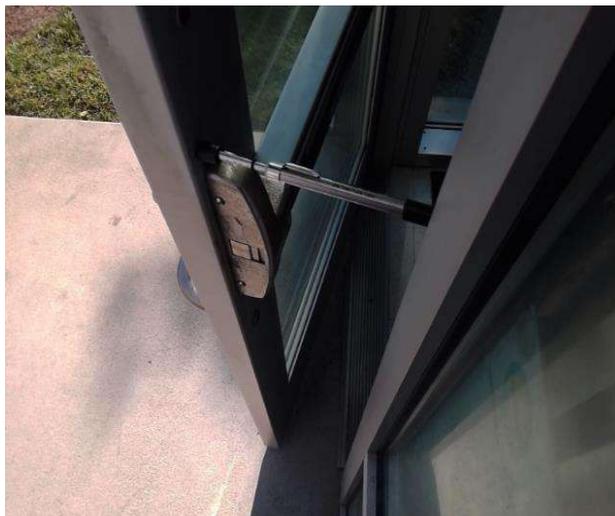
Main Entrance

Door , Hardware : Door Opening Pressure

The door opening force for this door is greater than allowed.

On-Site Finding 15.00 pounds

Adjust the closer on the door to meet the door opening force requirements.

Recommendation Up to 5.00 pounds

Adjust door closer pressure \$25

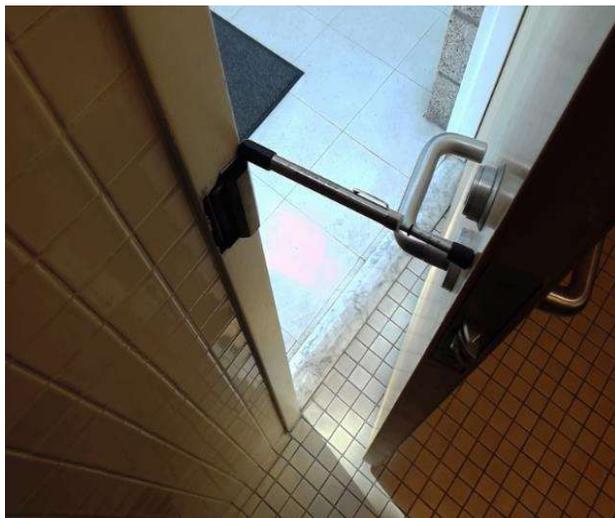
Unisex Restroom

Door , Hardware : Door Opening Pressure

The door opening force for this door is greater than allowed.

On-Site Finding 12.00 pounds

Adjust the closer on the door to meet the door opening force requirements.

Recommendation Up to 5.00 pounds

Adjust door closer pressure \$25

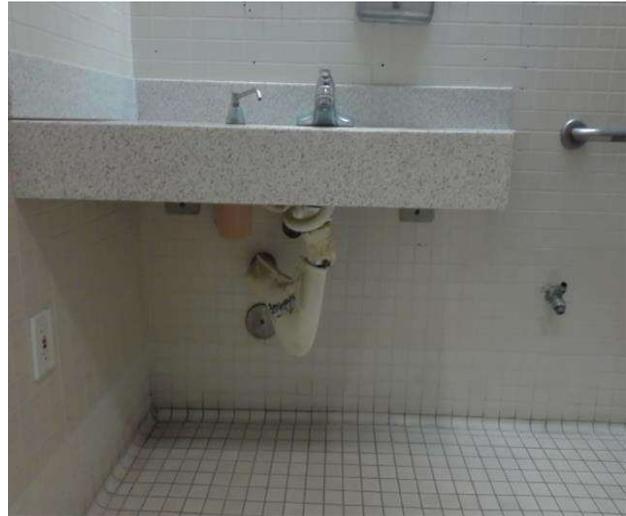
Unisex Restroom

Restroom , Lavatory : Lavatory - Supply Lines not wrapped

Supply lines are not wrapped at the lavatory.

On-Site Finding Not Wrapped

Wrap the supply lines around lavatory according to compliance.

Wrap supply lines \$149

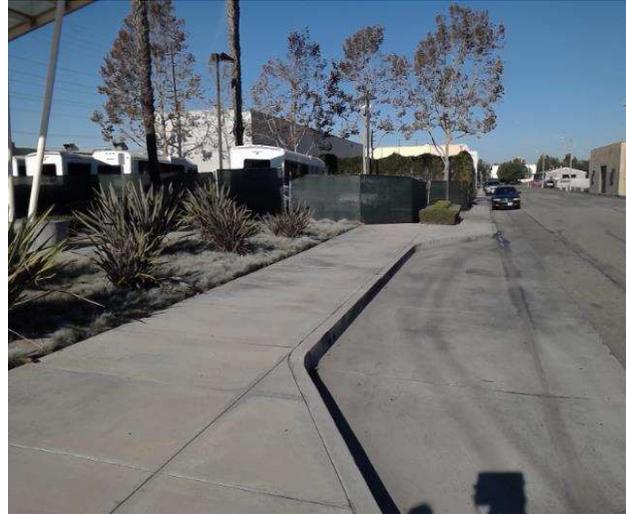
Passenger Loading Zone Next To Main Buiding

Passenger Loading Zone : No Access Aisle

There is no required striped access aisle adjacent to the passenger loading zone.

On-Site Finding None Found

Create an access aisle to meet the required minimum width and length adjacent and parallel to the vehicle pull-up space. The access aisle striping for the passenger loading zone shall provide immediate access to an adjacent curb ramp or primary path of travel.

Stripe vehicle space and install sign \$650

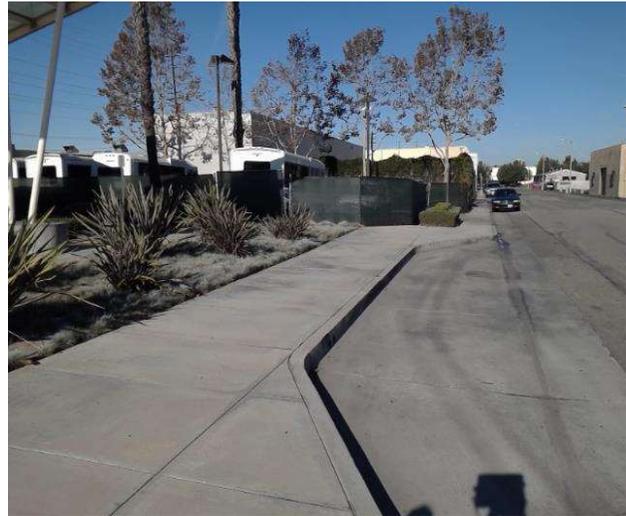
Passenger Loading Zone Next To Main Buiding

Passenger Loading Zone : No Sign

Passenger loading zone has no sign.

On-Site Finding Not Marked

Mark the passenger loading zone with ISA symbol of accessibility.

Mark access aisle \$220

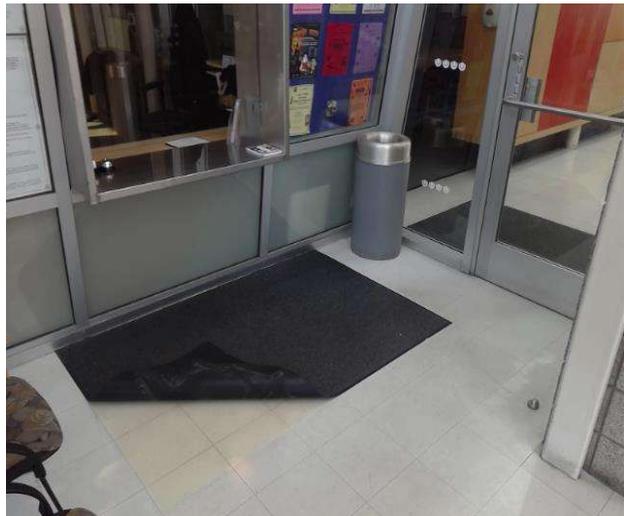
Lobby

Path Of Travel , Walking Surfaces : Mat or Runner

The mats or carpet runners do not adhere to the underlying floor surface and slip, thereby creating a hazardous path of travel.

On-Site Finding Not Accessible

Securely fasten the mats or carpet runners or replace with a mat or carpet runner that grips to the underlying floor surface to provide a firm, stable, continuous and relatively smooth path of travel surface. Mats or carpet runners along the primary path of travel shall provide beveled edges on all sides to prevent roll over.

Install mat or carpet runner \$84
that grips to the underlying
floor surface

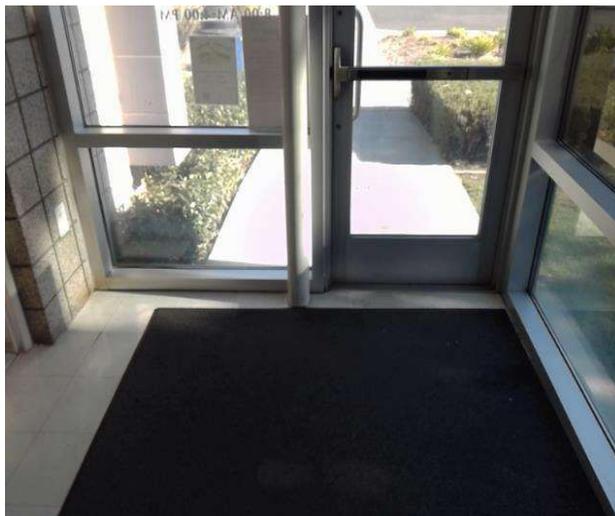
Main Entrance

Door , Clear Floor Space : Floor Mat

An unstable floor mat is provided at the door landing.

On-Site Finding Not Compliant

Notes : Pole obstructs latch side clearance.

Provide a compliant floor mat for the door.

Install mat that grips to the floor surface \$126

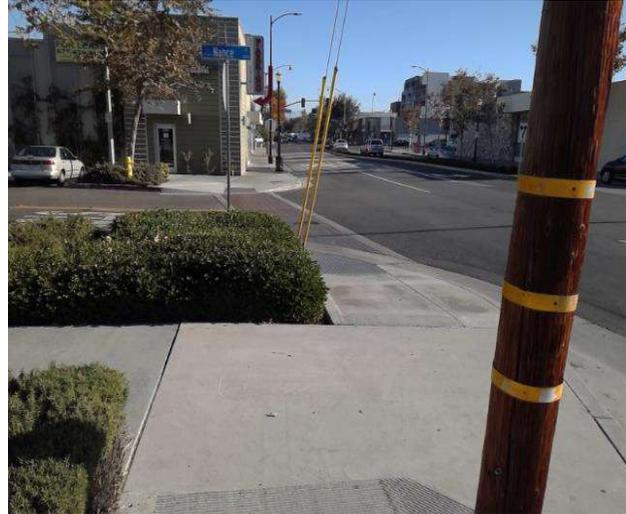
Directional Signage From The Public Right Of Way

Signage , Signage : No Directional or Information Signage

There is no directional signage.

On-Site Finding None Found

Install directional signage to each accessible element or room.

Install signage \$158

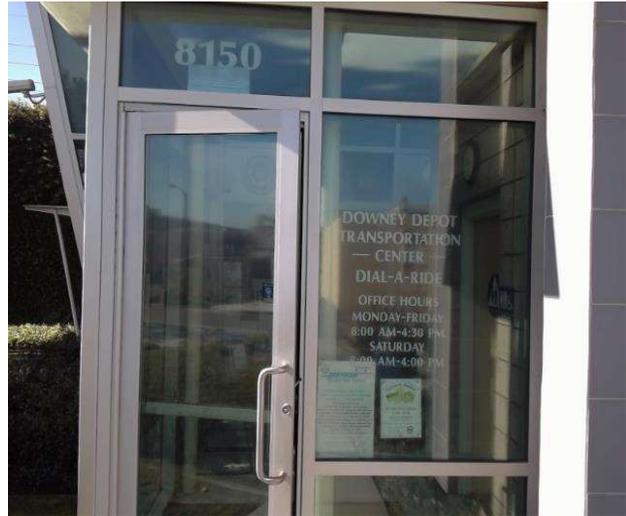
Main Entrance

Signage , Signage : No Accessible Element/Entrance Signage

There is no room signage.

On-Site Finding None Found

Install accessible room signage.

Install signage \$158

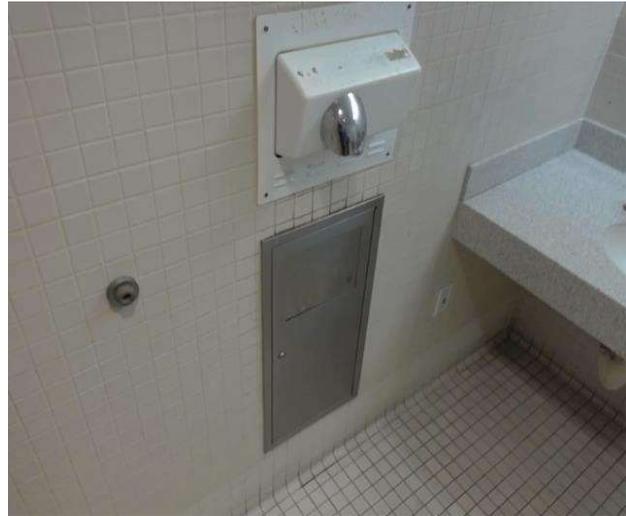
Unisex Restroom

Restroom , Dispensers : Dispenser Height

The height of the controls and operating mechanisms for the dispenser is not at the correct height.

On-Site Finding 44.00 inches

Relocate the dispenser to the correct height.

Recommendation Up to 40.00 inches

Provide compliant dispenser \$277

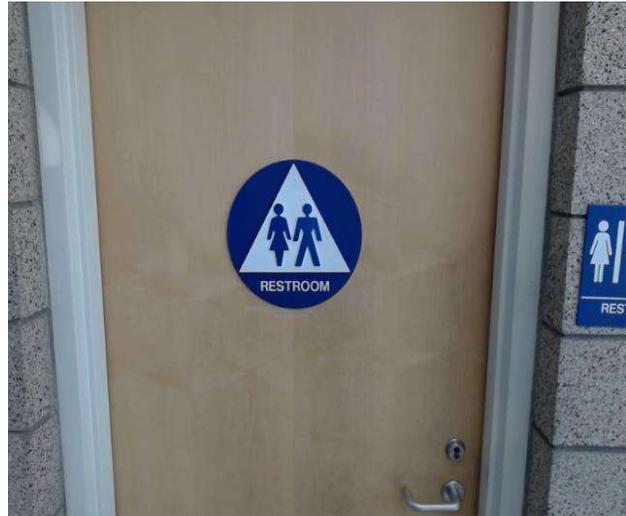
Unisex Restroom

Restroom , Door Signage : Door Signage Height

The gender use signage on the entrance door is not mounted at the required height.

On-Site Finding 61.00 inches

Post gender use signage on the center of the door at the required height.

Recommendation 58.00 - 60.00 inches

Install signage \$158

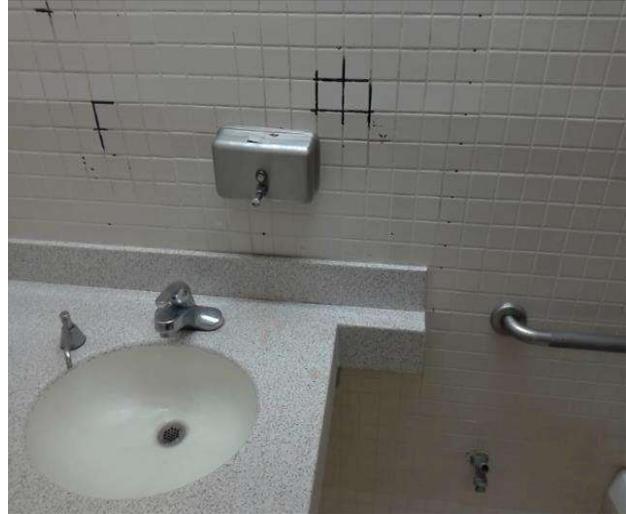
Unisex Restroom

Restroom , Dispensers : Dispenser Height

The height of the controls and operating mechanisms for the dispenser is not at the correct height.

On-Site Finding 44.00 inches

Relocate the dispenser to the correct height.

Recommendation Up to 40.00 inches

Provide compliant dispenser \$277

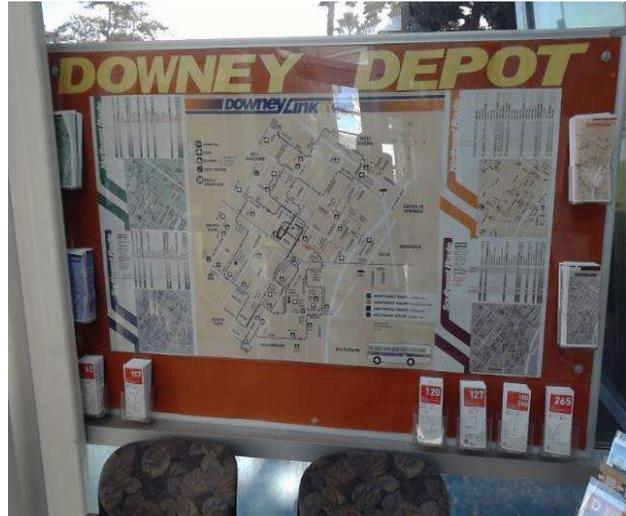
Lobby

Reach Range , Element Highest Point of Operation : Element Highest Point of Operation

The highest point of operation for the element is not compliant.

On-Site Finding 65.00 inches

Make sure that the highest point of operation is within the recommended value.

Recommendation 15.00 - 48.00 inches

Readjust element height \$50

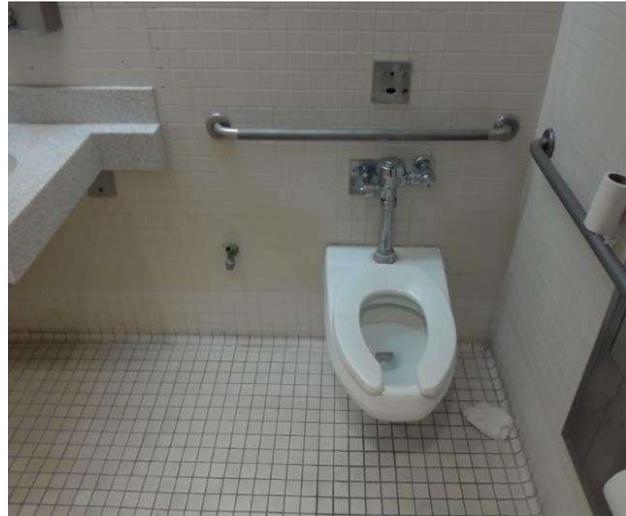
Unisex Restroom

Restroom , Toilet : Toilet Minimum Distance From Any fixture

The toilet is not located in a space which provides the minimum required distance from a fixture or the minimum required clear space from a wall at the wide side.

On-Site Finding 36.50 inches

Locate the toilet in a space which provides the required clearances.

Recommendation At least 42.00 inches

Relocate fixture \$2,500

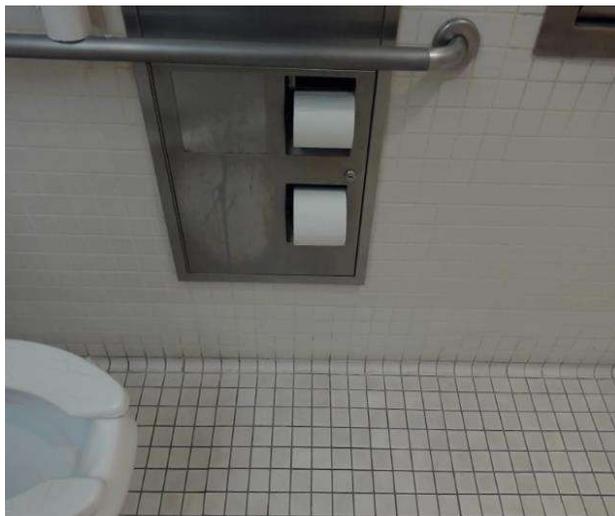
Unisex Restroom

Restroom , Toilet Compartment : Toilet Paper Dispenser Distance From Seat

The location of the toilet paper dispenser is not within the required distance from the front edge of the toilet seat.

On-Site Finding 12.00 inches

Remount the toilet paper dispenser so it is within the required distance from the front edge of the toilet seat. Toilet paper dispensers must allow continuous paper flow and shall not interfere with the use of the side grab bar.

Recommendation 7.00 - 9.00 inches

Provide compliant dispenser \$277

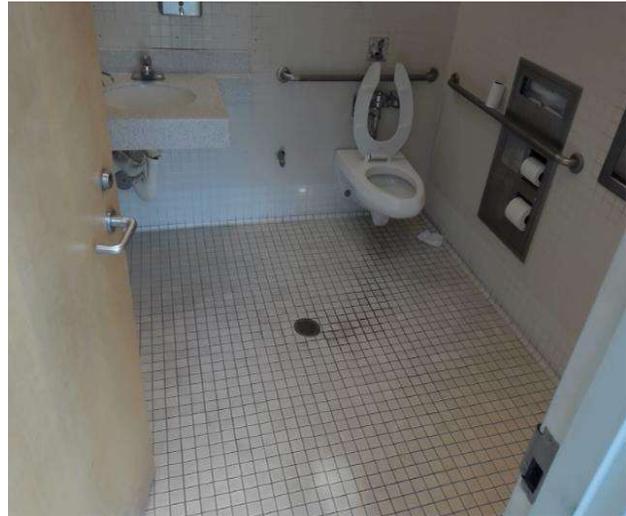
Unisex Restroom

Restroom : No Door Privacy Lock and Occupied Indicator

The restroom door does not provide a compliant privacy lock with occupancy indicator.

On-Site Finding None Found

Install a compliant privacy lock with occupancy indicator to the door.

Replace existing lock set with lever handled lock set \$804

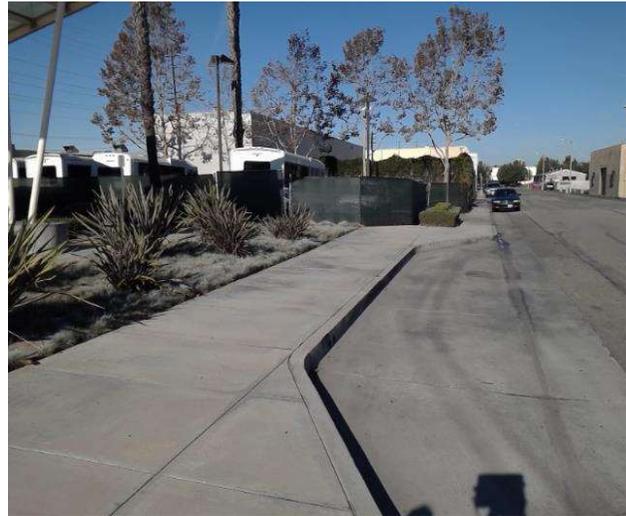
Passenger Loading Zone Next To Main Buiding

Passenger Loading Zone : Curbs Between Access Aisle and Vehicle Pull-up Space

There are curbs between the access aisle and the vehicle pull-up space.

On-Site Finding Curbs Exists

Remove curbs or install compliant curb ramp to provide accessible path of travel from the vehicle pull-up space and the access aisle.

Cut opening through island \$150

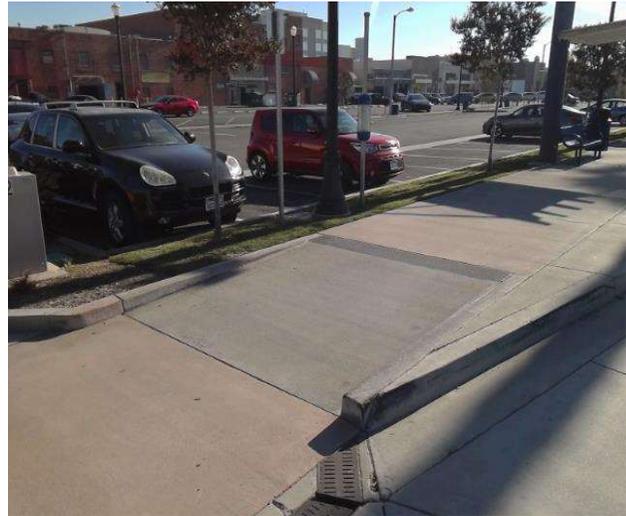
1st Curb Ramp From The Bus Stops To Main Entrance

Curb Ramp : No Detectable Warnings

The curb ramp does not provide a detectable warning surface which includes truncated domes.

On-Site Finding Not Found

Provide compliant detectable warnings to surface.

Provide detectable warning to surface \$248

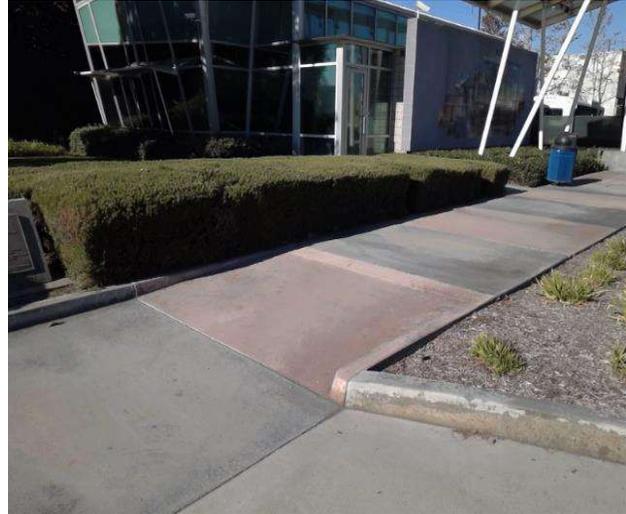
2nd Curb Ramp From The Bus Stops To Main Entrance

Curb Ramp : No Detectable Warnings

The curb ramp does not provide a detectable warning surface which includes truncated domes.

On-Site Finding Not Found

Provide compliant detectable warnings to surface.

Provide detectable warning to surface \$248

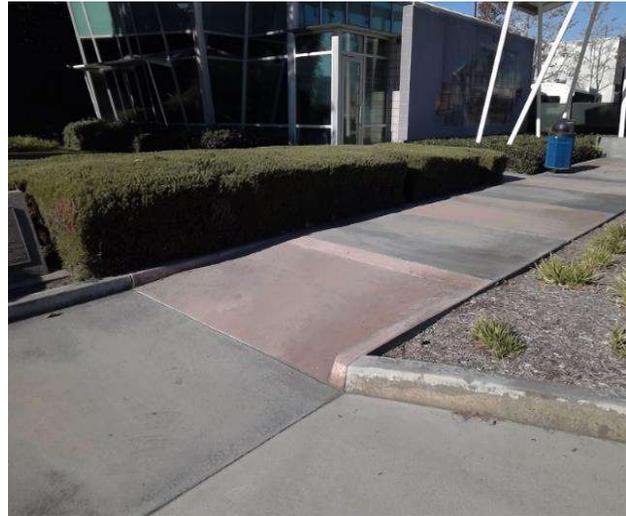
2nd Curb Ramp From The Bus Stops To Main Entrance

Curb Ramp , Landings and Transitions : Bottom Landing Slope

The slope at the bottom landing is greater than allowed.

On-Site Finding 2.70 percent

Provide a compliant bottom landing that does not exceed the maximum slope requirements.

Recommendation Up to 2.08 percent

Provide compliant landing \$240

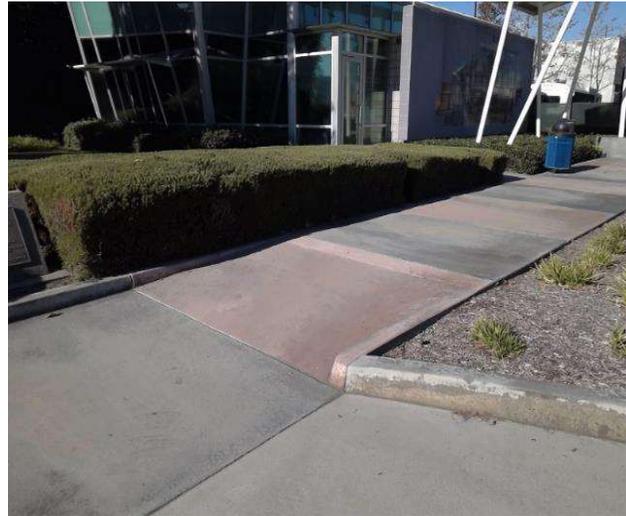
2nd Curb Ramp From The Bus Stops To Main Entrance

Curb Ramp , Landings and Transitions : Top Landing Slope

The slope at the top landing is greater than allowed.

On-Site Finding 2.40 percent

Provide a top landing surface that does not exceed the maximum slope and cross slope. Provide a sufficient maneuvering clearance that does not accumulate water.

Recommendation Up to 2.08 percent

Provide compliant landing \$1,260

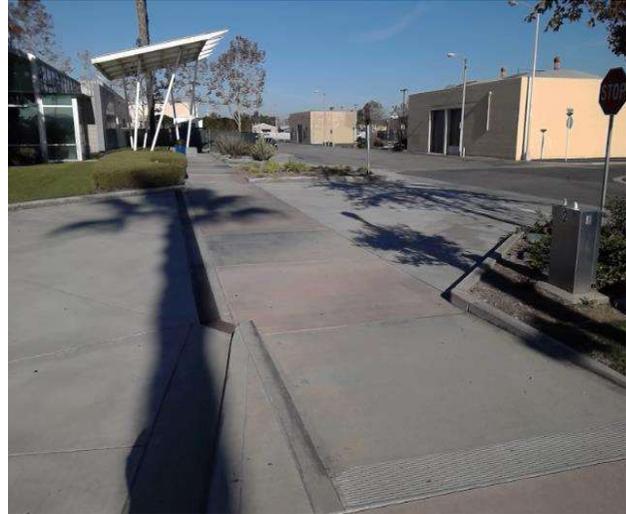
Sidewalk From Bus Stop To Main Building

Path Of Travel , Vehicular Traffic : Cross Walks and Detectable Warnings

There are no detectable warnings where the pedestrian route crosses vehicular traffic.

On-Site Finding None Found

Provide detectable warnings.

Install compliant detectable warnings \$190

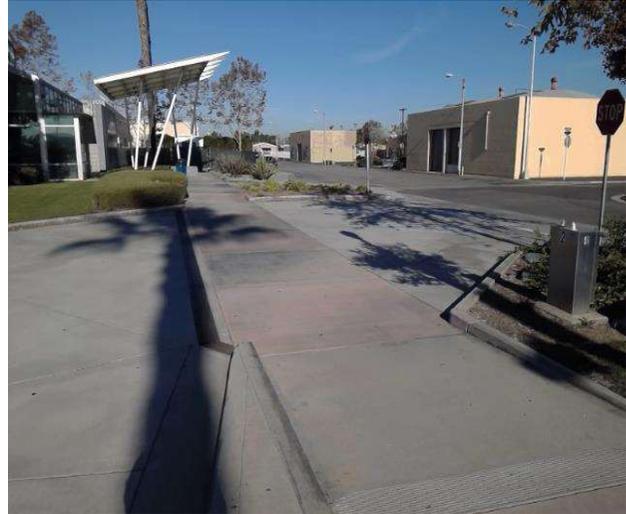
Sidewalk From Bus Stop To Main Building

Path Of Travel , Walking Surfaces : Walking Surface Cross Slope

There are cross slopes greater than allowed on the primary path of travel.

On-Site Finding 2.50 percent for 20.00 feet

Provide a compliant path of travel.

Recommendation Up to 2.08 percent

Install pathway \$3,600

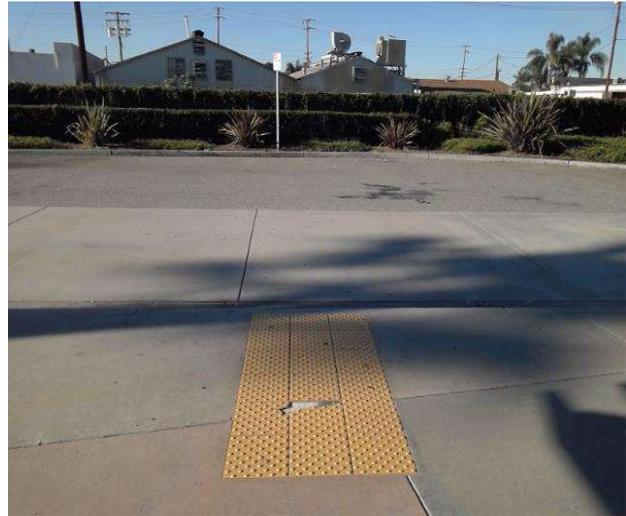
Notes : The truncated dome strip is damaged and should be repaired.

\$24

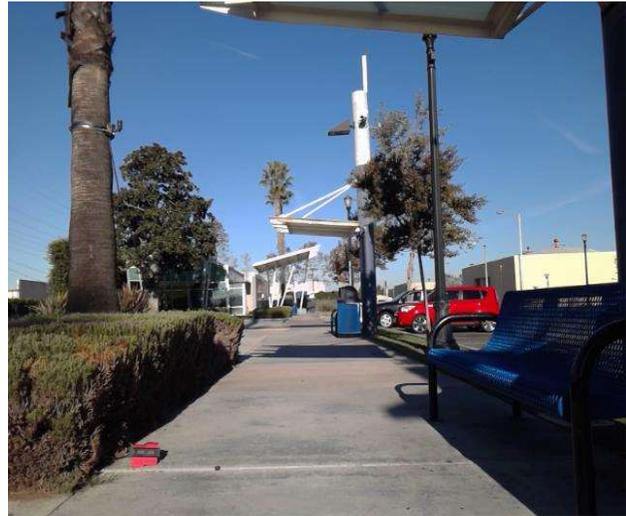
Notes : Cross slope greater than 2% continues for 360 feet.

Recommendation Up to 2.08 percent

Install pathway \$3,600

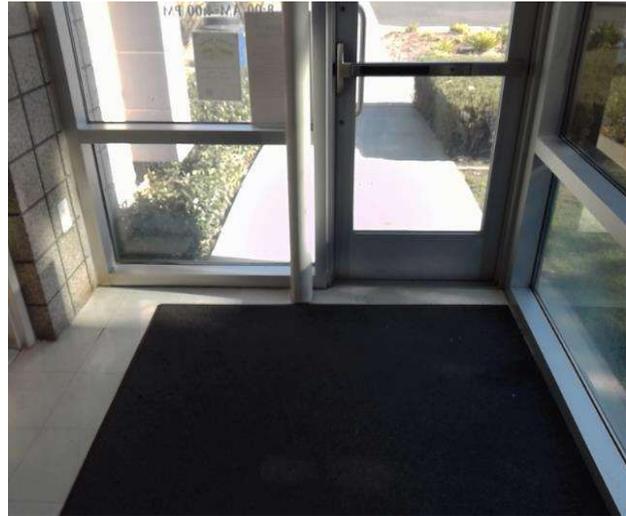
Notes : Pole obstructs latch side clearance.

Provide the recommended latch side clearance on the push side of the door. Otherwise, install an automatic door opening device.

Recommendation At least 12.00 inches

Install automatic door opener \$2,921
