# Accessibility Survey

## Wilderness Park

10999 Little Lake Road  
Downey, CA 90240

Date of Inspection  
11/29/2016

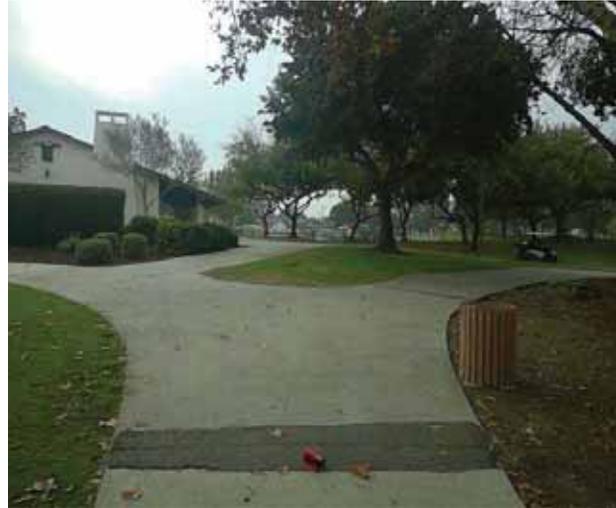
**Park Path From Park Building to Picnic Shelter #1**

**Change In Level**

There is a change in elevation greater than recommended value.

**On-Site Finding** 1.00 inches

Bevel the area or resurface the area to provide a smooth and level path of travel.

Recommendation Up to 0.50 inches

Patch pathway \$480

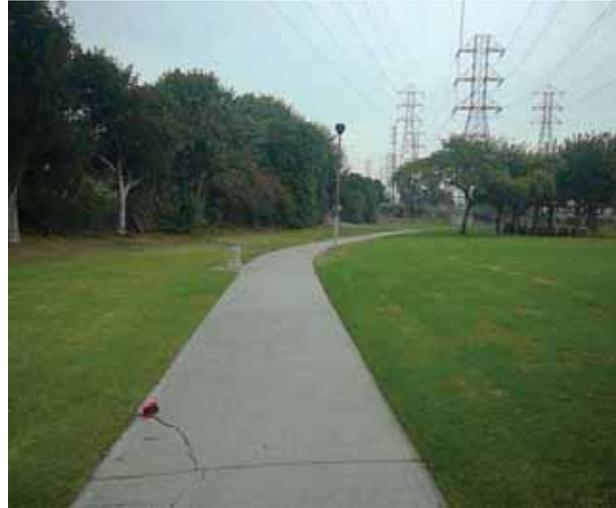
There is a change in elevation greater than recommended value.

Ensure that the change in elevation is within the recommended value.

Recommendation Up to 0.25 inches

Provide smooth surface \$150

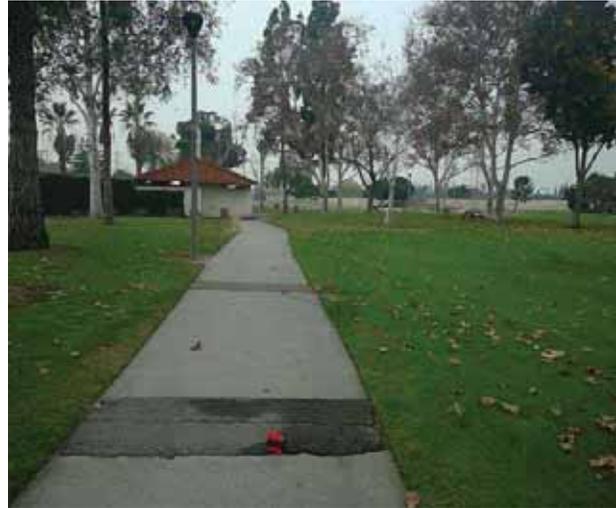
There is a change in elevation greater than recommended value.

Ensure that the change in elevation is within the recommended value.

Recommendation Up to 0.25 inches

Provide smooth surface \$300

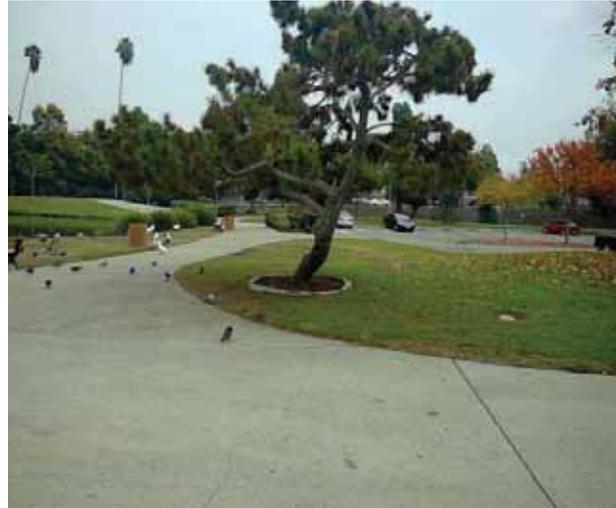
There is a change in elevation greater than recommended value.

Recommendation Up to 0.50 inches

Patch pathway \$480

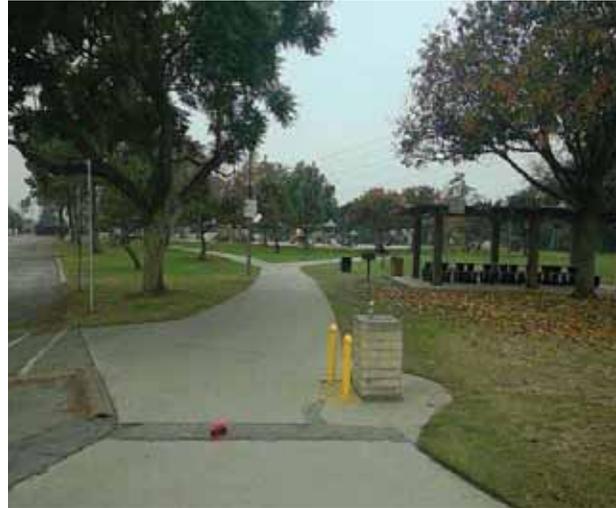
There is a change in elevation greater than recommended value.

Ensure that the change in elevation is within the recommended value.

Recommendation Up to 0.25 inches

Provide smooth surface \$150

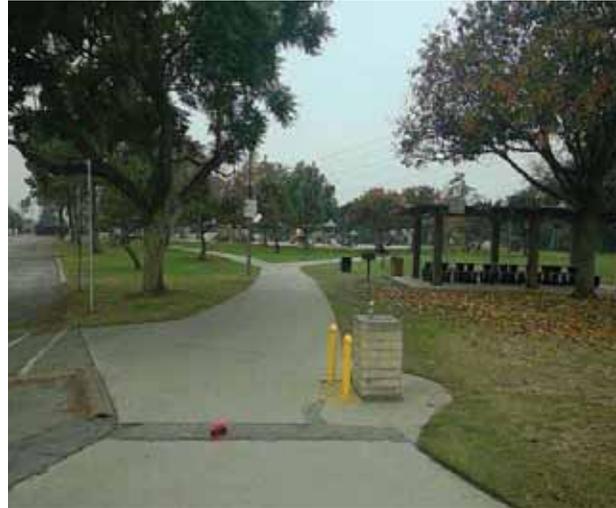
There is a change in elevation greater than recommended value.

Ensure that the change in elevation is within the recommended value.

Recommendation Up to 0.25 inches

Provide smooth surface \$150

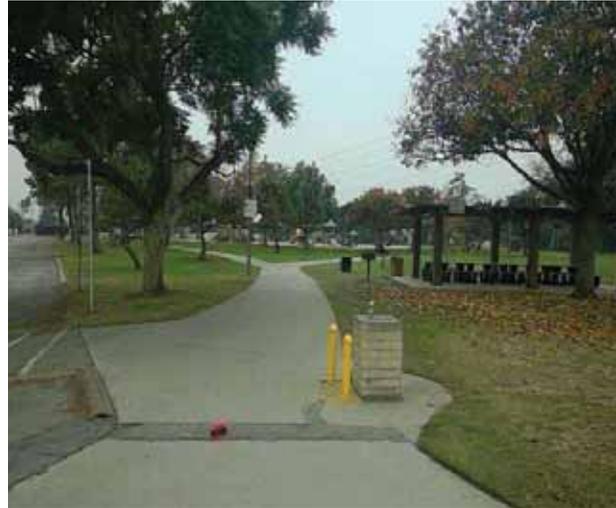
There is a change in elevation greater than recommended value.

Ensure that the change in elevation is within the recommended value.

Recommendation Up to 0.25 inches

Provide smooth surface \$150

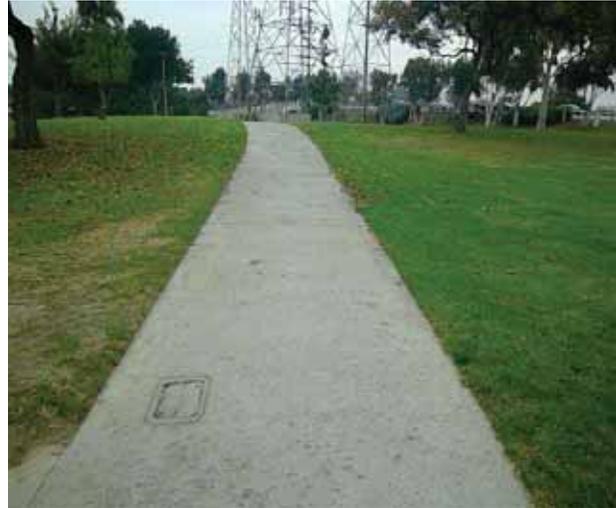
There is a change in elevation greater than recommended value.

Ensure that the change in elevation is within the recommended value.

Recommendation Up to 0.25 inches

Provide smooth surface \$150

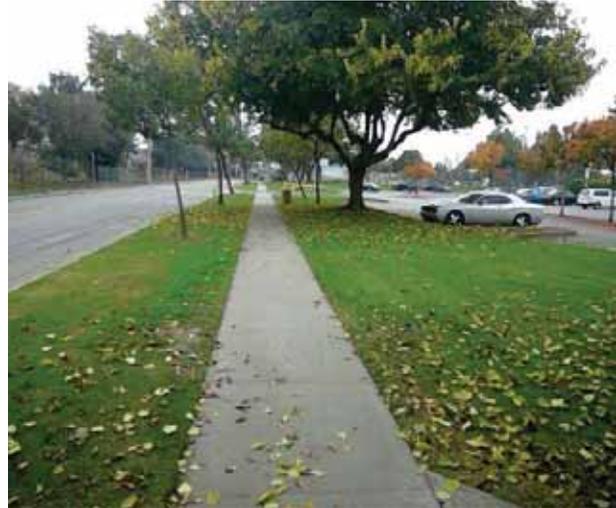
There is a change in elevation greater than recommended value.

Recommendation Up to 0.50 inches

Patch pathway \$2,400

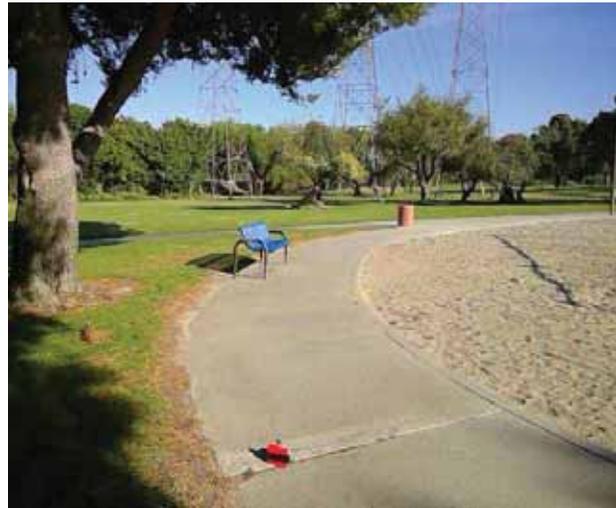
There is a change in elevation greater than recommended value.

Ensure that the change in elevation is within the recommended value.

Recommendation Up to 0.25 inches

Provide smooth surface \$150

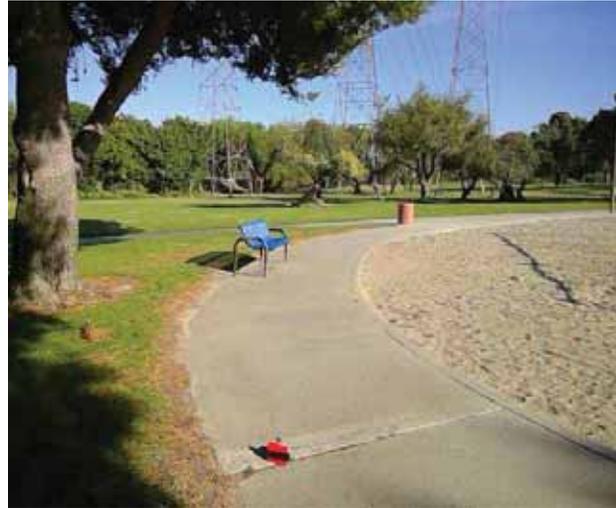
There is a change in elevation greater than recommended value.

Recommendation Up to 0.50 inches

Patch pathway \$480

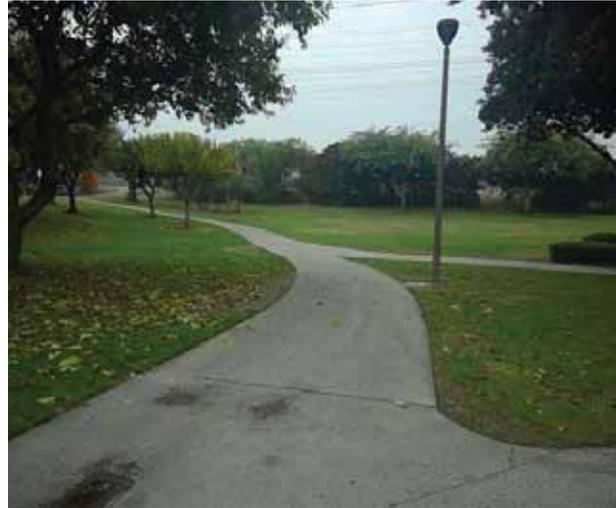
There is a change in elevation greater than recommended value.

Ensure that the change in elevation is within the recommended value.

Recommendation Up to 0.25 inches

Provide smooth surface \$150

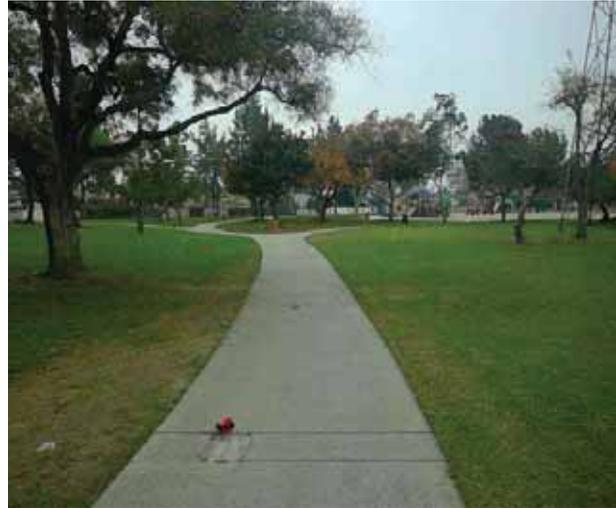
There is a change in elevation greater than recommended value.

Ensure that the change in elevation is within the recommended value.

Recommendation Up to 0.25 inches

Provide smooth surface \$150

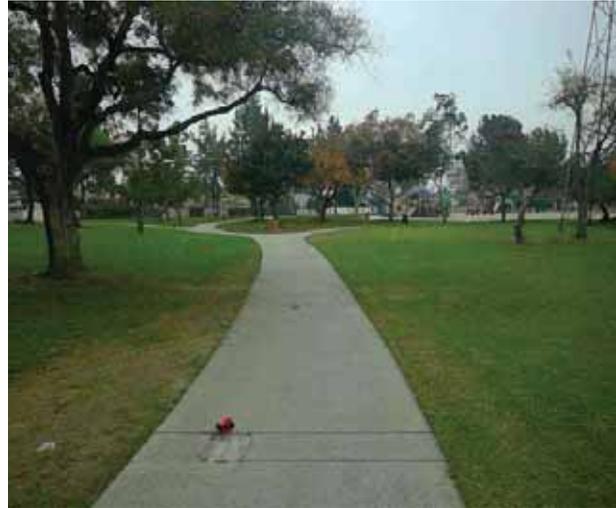
There is a change in elevation greater than recommended value.

Ensure that the change in elevation is within the recommended value.

Recommendation Up to 0.25 inches

Provide smooth surface \$150

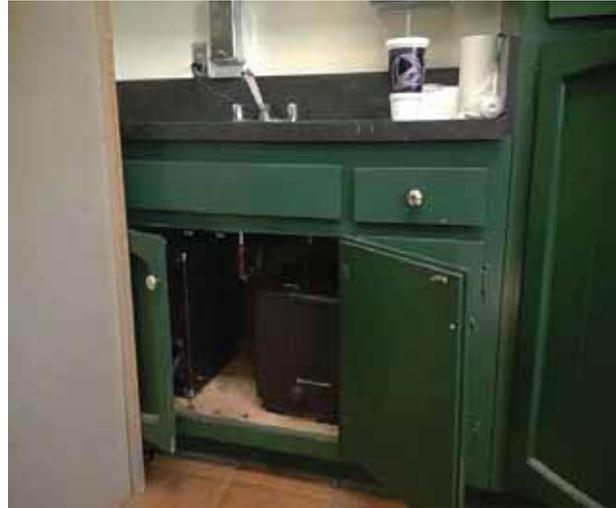
Notes : File cabinet restricts sink.

Wrap pipes \$149

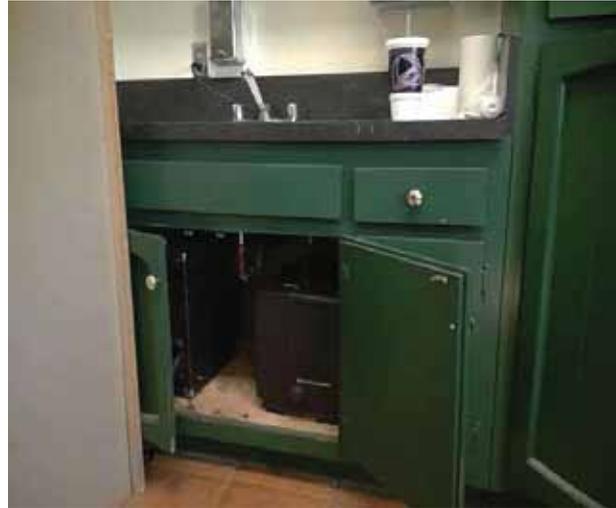
Notes : File cabinet restricts sink.

Wrap pipes \$149

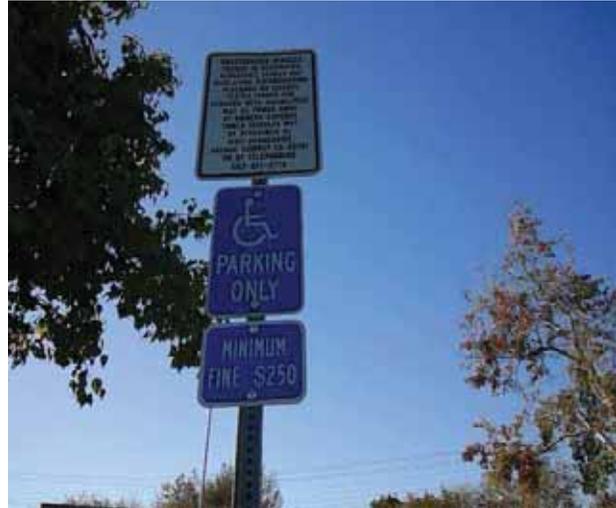
Notes : Signage states: "Unauthorized vehicles...may be towed...".

Install signage \$300

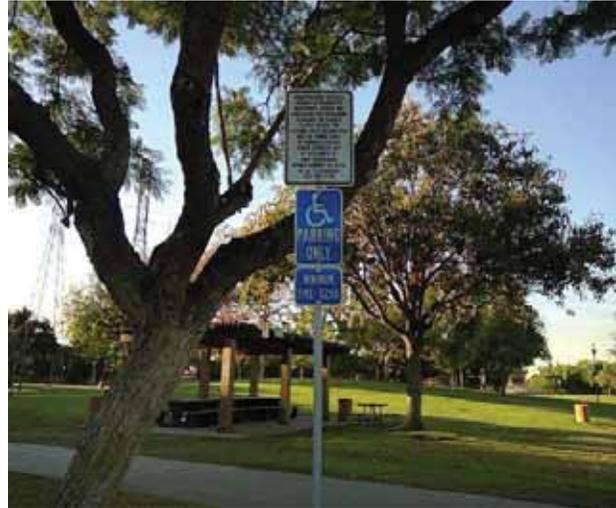
Notes : Signage states: "Unauthorized vehicles...may be towed...".

Install signage \$300

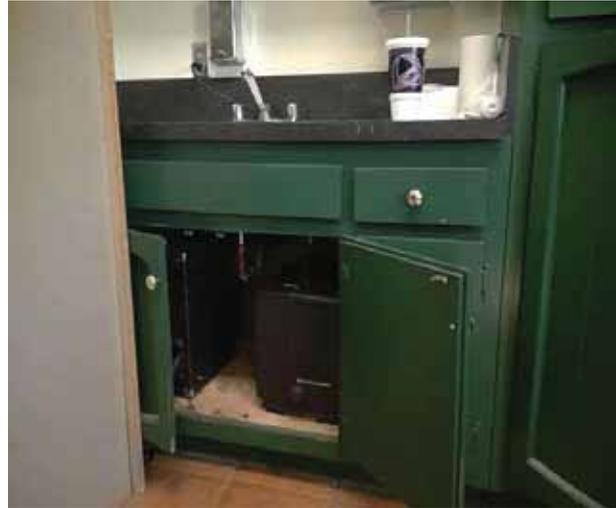
Notes : File cabinet restricts sink.

Replace knob faucets with paddle faucets \$392
