Accessibility Survey

Public Works Utility Yard

9252 Stewart and Gray Road
Downey, CA 90240

Date of Inspection
1/17/2017

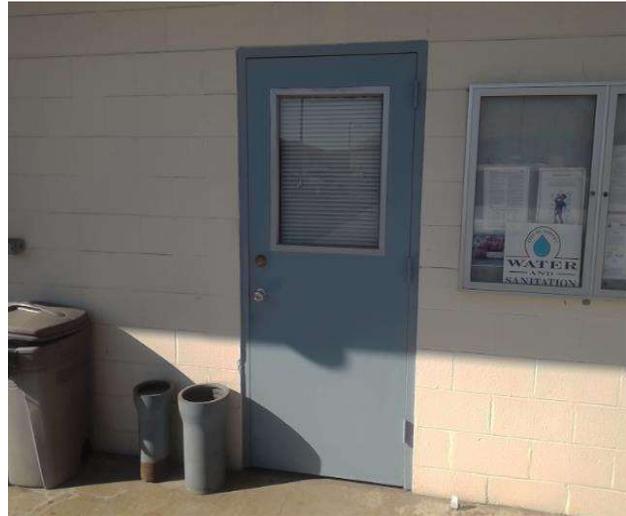
On-Site Finding None Found

Install signage \$158

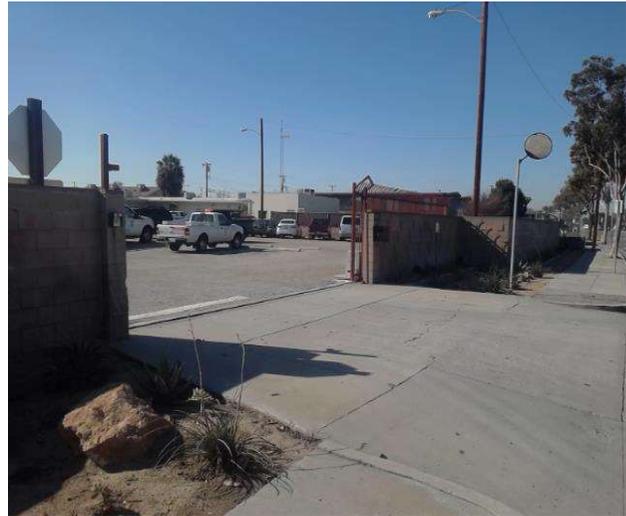
On-Site Finding None Found

Install signage \$158

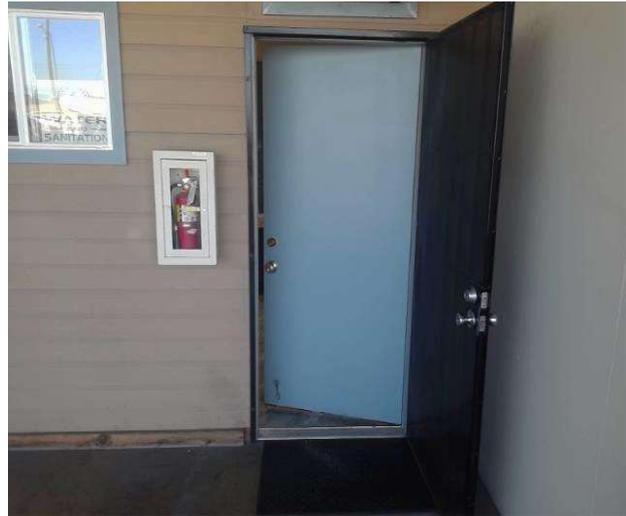
On-Site Finding None Found

Install signage \$158

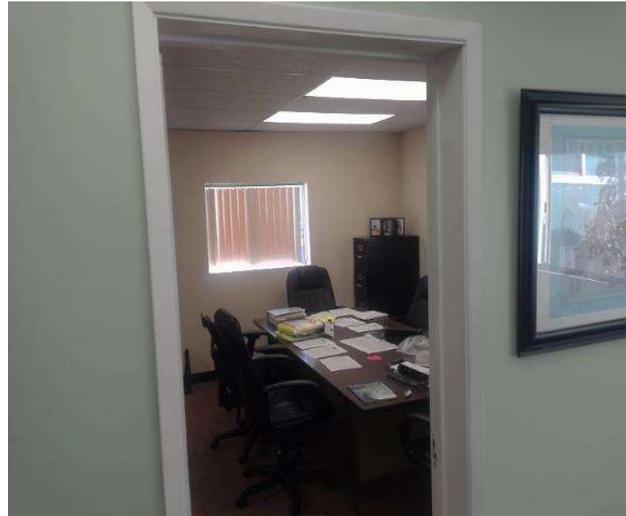
On-Site Finding None Found

Install signage \$158

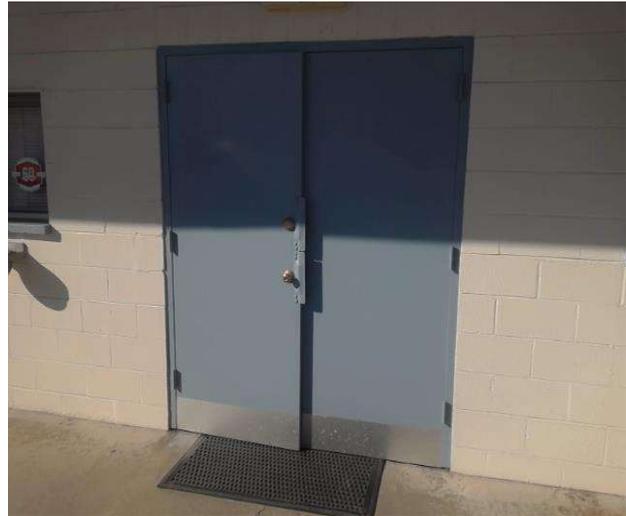
On-Site Finding None Found

Install signage \$474

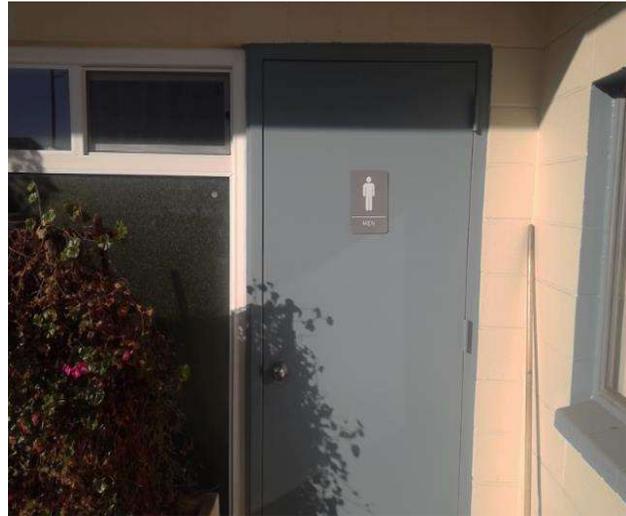
On-Site Finding None Found

Install signage \$158

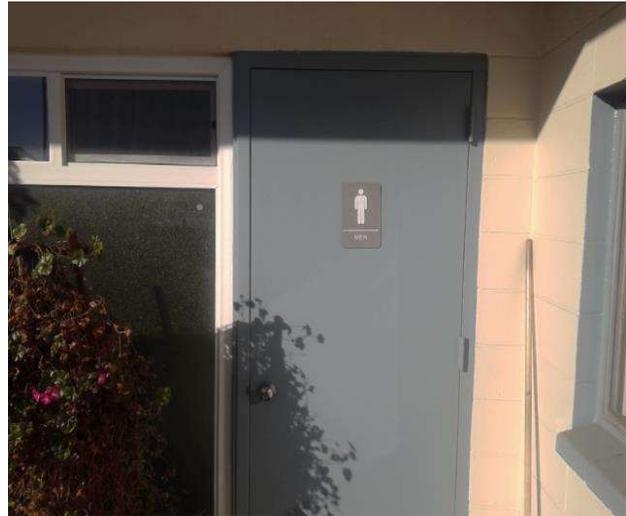
On-Site Finding None Found

Install signage \$158

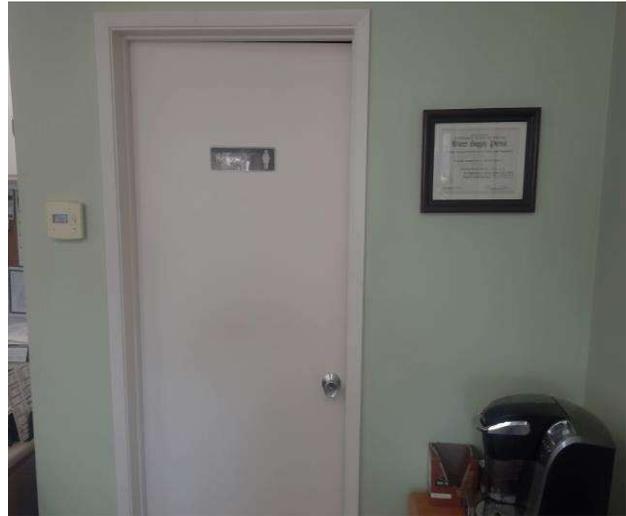
On-Site Finding None Found

Install signage \$158

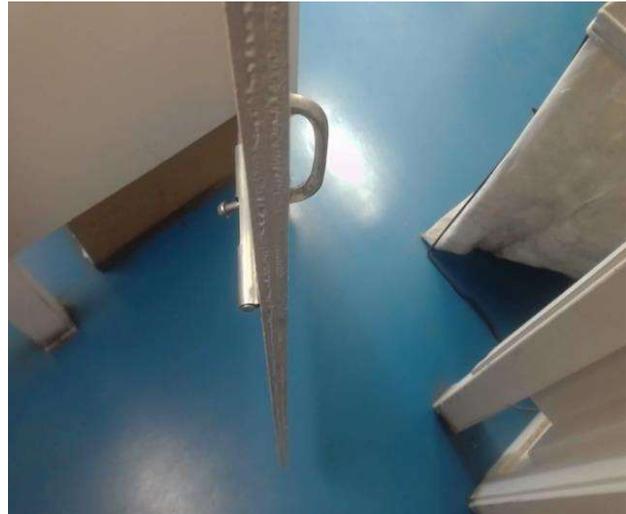
On-Site Finding Missing Hardware

Install accessible hardware on stall door \$269

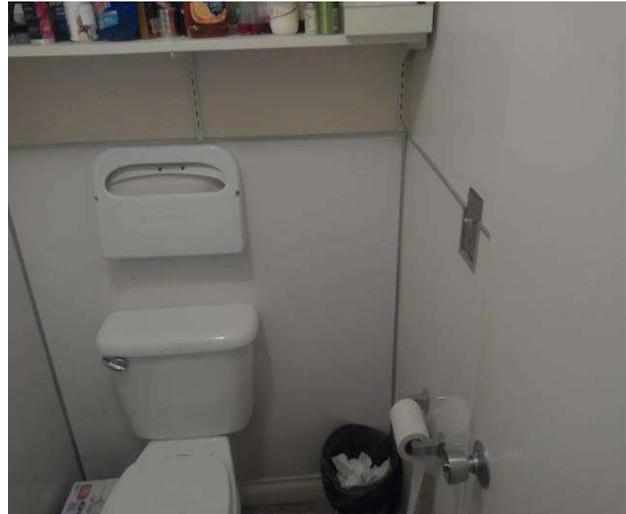
On-Site Finding None Found

Provide compliant dispenser \$277

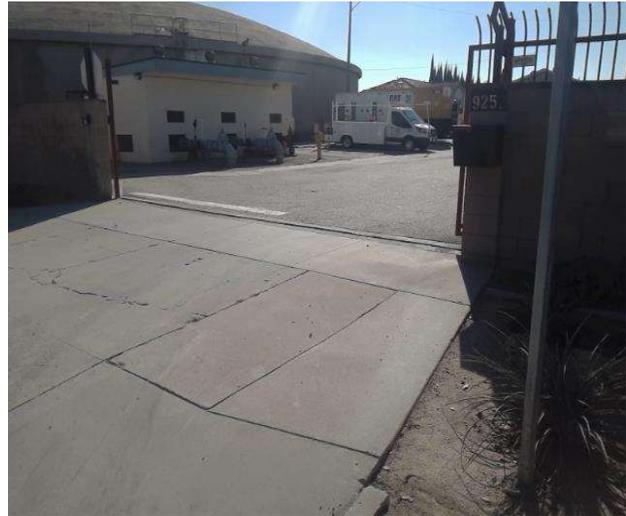
On-Site Finding None Found

Notes : There is a public sidewalk.

Install Pathway \$1,840

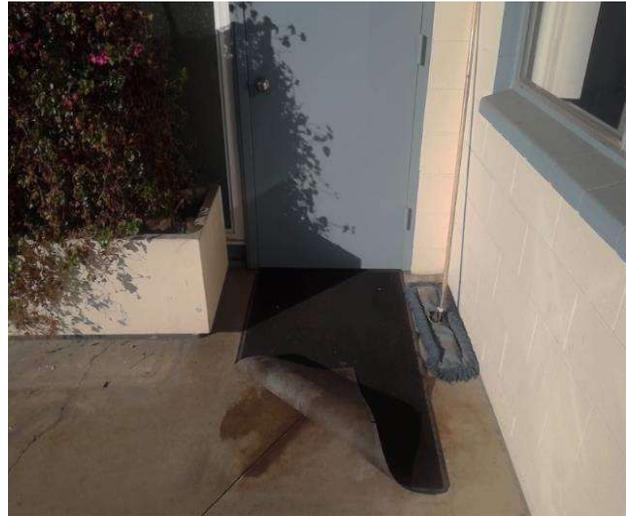
Notes : Concrete planter obstructs the latch side clearance.

Install automatic door opener \$2,921

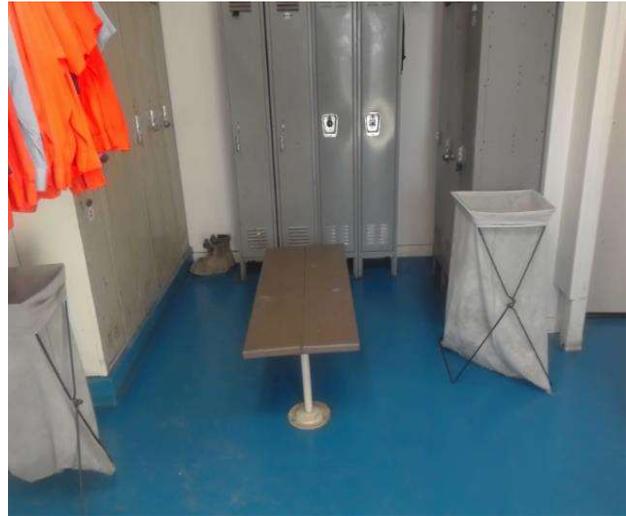
No accessible lockers were found.

On-Site Finding None Found

Requires assembly or design \$1,840

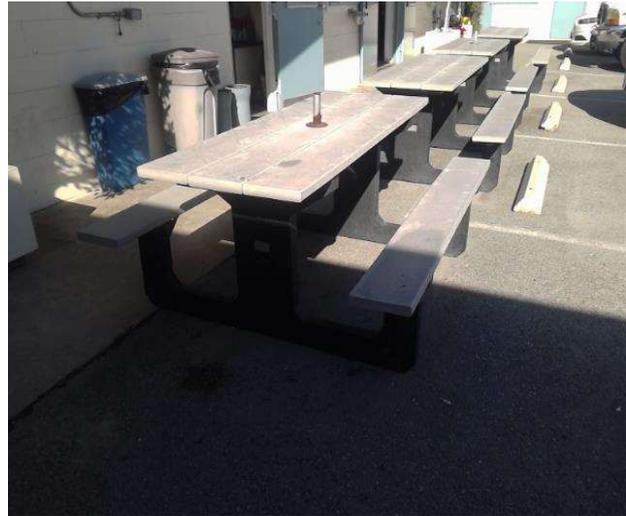
On-Site Finding None Found

Recommendation At least 1.00 tables

Accessible table (each) \$500

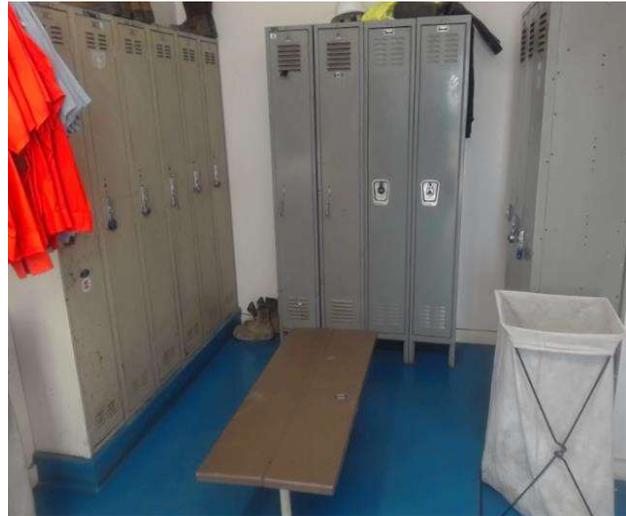
No accessible lockers were found.

Requires assembly or design \$1,840

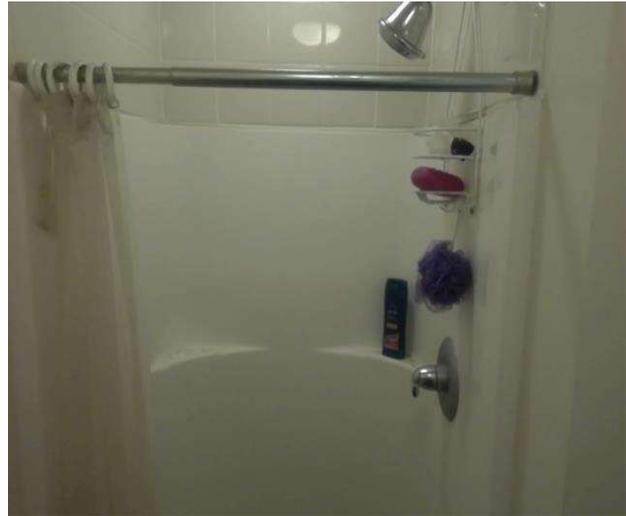
On-Site Finding None Found

Recommendation At least 1.00 showers

Provide compliant showers \$4,500
