Accessibility Survey

Parking Structure

2nd Street and La Reina Avenue
Downey, CA 90240

Date of Inspection
12/21/2016

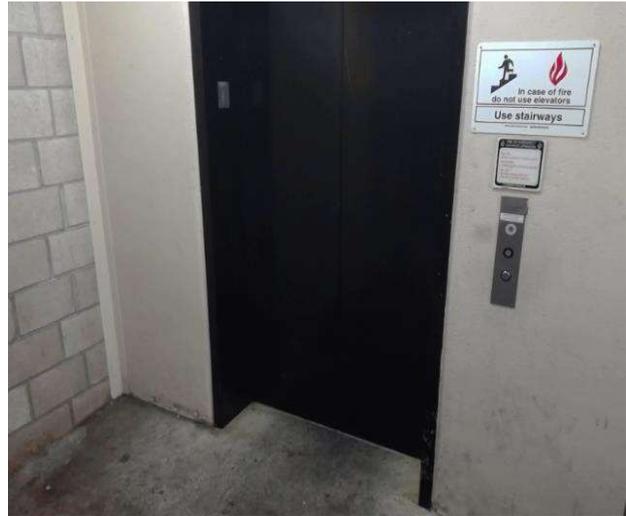
On-Site Finding None Found

Recommendation See Recommendation

Provide star \$180

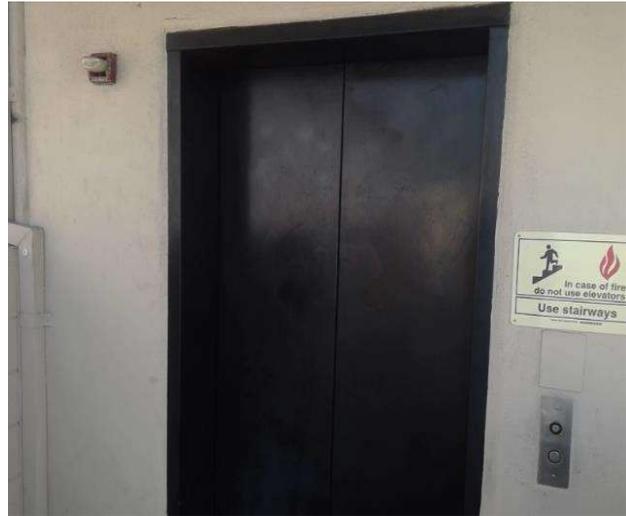
On-Site Finding Not Found

Recommendation See Recommendation

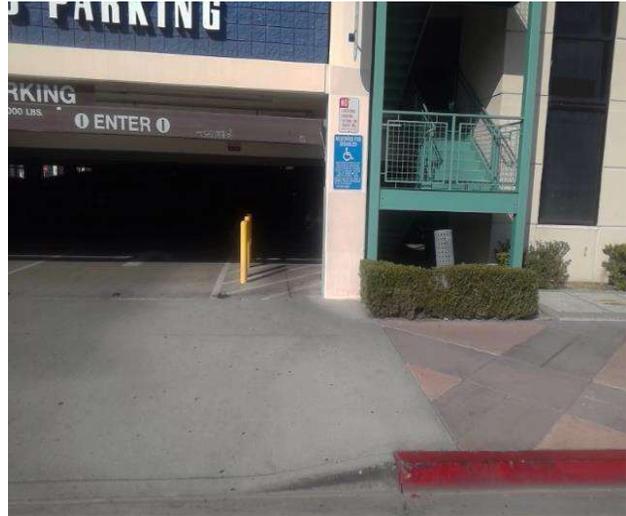
On-Site Finding None Found

Recommendation See Recommendation

Install signage \$158
