# Accessibility Survey

## Furman Park

10419 Rives Avenue  
Downey, CA 90241

Date of Inspection  
4/27/2017

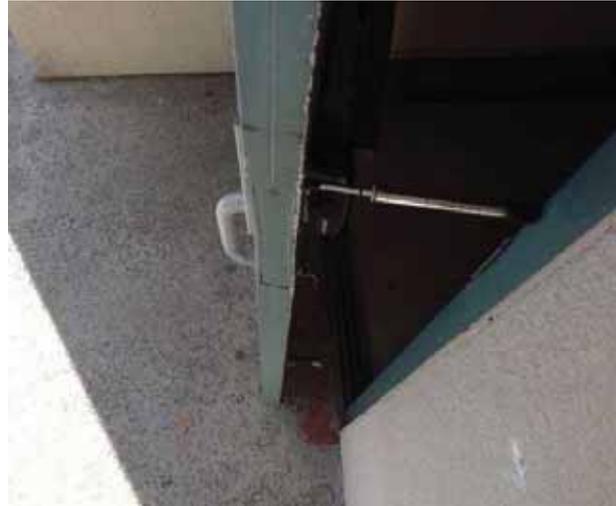
Recommendation Up to 5.00 pounds

Adjust door closer pressure \$25

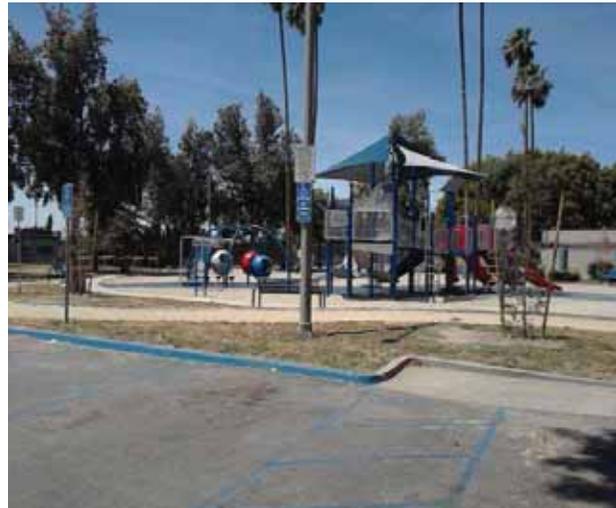
Notes : Signage states: "Unauthorized vehicles...may be towed...".

Install signage \$300

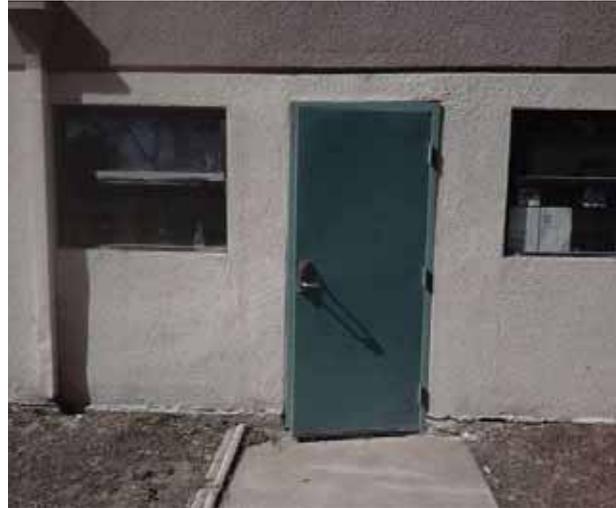
**On-Site Finding** None Found

Install signage \$158

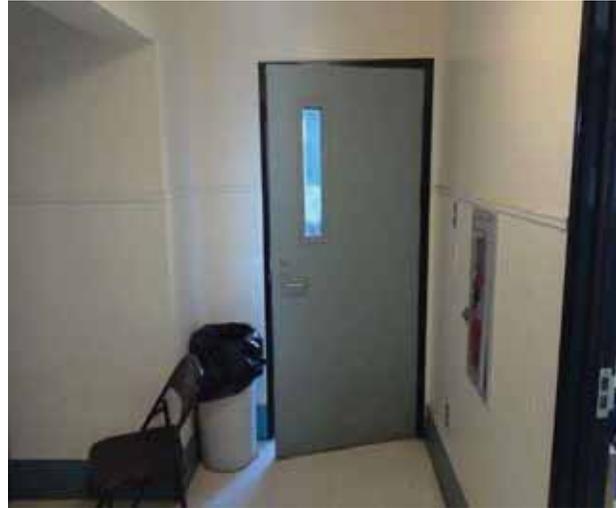
**On-Site Finding** None Found

Install signage \$158

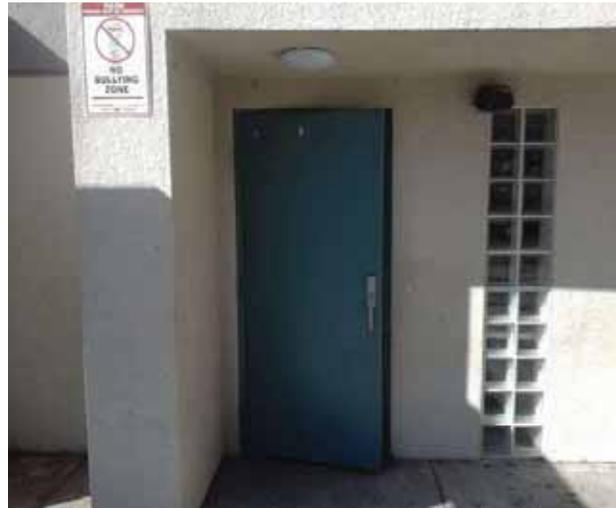
**On-Site Finding** None Found

Install signage \$158

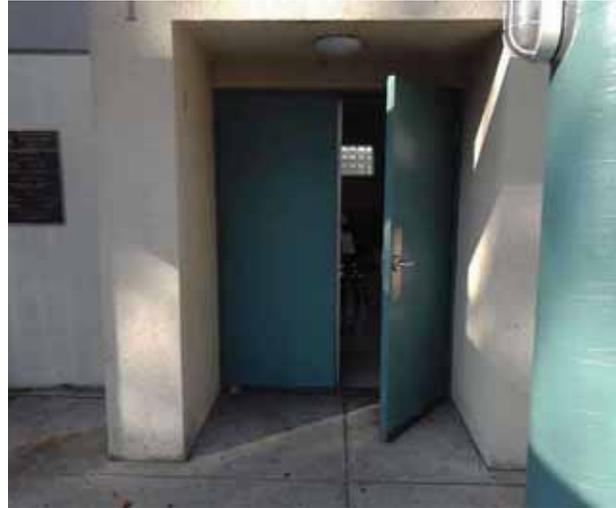
**On-Site Finding** None Found

Install signage \$316

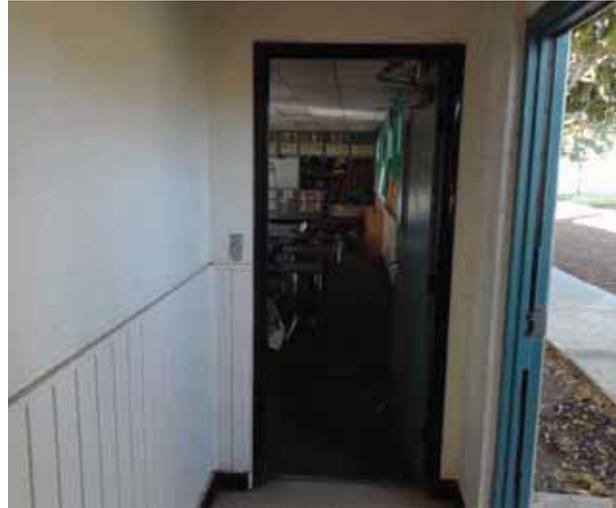
**On-Site Finding** None Found

Install signage \$158

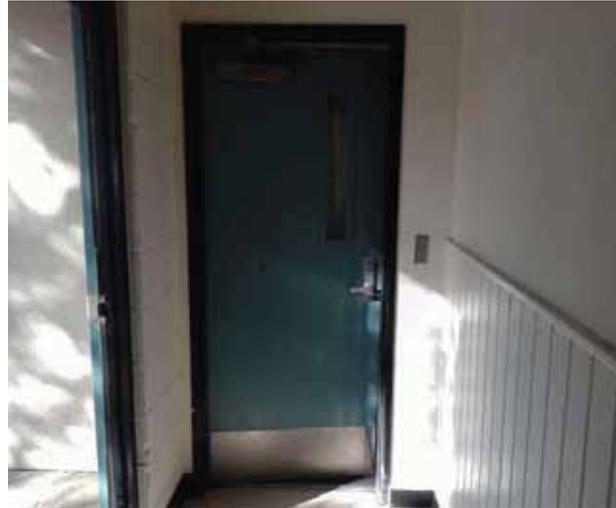
**On-Site Finding** None Found

Install signage \$158

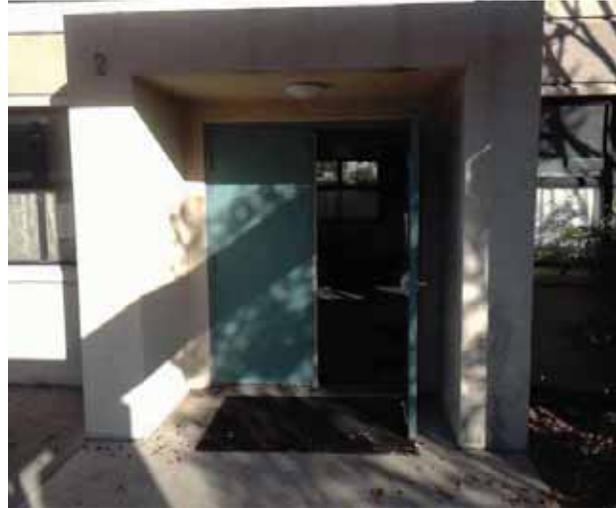
**On-Site Finding** None Found

Install signage \$158

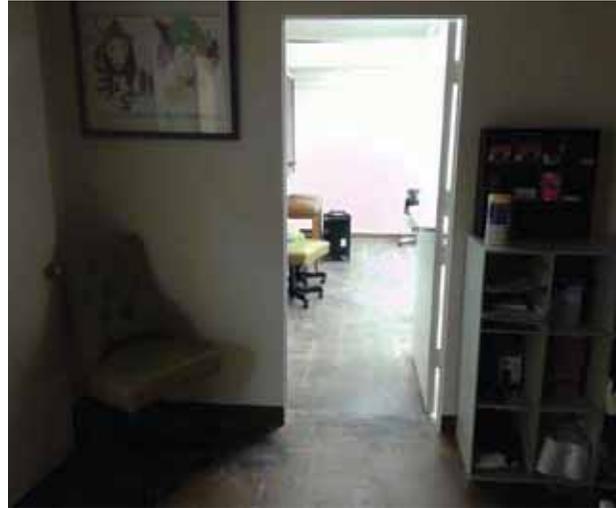
**On-Site Finding** None Found

Install signage \$316

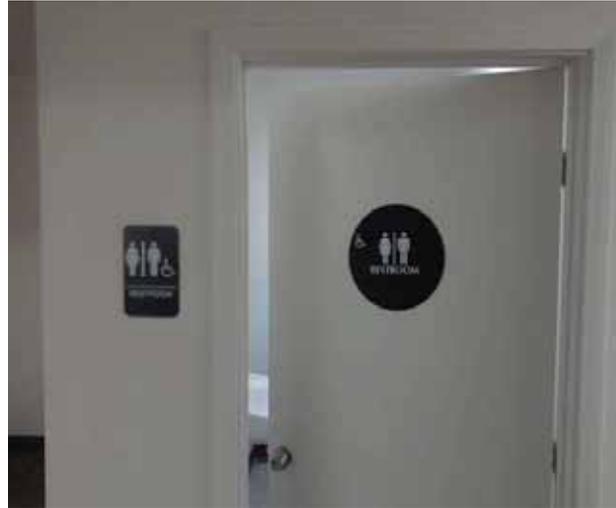
Recommendation 58.00 - 60.00 inches

Install signage \$158

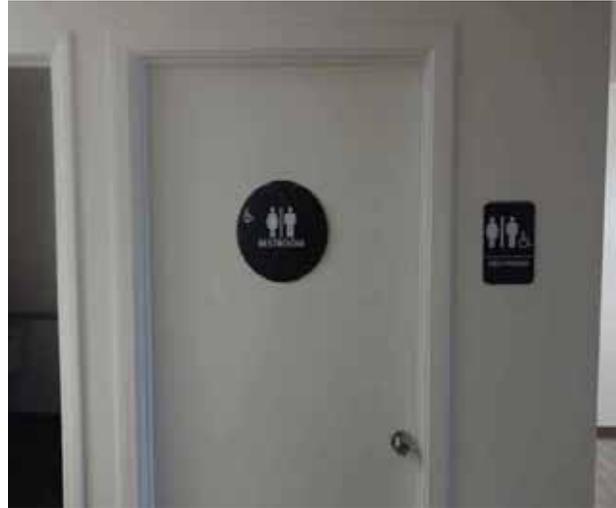
Recommendation 58.00 - 60.00 inches

Install signage \$158

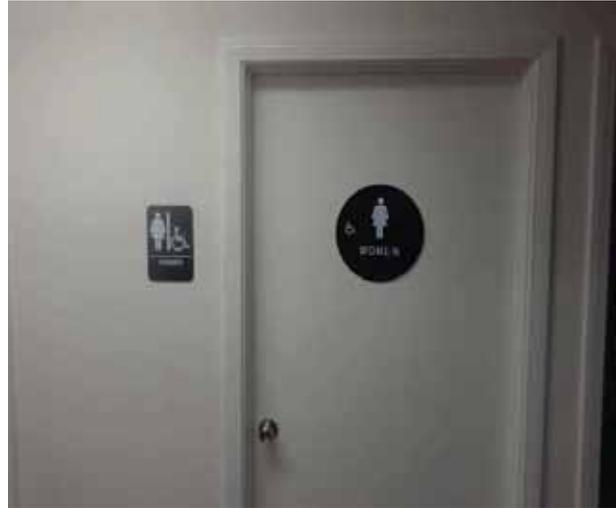
Recommendation 58.00 - 60.00 inches

Install signage \$158

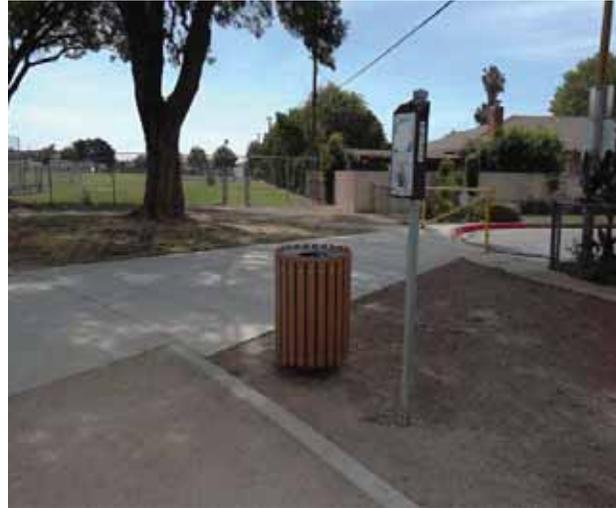
Recommendation 15.00 - 48.00 inches

Make sure that the highest point of operation is within the recommended value.

Readjust element height \$100

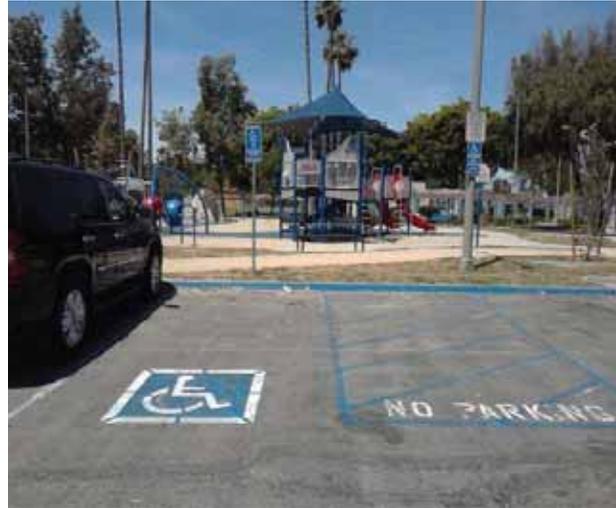
Recommendation At least 108.00 inches

Re-stripe existing parking space \$350

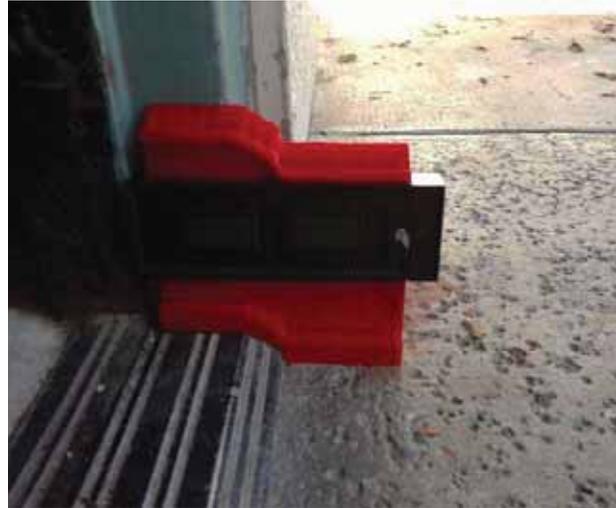
Recommendation Up to 0.50 inches

Modify or replace the threshold to provide the recommended height.

Provide smooth transition \$436

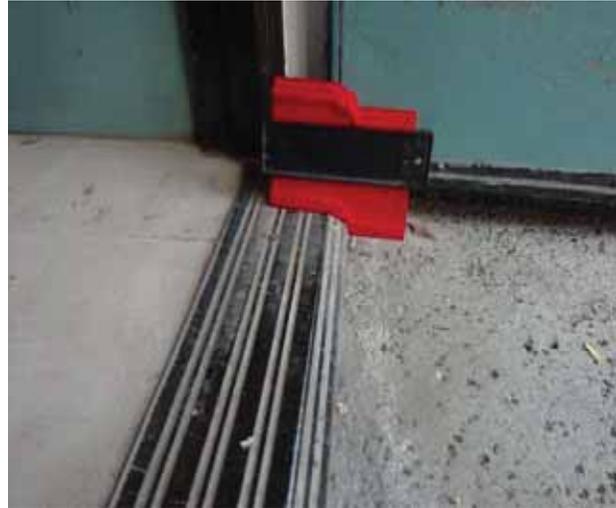
Recommendation Up to 0.50 inches

Modify or replace the threshold to provide the recommended height.

Provide smooth transition \$436

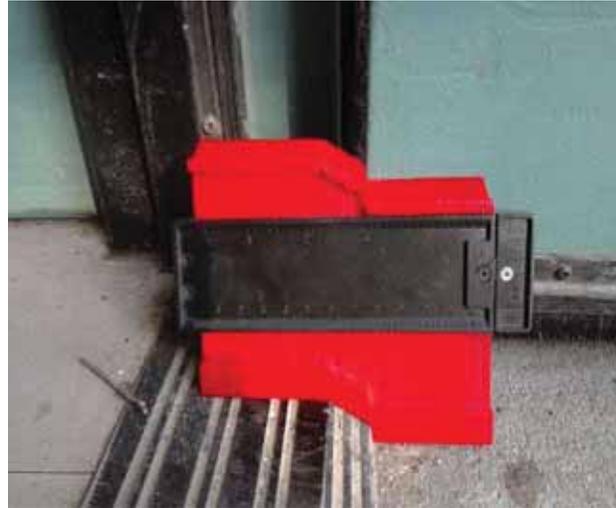
Recommendation Up to 0.50 inches

Modify or replace the threshold to provide the recommended height.

Provide smooth transition \$436

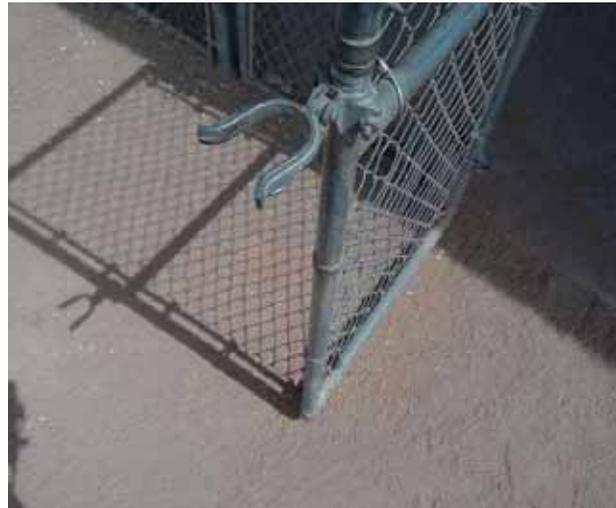
The bottom of the door does not provide a smooth, uninterrupted surface, or panel to allow the door to be opened by a wheelchair footrest without creating a trap or hazardous condition.

Install a panel or replace the door to provide a smooth, uninterrupted surface at the bottom of the door.

Install compliant door \$4,000

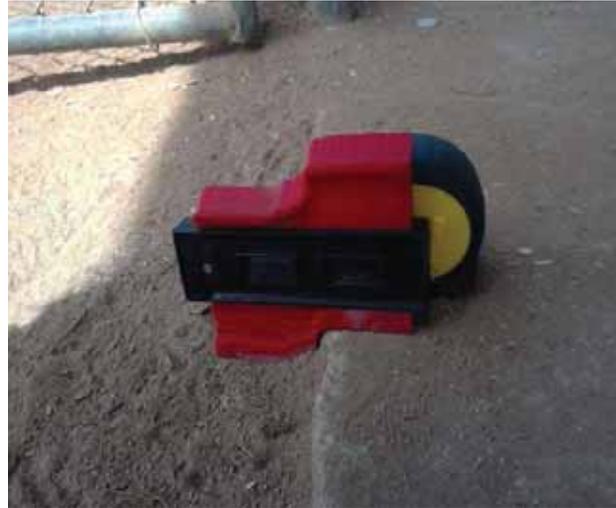
Recommendation Up to 0.50 inches

Modify or replace the threshold to provide the recommended height.

Provide smooth transition \$436

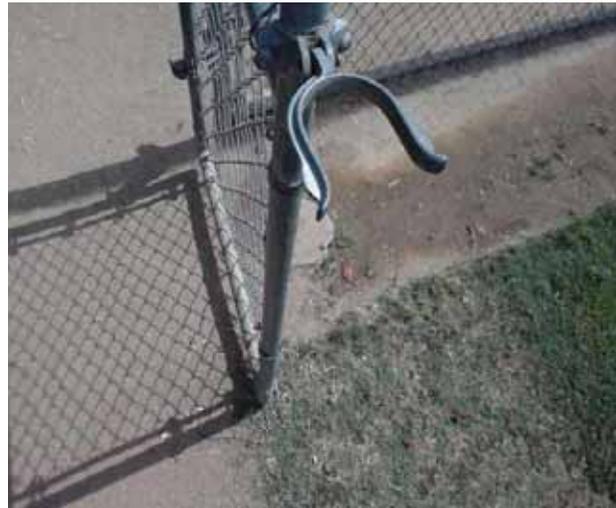
The bottom of the door does not provide a smooth, uninterrupted surface, or panel to allow the door to be opened by a wheelchair footrest without creating a trap or hazardous condition.

Install a panel or replace the door to provide a smooth, uninterrupted surface at the bottom of the door.

Install compliant door \$2,000

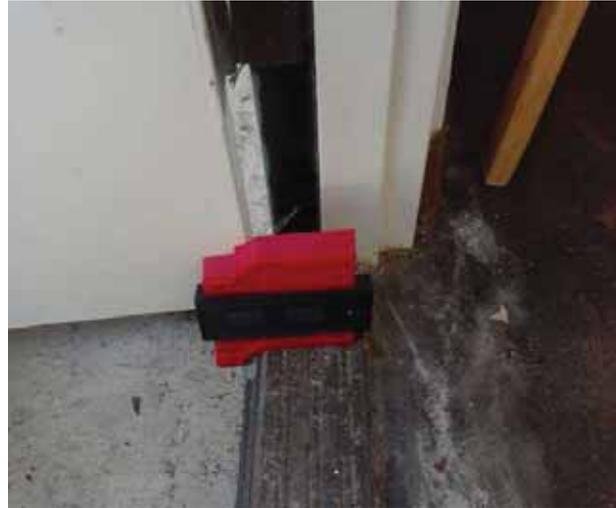
Recommendation Up to 0.50 inches

Modify or replace the threshold to provide the recommended height.

Provide smooth transition \$436

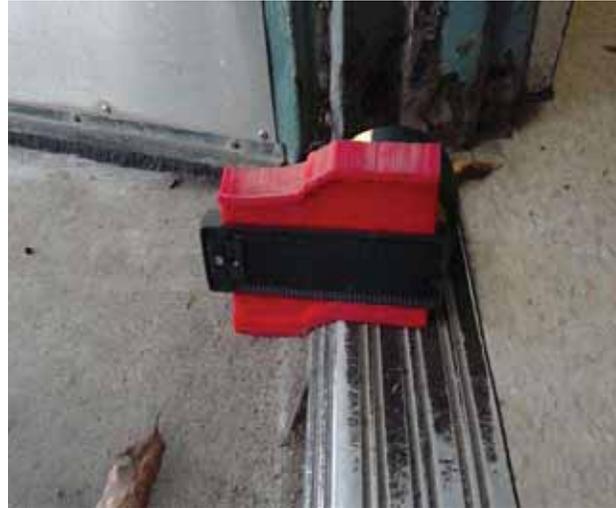
Recommendation Up to 0.50 inches

Modify or replace the threshold to provide the recommended height.

Provide smooth transition \$436

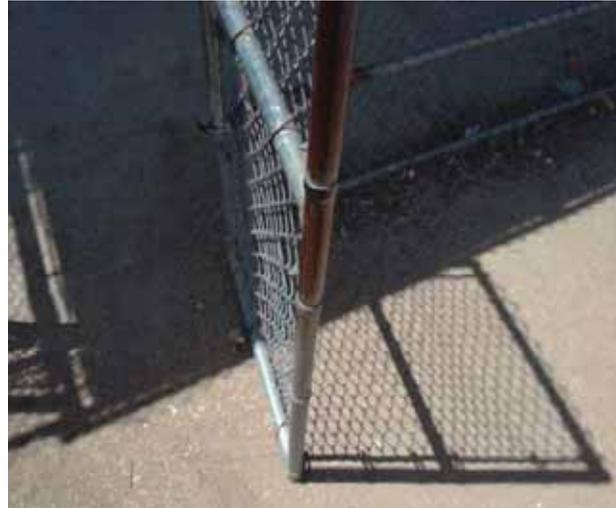
Door hardware broken or missing.

Provide door hardware \$680

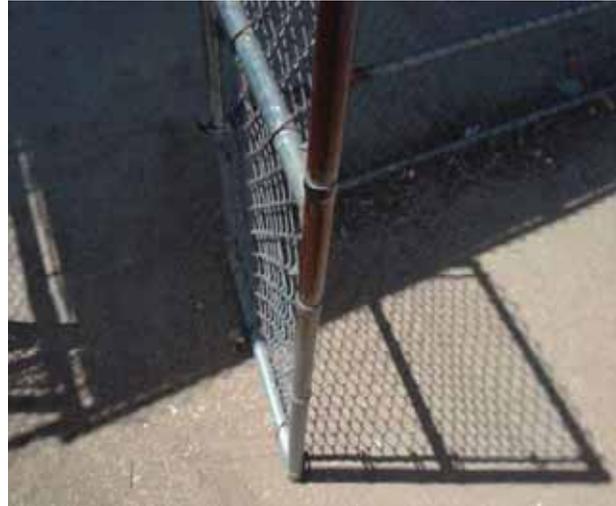
The bottom of the door does not provide a smooth, uninterrupted surface, or panel to allow the door to be opened by a wheelchair footrest without creating a trap or hazardous condition.

Install a panel or replace the door to provide a smooth, uninterrupted surface at the bottom of the door.

Install compliant door \$4,000

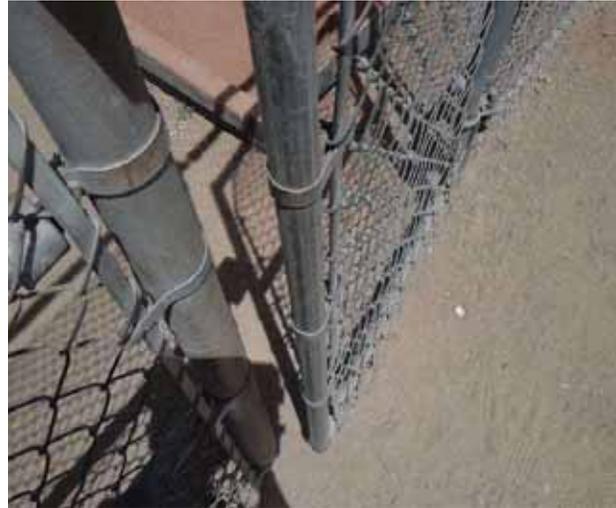
Door hardware broken or missing.

Provide door hardware \$680

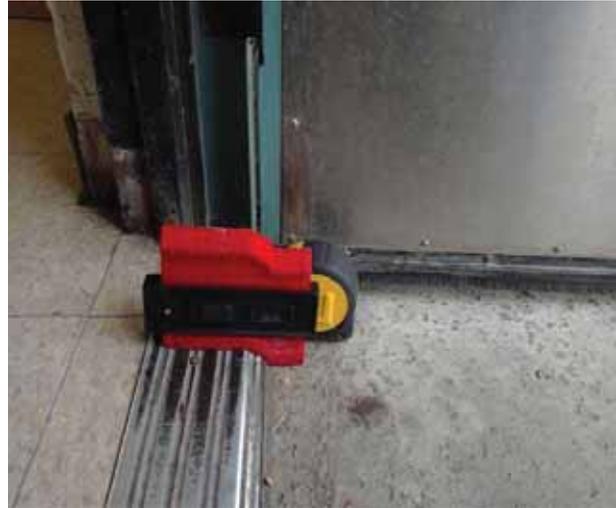
Recommendation Up to 0.50 inches

Modify or replace the threshold to provide the recommended height.

Provide smooth transition \$436

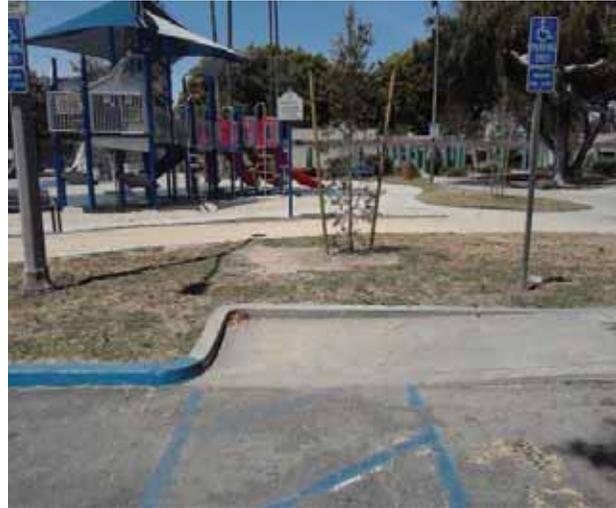
**On-Site Finding** None Found

Recommendation See Recommendation

Install detectable warnings \$144

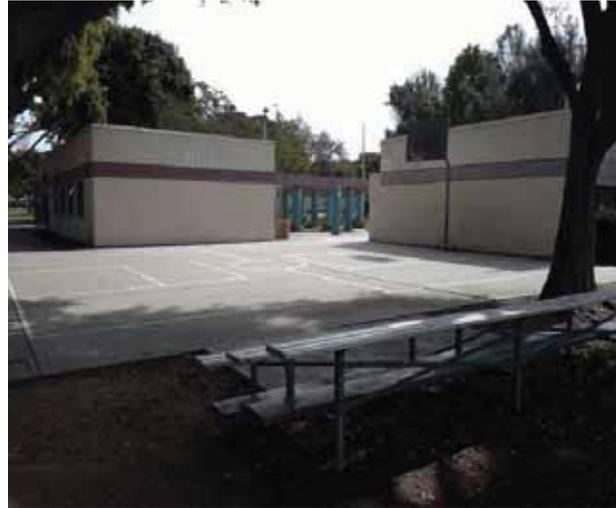
**On-Site Finding** None Found

Recommendation At least 2.00 seats

Requires re-design \$600

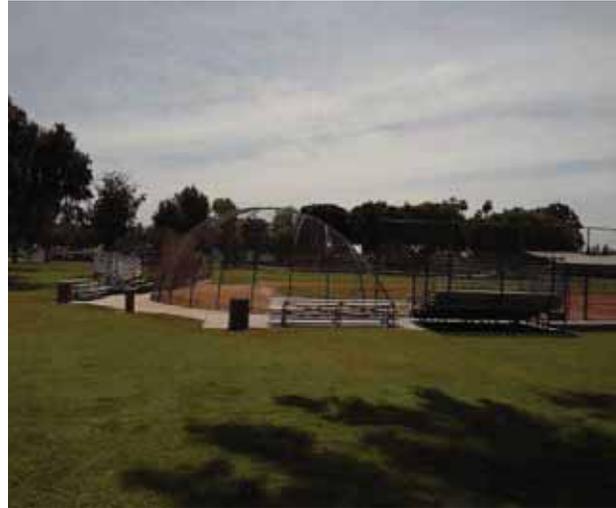
**On-Site Finding** None Found

Recommendation At least 4.00 seats

Requires re-design \$600

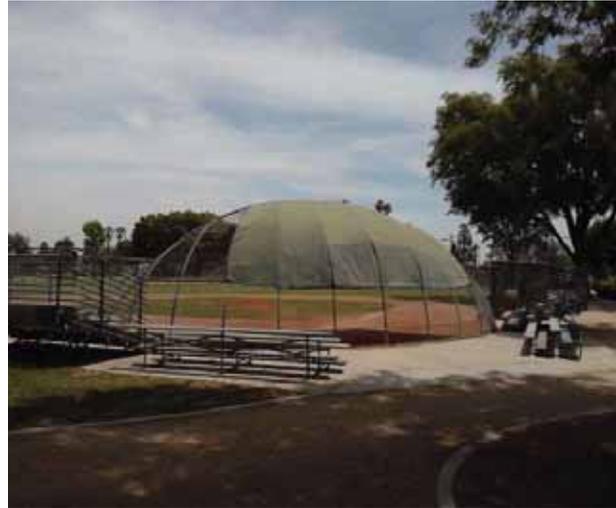
**On-Site Finding** None Found

Recommendation At least 4.00 seats

Requires re-design \$600

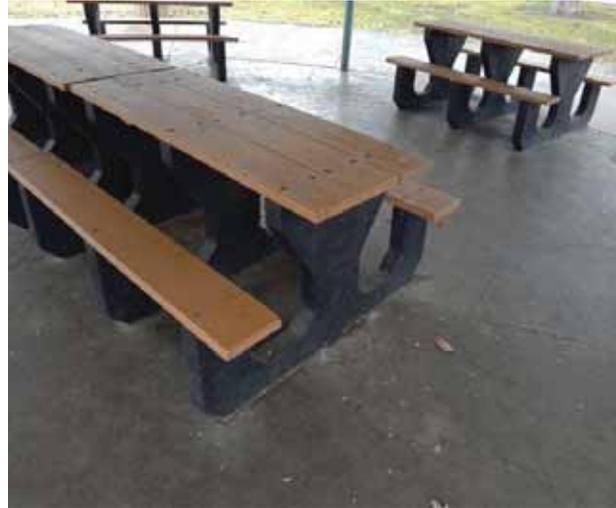
**On-Site Finding** None Found

Provide compliant route \$1,440

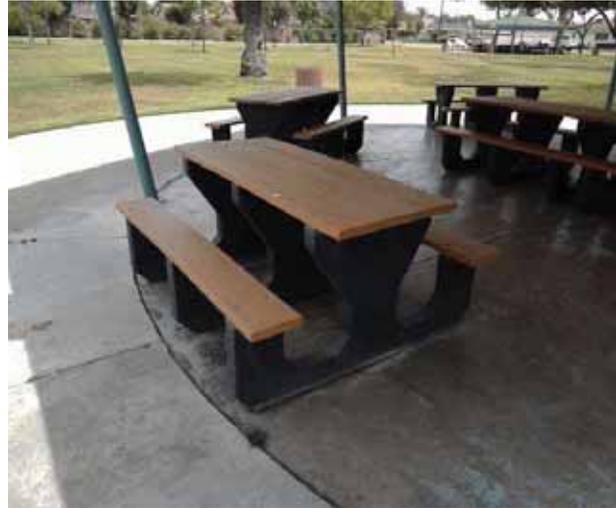
**On-Site Finding** None Found

Provide compliant route \$1,440

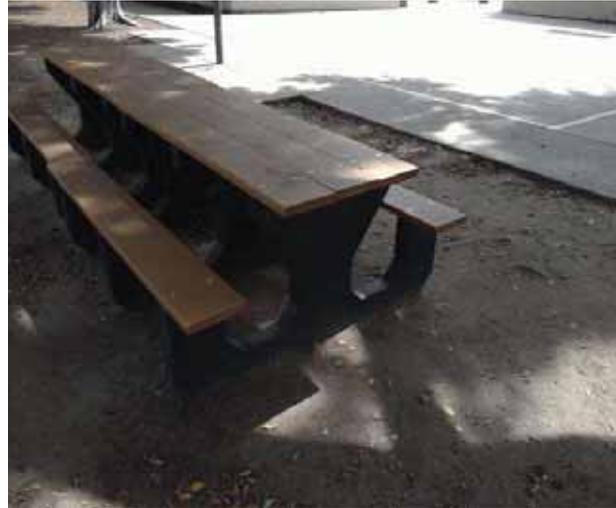
**On-Site Finding** None Found

Recommendation At least 1.00 tables

Accessible table (each) \$500

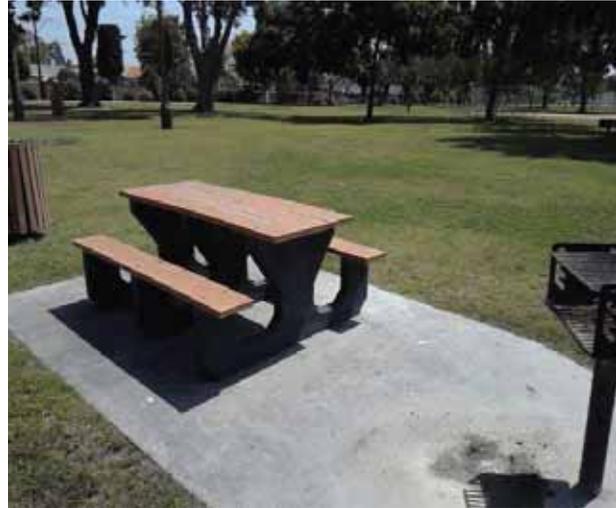
**On-Site Finding** None Found

Provide compliant route \$1,440

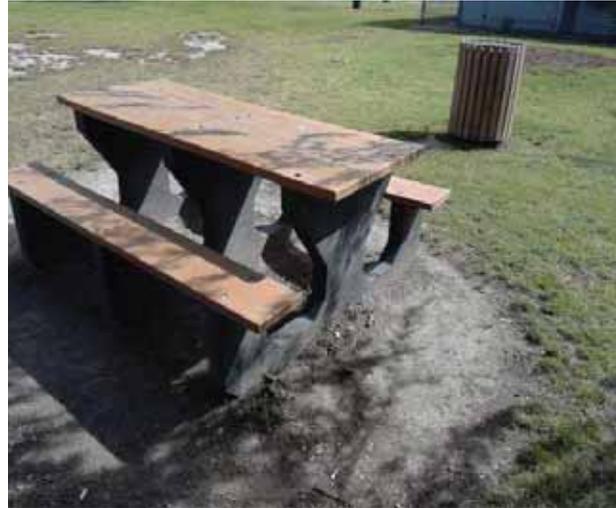
**On-Site Finding** None Found

Provide compliant route \$1,440

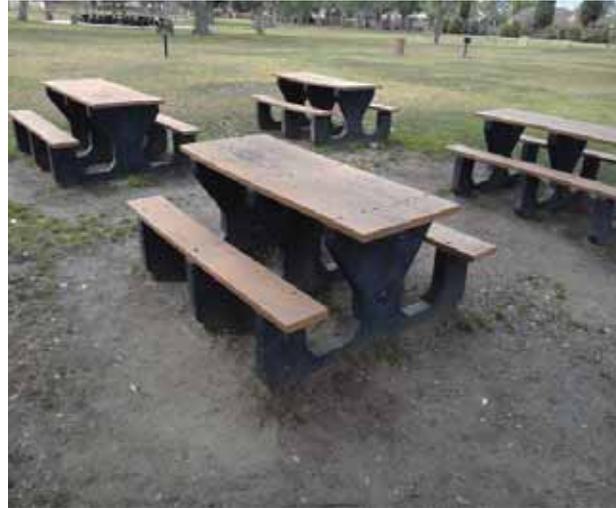
**On-Site Finding** None Found

Provide compliant route \$1,440

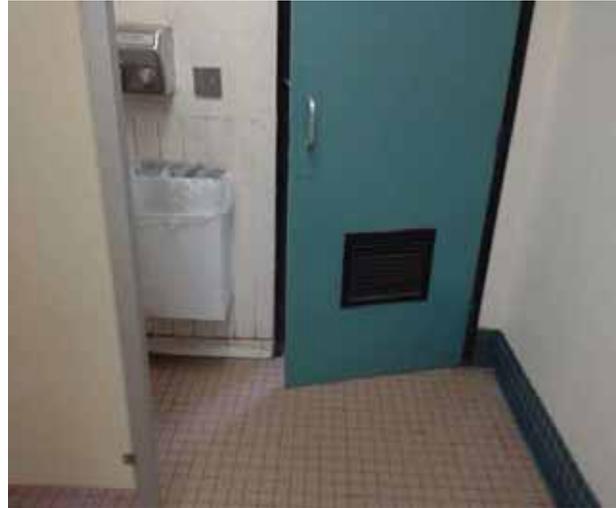
Notes : Partition obstructs clear floor space length.

Provide the recommended clear floor space on the pull side of the door.

Recommendation At least 60.00 inches

Install automatic door opener \$2,921

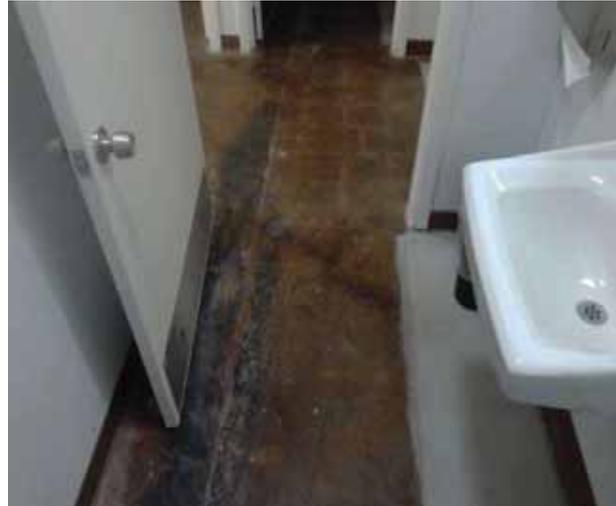
Notes : Lavatory obstructs clear floor space length.

Recommendation At least 18.00 inches

Install automatic door opener \$4,000

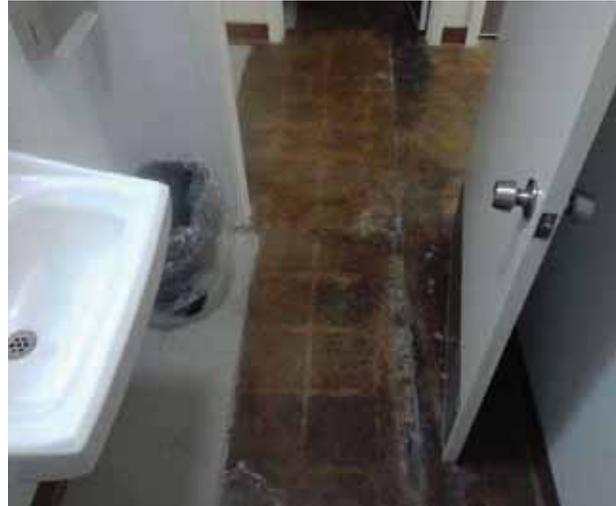
Notes : Lavatory obstructs clear floor space length.

Recommendation At least 18.00 inches

Install automatic door opener \$4,000

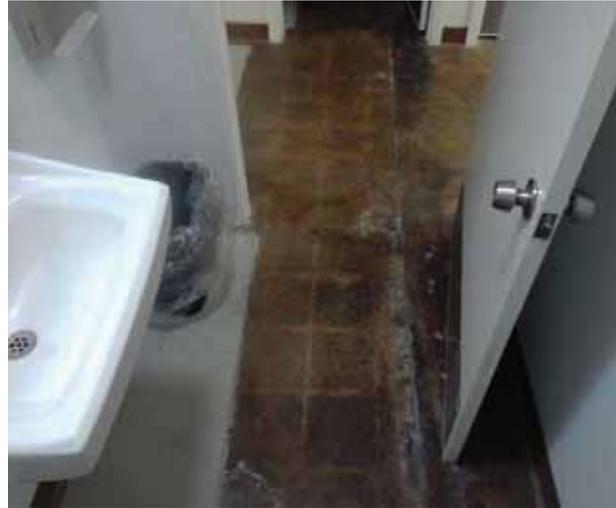
Notes : Lavatory obstructs clear floor space length.

Provide the recommended clear floor space on the pull side of the door.

Recommendation At least 60.00 inches

Install automatic door opener \$2,921

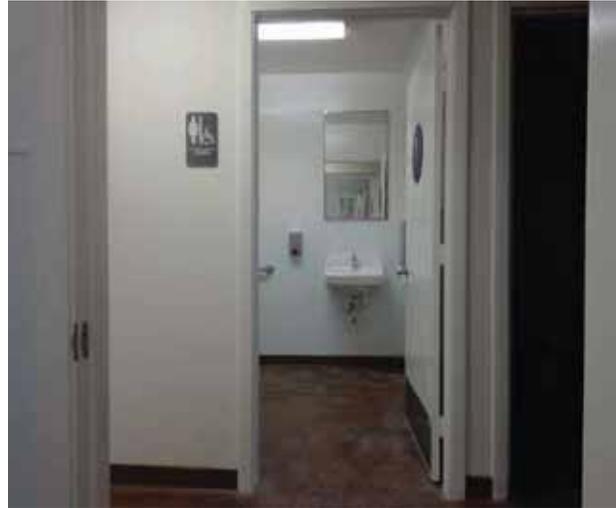
Recommendation At least 80.00 inches

Install compliant door \$2,000

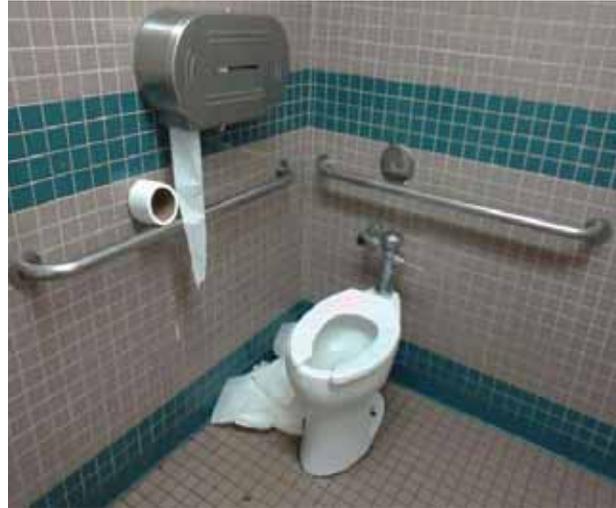
Recommendation At least 54.00 inches

Provide compliant grab bar \$267

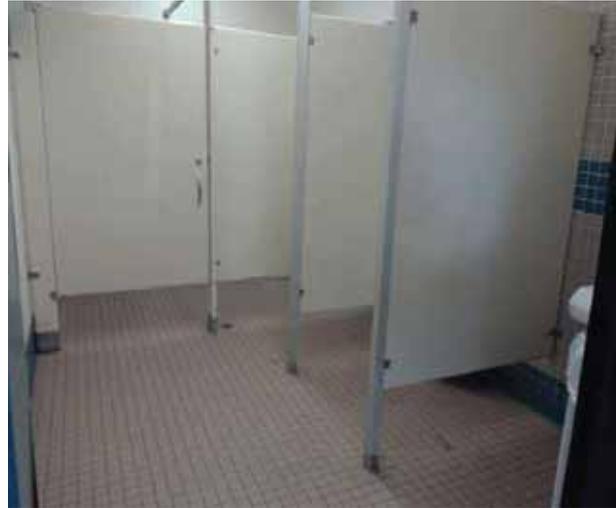
Recommendation At least 60.00 inches

Notes : Partition obstructs turning space diameter.

Install single-use toilet room \$14,000

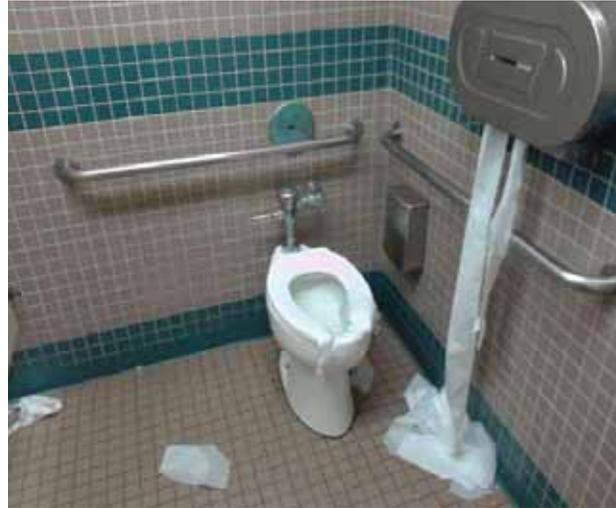
Recommendation At least 54.00 inches

Provide compliant grab bar \$267

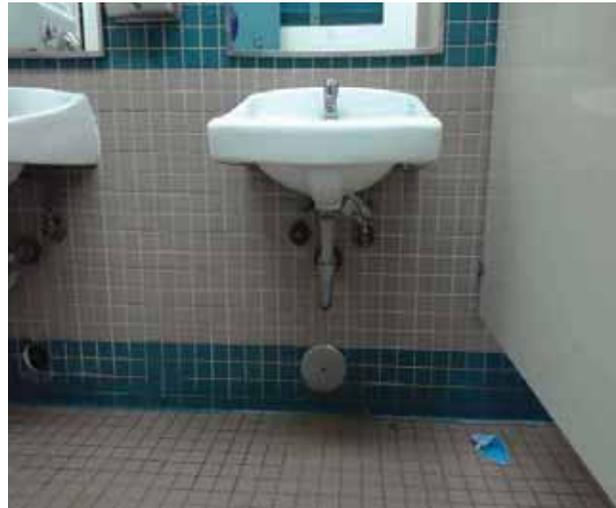
Recommendation      At least 18.00 inches on center

Replace or remount lavatory to meet the minimum required distance to the center line of the fixture, when located adjacent to a side wall or partition.

Install new sink, faucet and handles      \$2,500

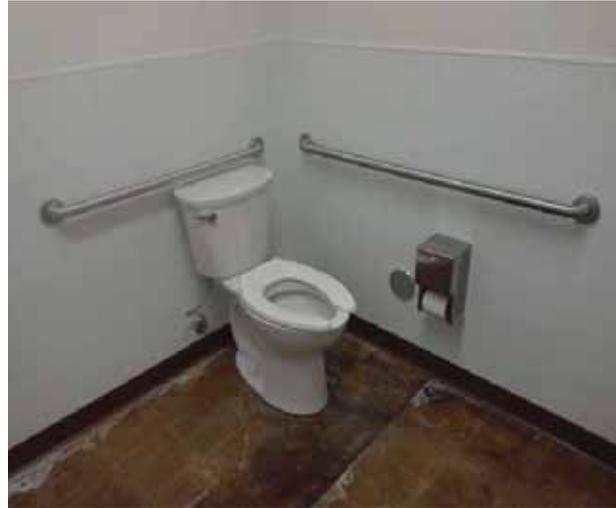
Recommendation At least 54.00 inches

Provide compliant grab bar \$267

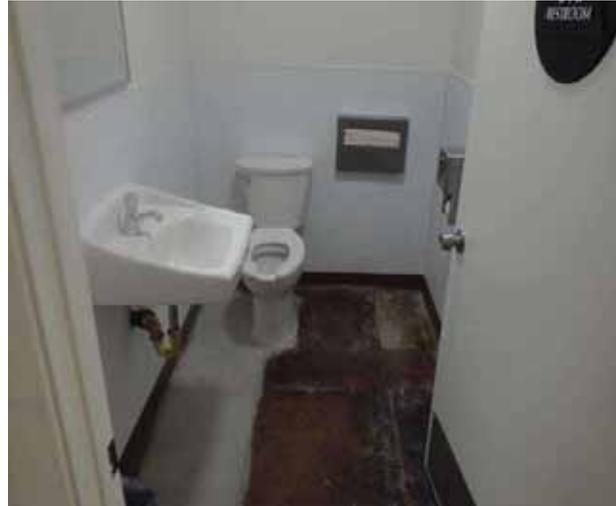
Recommendation At least 60.00 inches

Modify fixture \$1,707

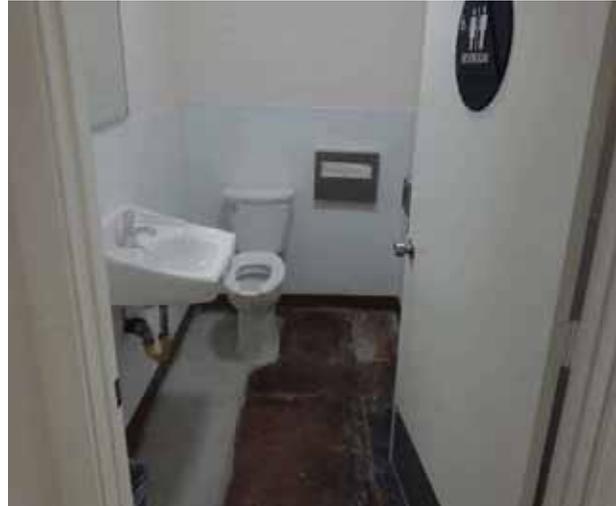
Recommendation At least 60.00 inches

Notes : Lavatory obstructs turning space diameter.

Install single-use toilet room \$14,000

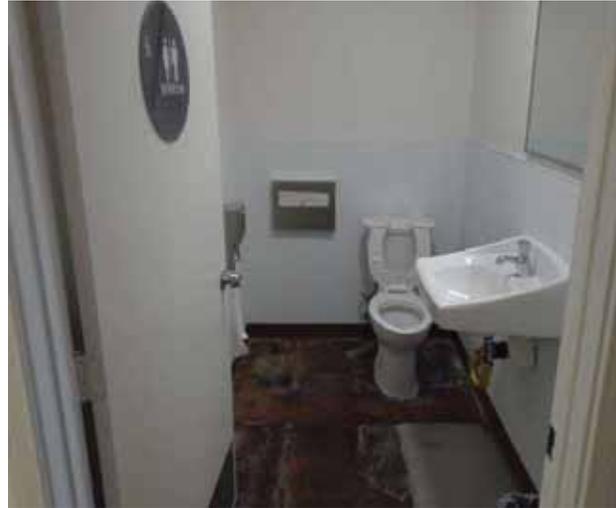
Recommendation At least 60.00 inches

Notes : Lavatory obstructs turning space diameter.

Install single-use toilet room \$14,000

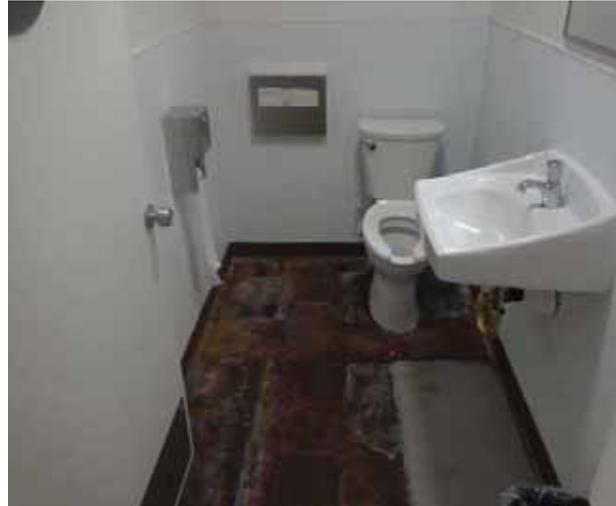
Recommendation At least 56.00 inches

Modify fixture \$1,707

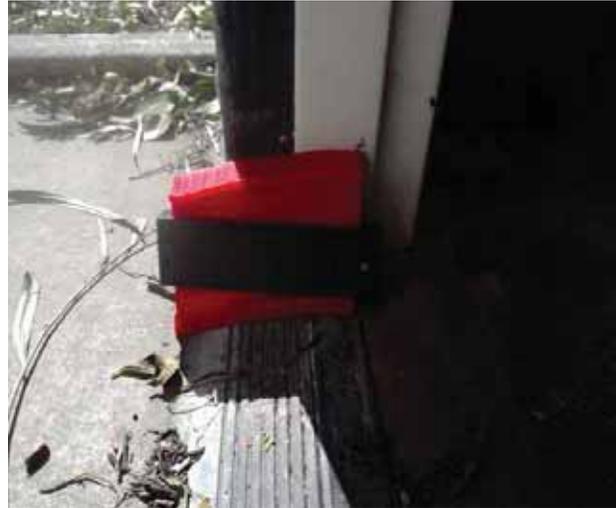
Recommendation Up to 0.50 inches

Modify or replace the threshold to provide the recommended height.

Provide smooth transition \$436

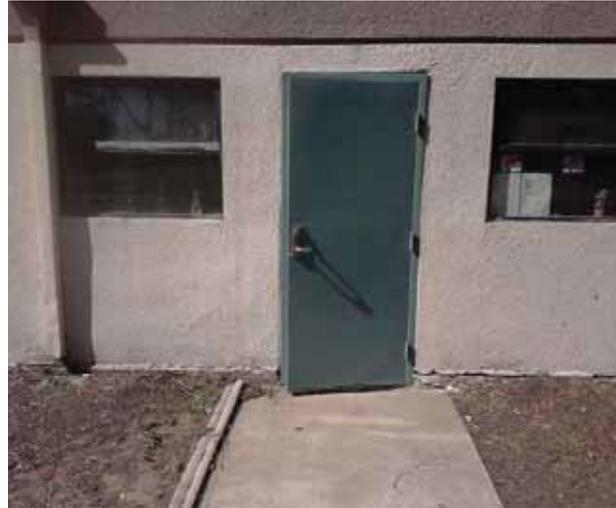
Recommendation At least 24.00 inches

Install automatic door opener \$2,921

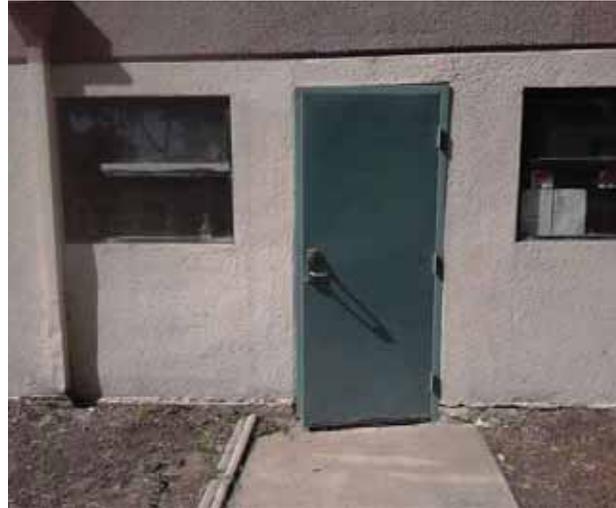
Recommendation At least 78.00 inches

Replace the door closing device with a device that fits above the door casing and does not protrude into the primary path of travel.

Install new door opener \$250

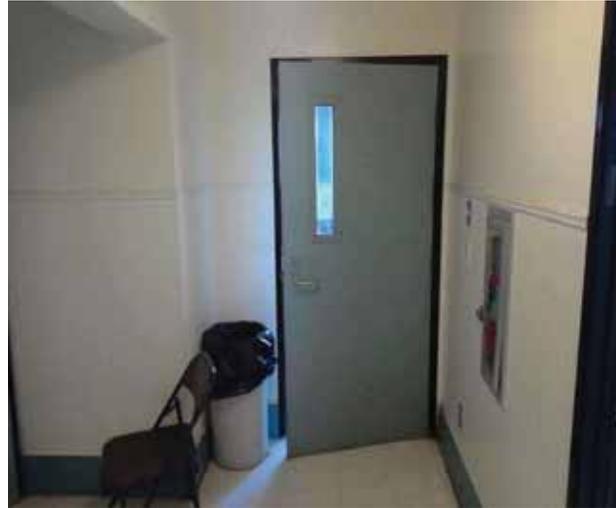
Recommendation At least 78.00 inches

Replace the door closing device with a device that fits above the door casing and does not protrude into the primary path of travel.

Install new door opener \$250

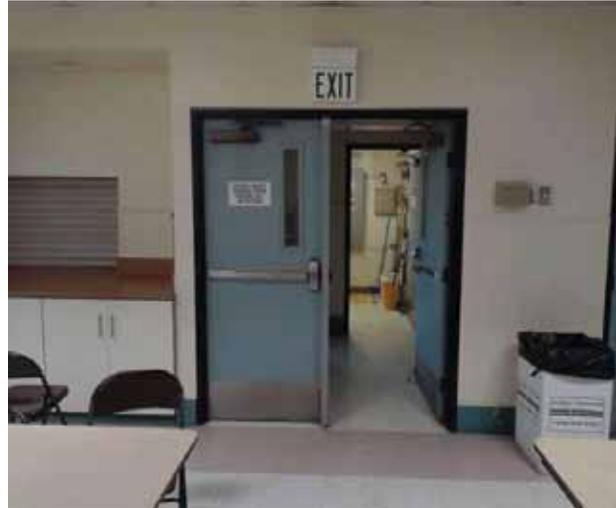
Recommendation At least 78.00 inches

Replace the door closing device with a device that fits above the door casing and does not protrude into the primary path of travel.

Install new door opener \$250

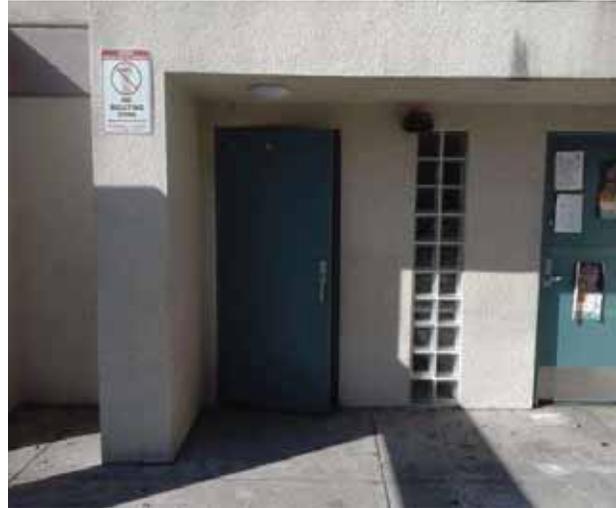
Recommendation At least 78.00 inches

Replace the door closing device with a device that fits above the door casing and does not protrude into the primary path of travel.

Install new door opener \$250

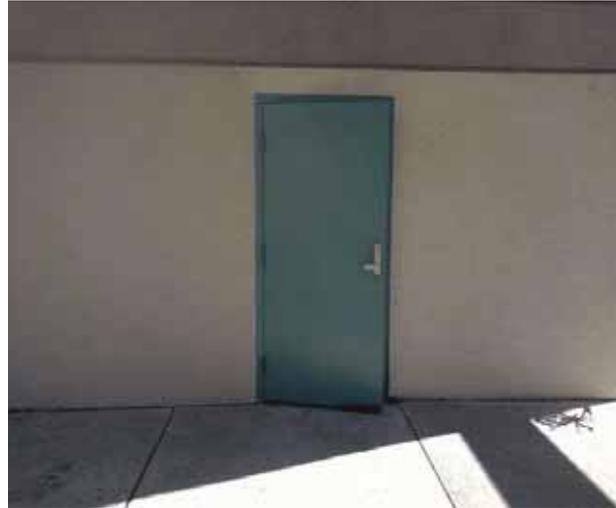
**Recommendation** At least 78.00 inches

Replace the door closing device with a device that fits above the door casing and does not protrude into the primary path of travel.

Install new door opener \$250

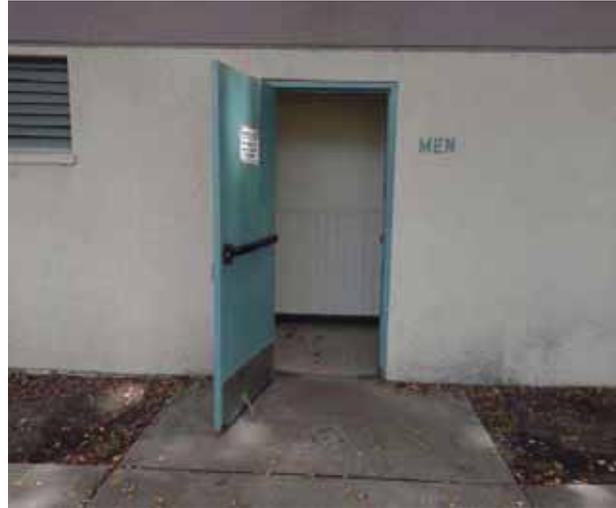
Recommendation At least 80.00 inches

Install compliant door \$2,000

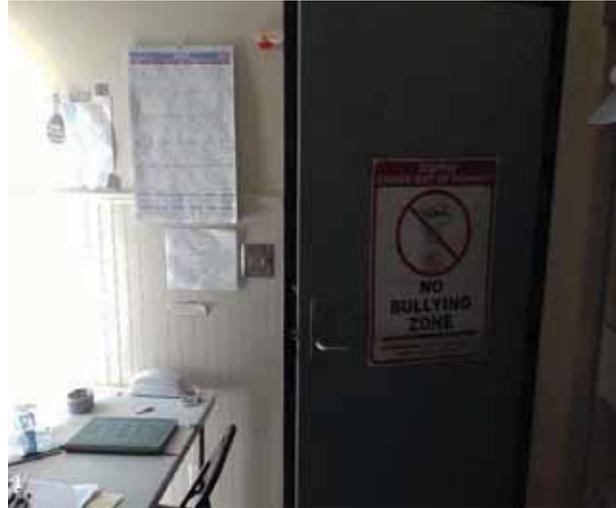
Recommendation At least 80.00 inches

Install compliant door \$2,000

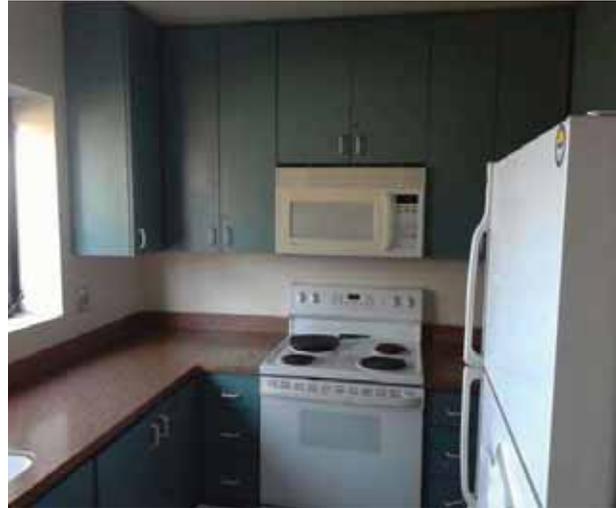
Recommendation Up to 48.00 inches

Adjust appliance height \$1,200
