Accessibility Survey

Rio San Gabriel Park

9612 Ardine Street
Downey, CA 90240

Date of Inspection
1/17/2017

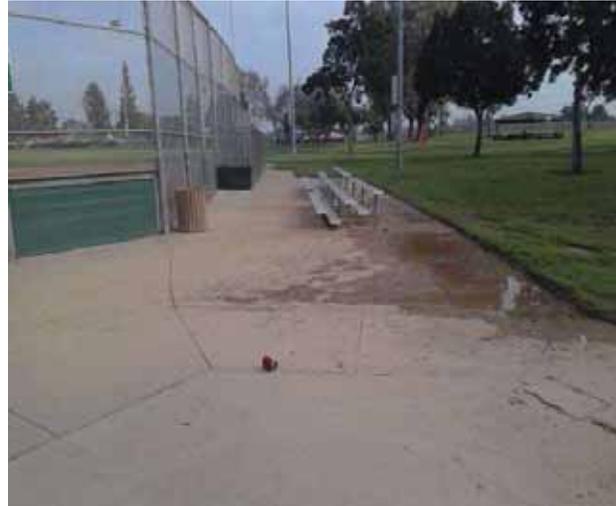
There is a change in elevation greater than recommended value.

Notes : Surface accumulates water for 30 feet.

Ensure that the change in elevation is within the recommended value.

Recommendation Up to 0.25 inches

Provide smooth surface \$450

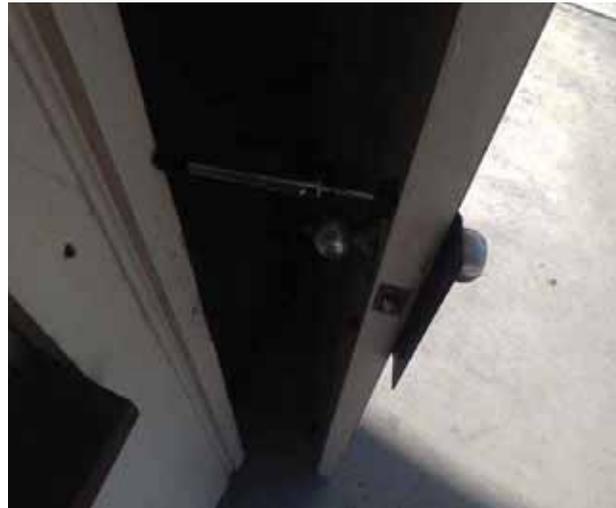
On-Site Finding Found

Remove door stop \$50

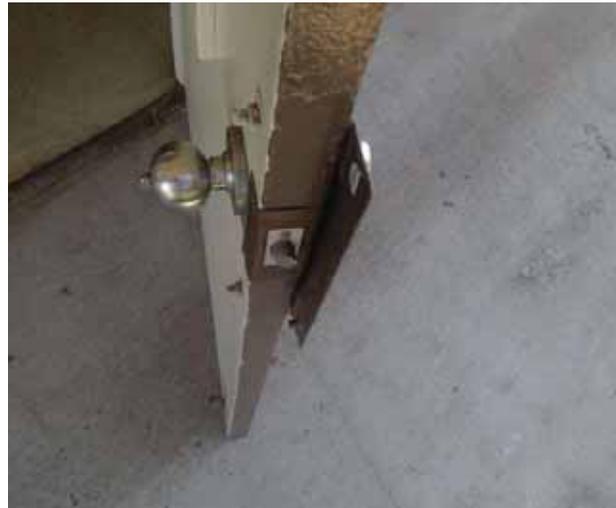
On-Site Finding Found

Remove door stop \$50

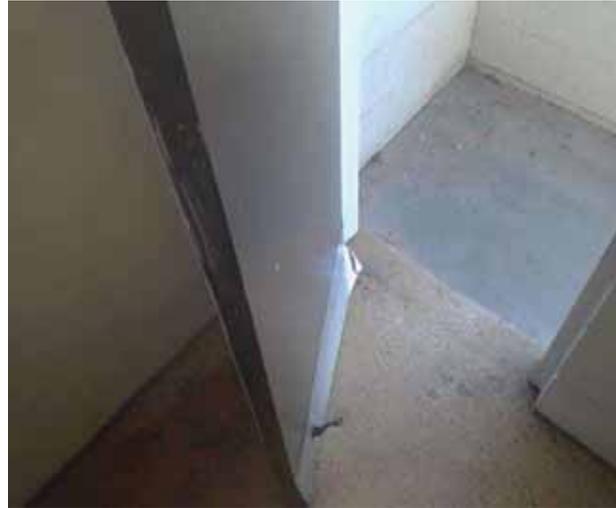
On-Site Finding Found

Remove door stop \$50

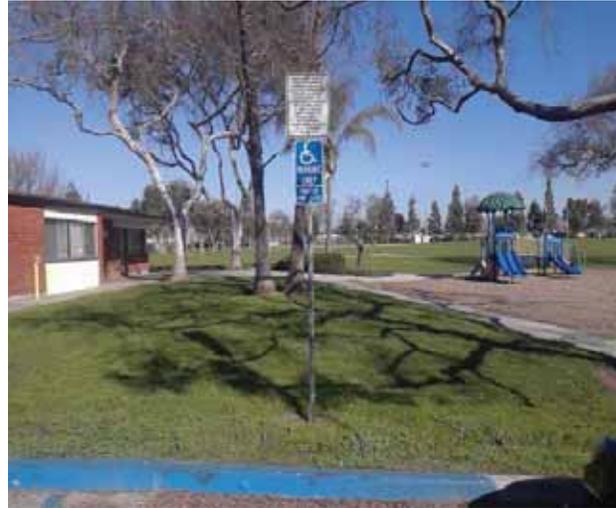
Notes : Signage states: "Unauthorized vehicles...may be towed...".

Install signage \$300

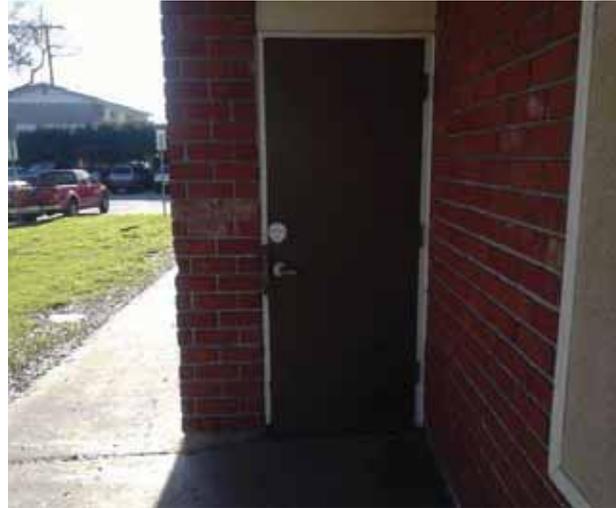
On-Site Finding None Found

Install signage \$158

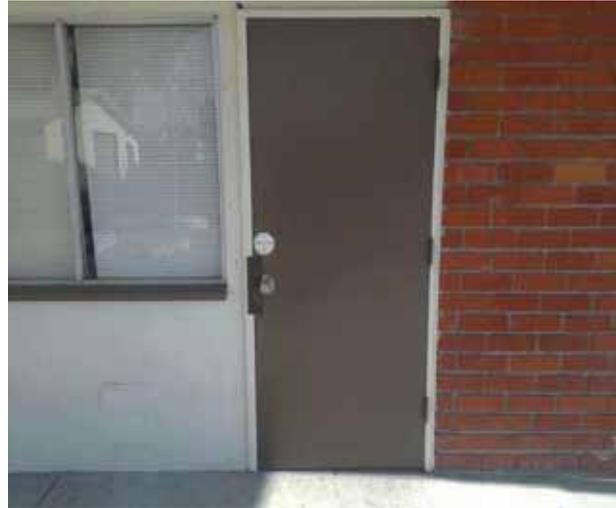
On-Site Finding None Found

Install signage \$158

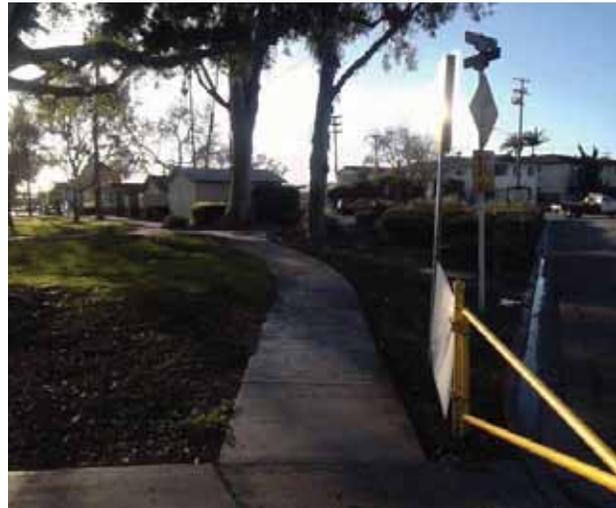
On-Site Finding None Found

Install signage \$158

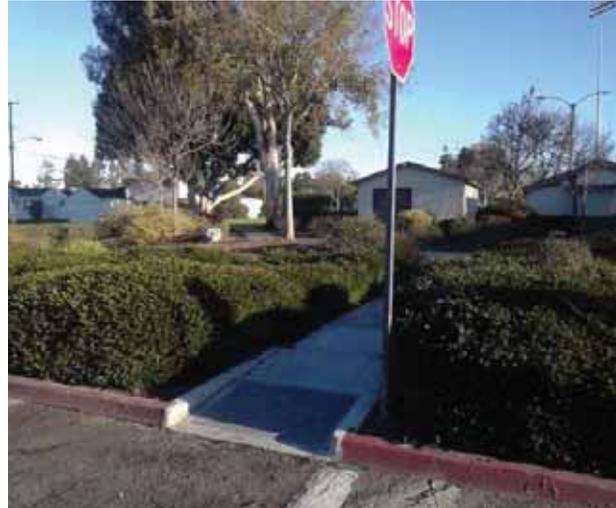
On-Site Finding None Found

Install signage \$158

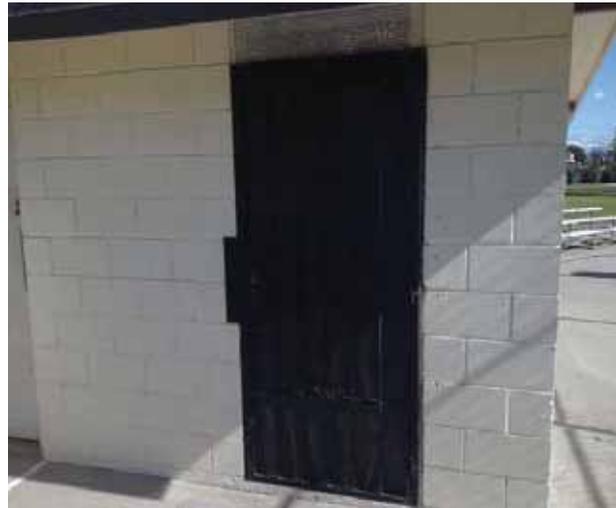
On-Site Finding None Found

Install signage \$158

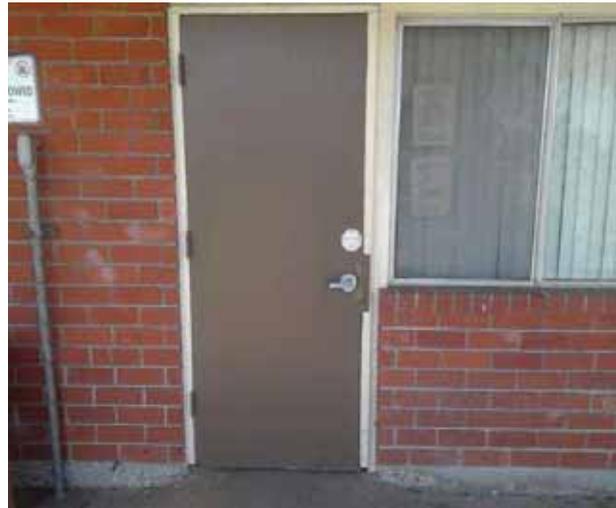
On-Site Finding None Found

Install signage \$158

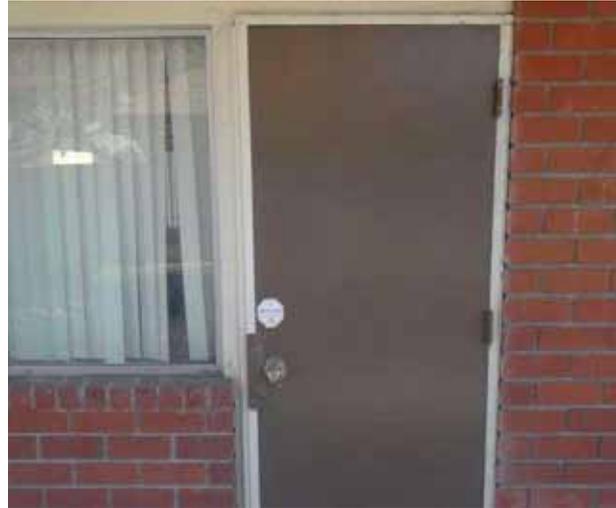
On-Site Finding None Found

Install signage \$158

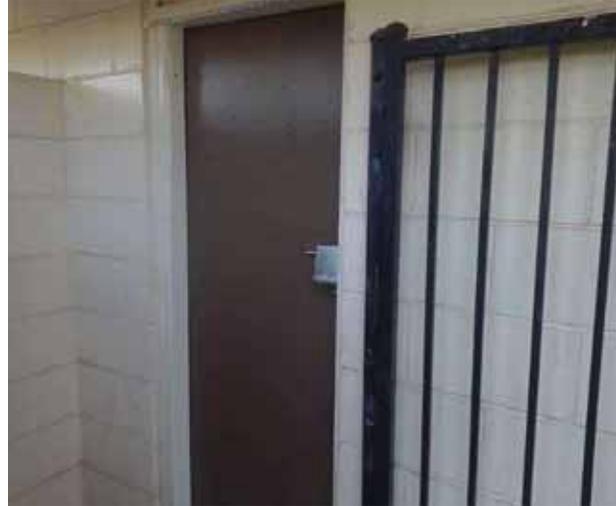
On-Site Finding None Found

Install signage \$158

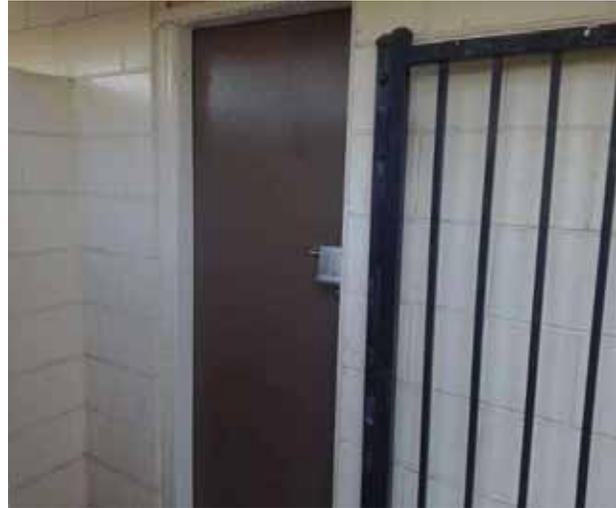
On-Site Finding None Found

Install signage \$158

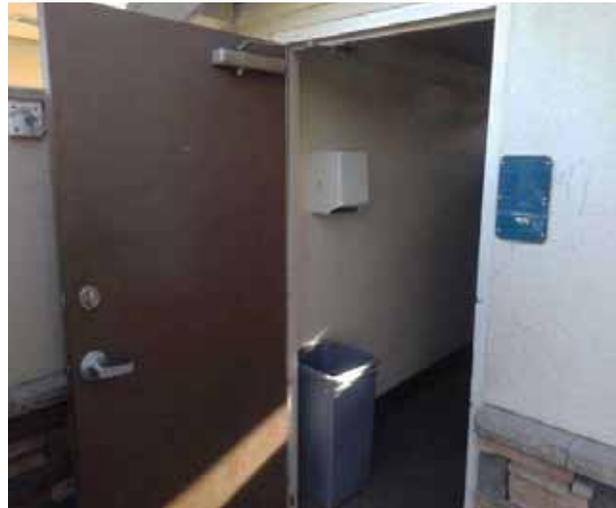
On-Site Finding None Found

Install signage \$158

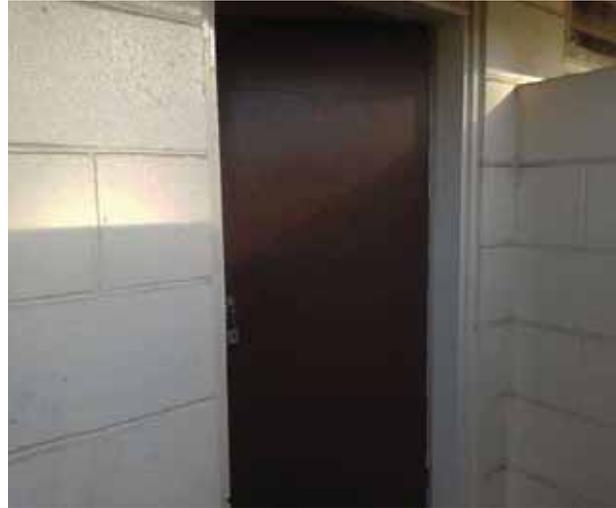
On-Site Finding None Found

Install signage \$158

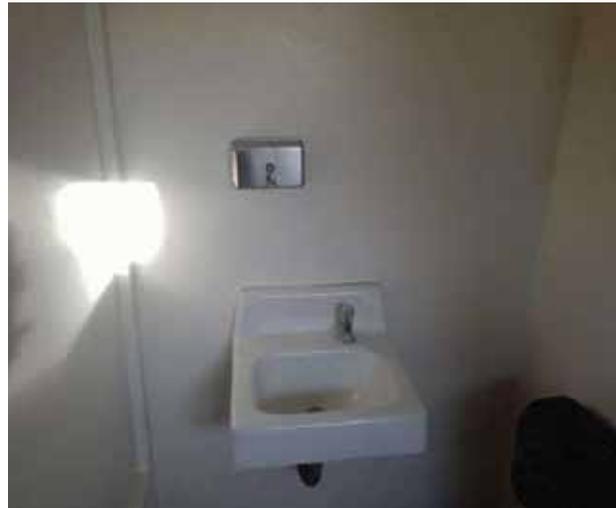
Recommendation Up to 40.00 inches

Recommendation

Provide compliant dispenser \$277

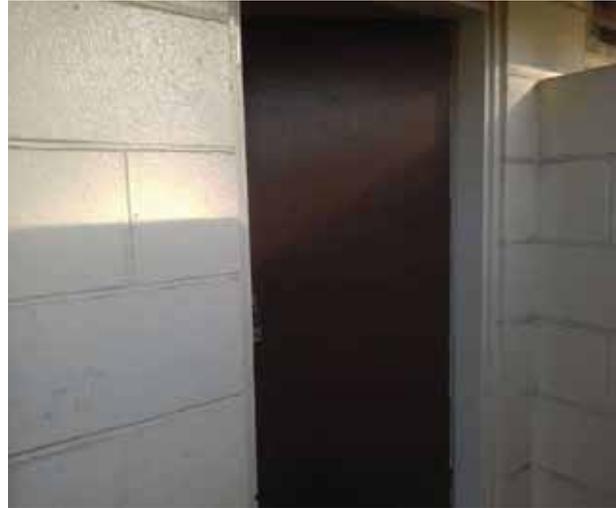
On-Site Finding None Found

Install signage \$158

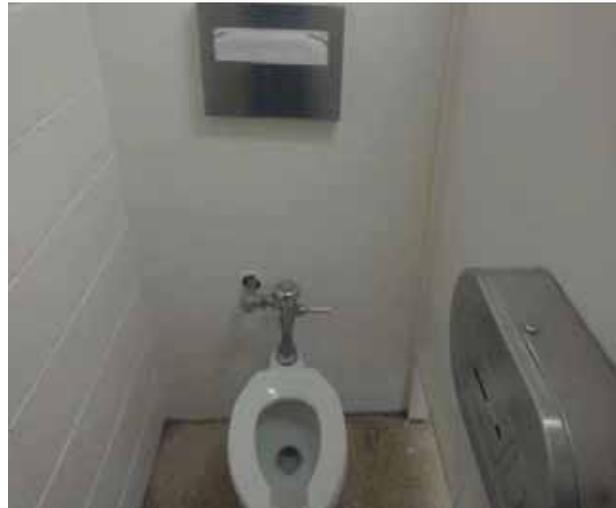
Recommendation Up to 40.00 inches

Provide compliant dispenser \$277

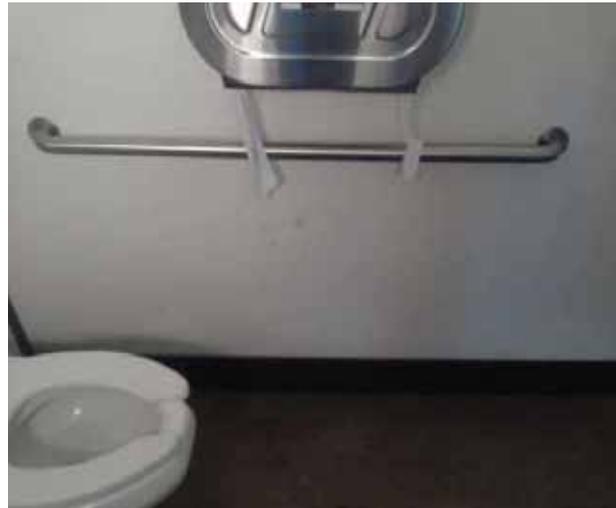
Recommendation 7.00 - 9.00 inches

Provide compliant dispenser \$277

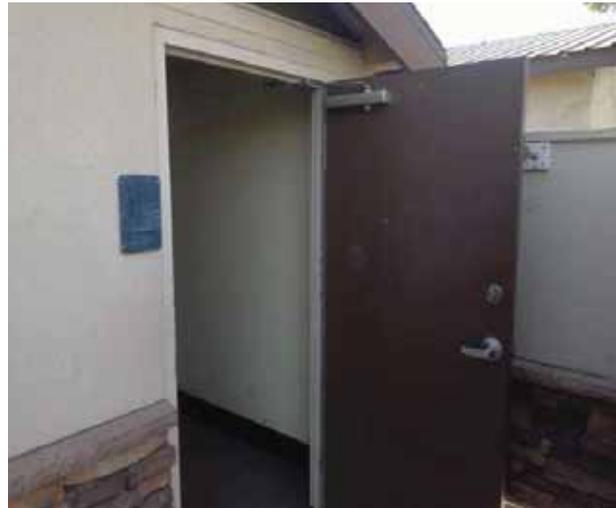
On-Site Finding None Found

Install signage \$158

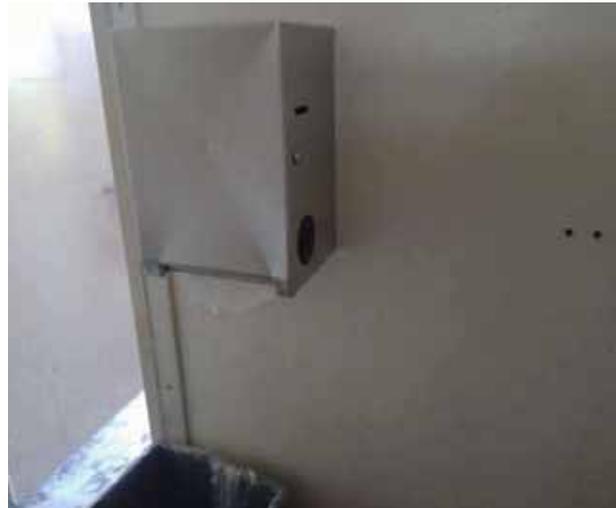
Recommendation Up to 40.00 inches

Provide compliant dispenser \$277

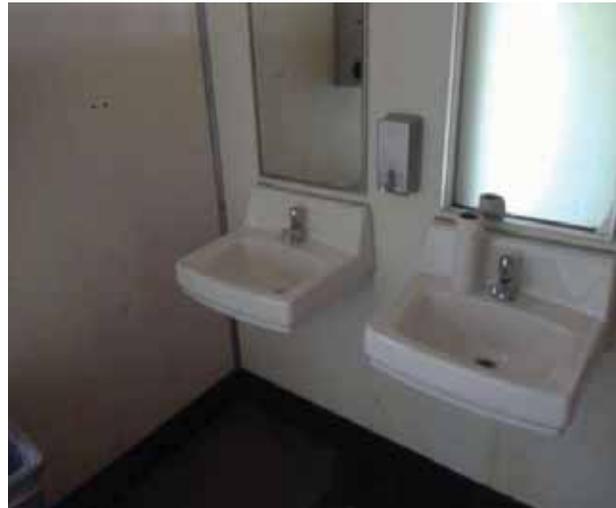
Recommendation Up to 40.00 inches

Provide compliant dispenser \$277

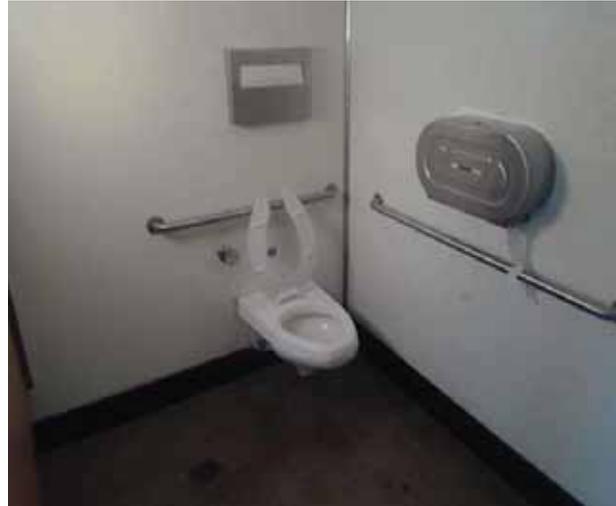
Recommendation Up to 40.00 inches

Provide compliant dispenser \$277

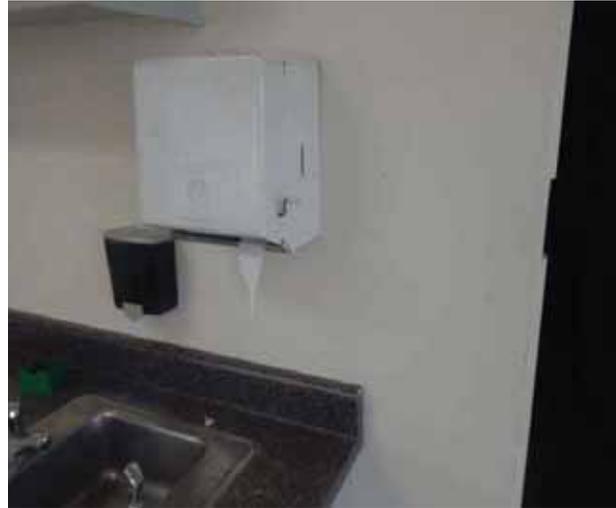
Recommendation Up to 40.00 inches

Replace dispenser \$180

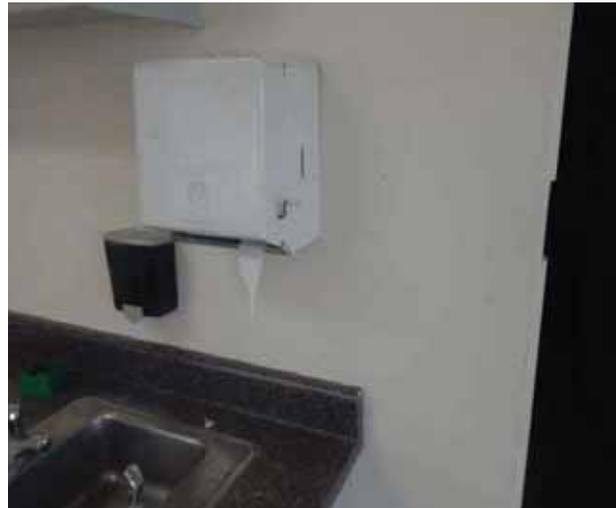
On-Site Finding None Found

Replace dispenser with one that allows operation with one hand and does not require tight grasping, pinching, or twisting of the wrist. The force required to activate operable parts shall be 5 pounds. Consider installing automatic dispensers.

Replace dispenser \$980

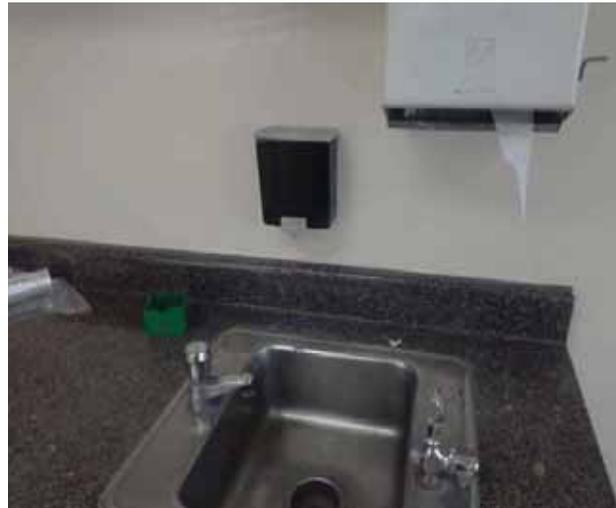
Recommendation Up to 40.00 inches

Replace dispenser \$180

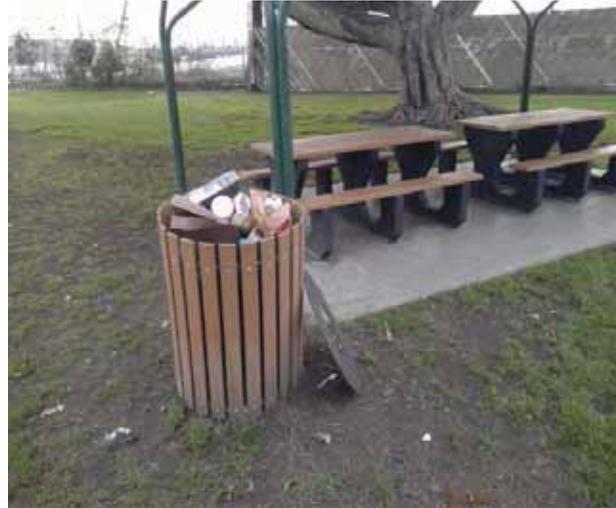
Notes : Landing is grass/dirt.

\$1,260

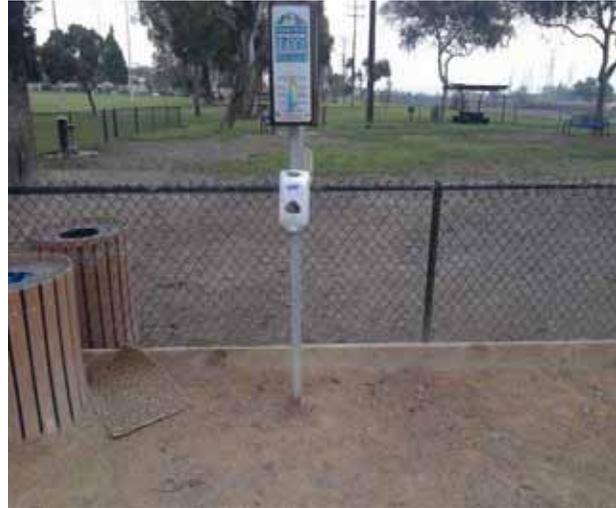
Recommendation 15.00 - 48.00 inches

Make sure that the highest point of operation is within the recommended value.

Readjust element height \$50

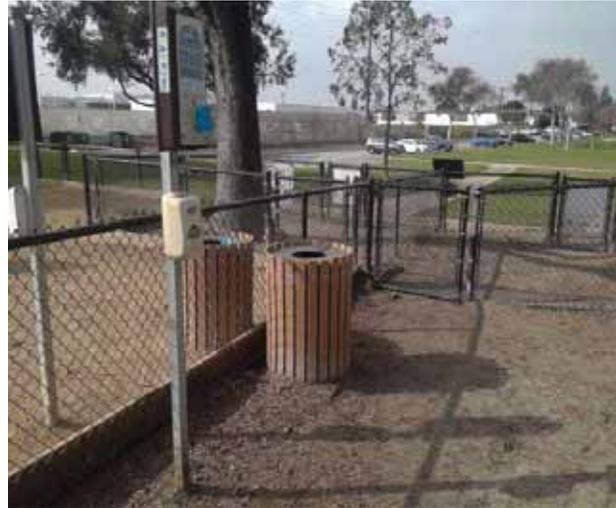
Recommendation 15.00 - 48.00 inches

Notes : Landing is grass/dirt.

Make sure that the highest point of operation is within the recommended value.

Readjust element height \$50

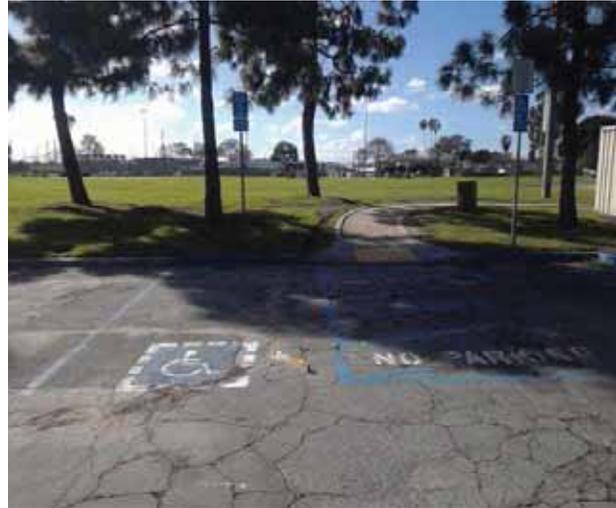
Recommendation At least 108.00 inches

Re-stripe existing parking space \$350

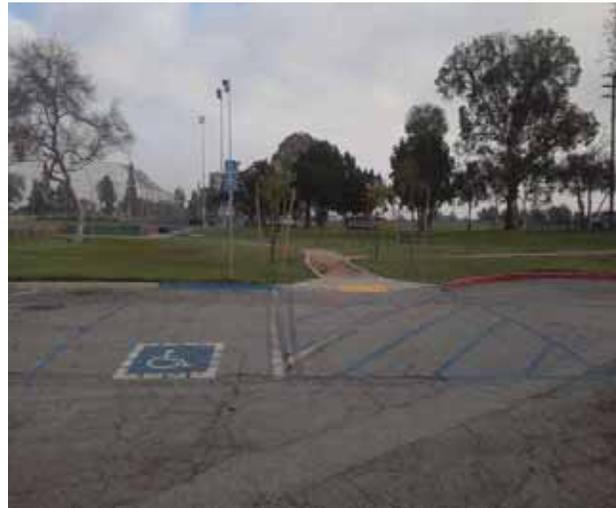
On-Site Finding None Found

Stripe an access aisle \$250

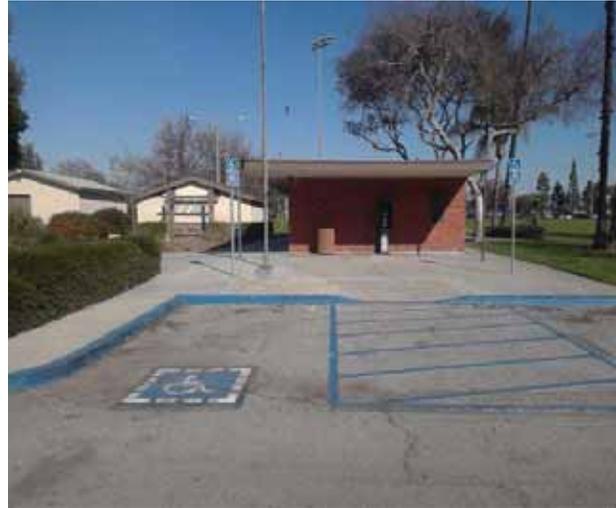
On-Site Finding None Found

Stripe an access aisle \$250

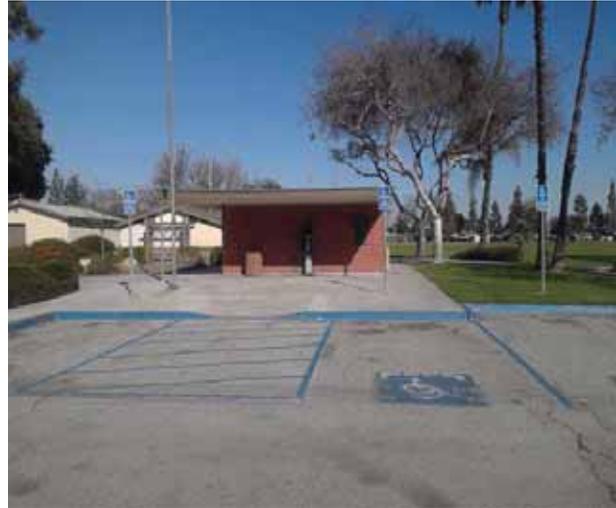
Recommendation At least 216.00 inches

Re-stripe existing parking space \$350

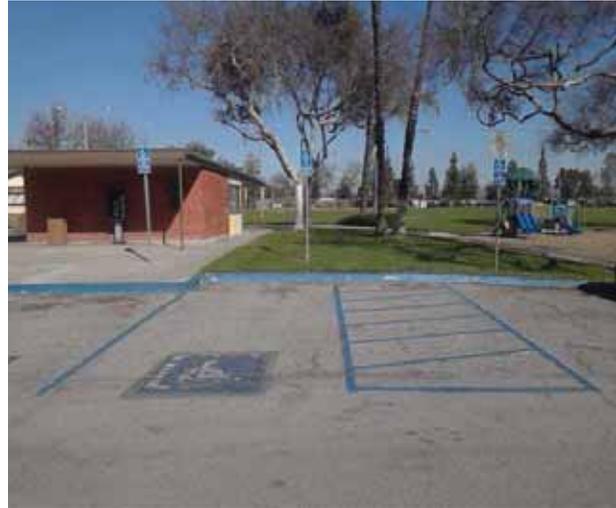
Recommendation At least 96.00 inches

Stripe an access aisle \$250

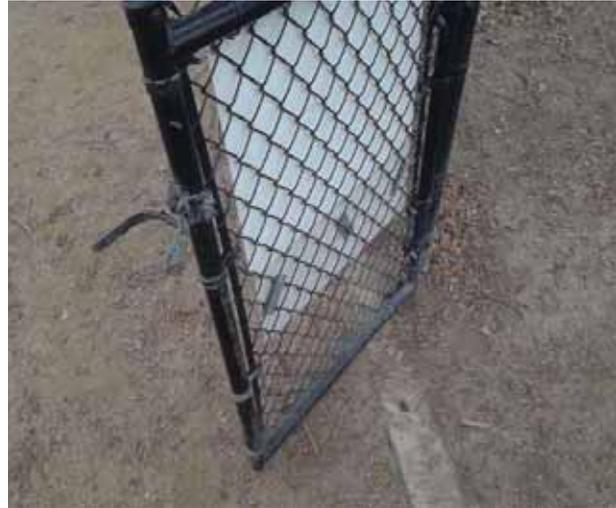
The bottom of the door does not provide a smooth, uninterrupted surface, or panel to allow the door to be opened by a wheelchair footrest without creating a trap or hazardous condition.

Install a panel or replace the door to provide a smooth, uninterrupted surface at the bottom of the door.

Install compliant door \$2,000

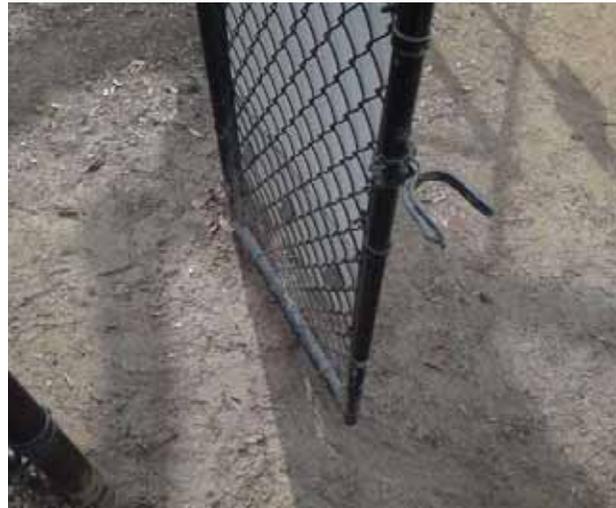
The bottom of the door does not provide a smooth, uninterrupted surface, or panel to allow the door to be opened by a wheelchair footrest without creating a trap or hazardous condition.

Install a panel or replace the door to provide a smooth, uninterrupted surface at the bottom of the door.

Install compliant door \$2,000

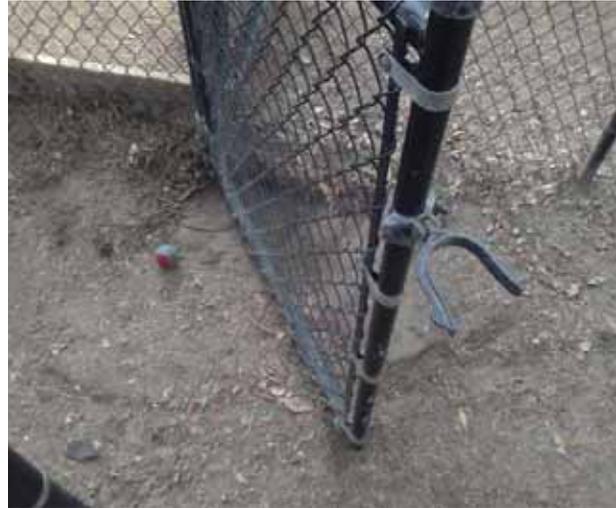
The bottom of the door does not provide a smooth, uninterrupted surface, or panel to allow the door to be opened by a wheelchair footrest without creating a trap or hazardous condition.

Install a panel or replace the door to provide a smooth, uninterrupted surface at the bottom of the door.

Install compliant door \$2,000

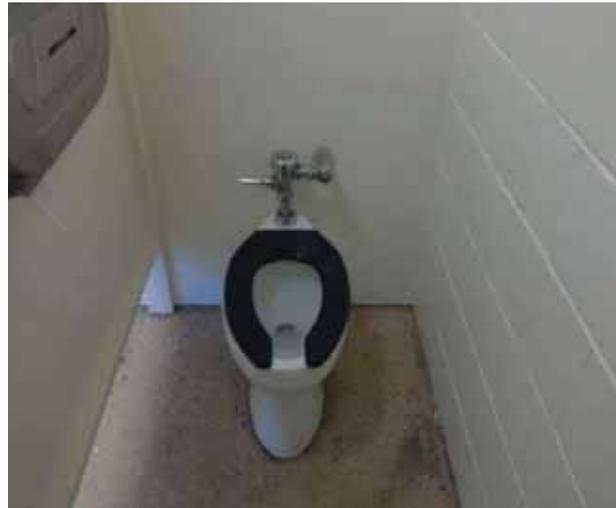
Recommendation At least 42.00 inches

Relocate fixture \$2,500

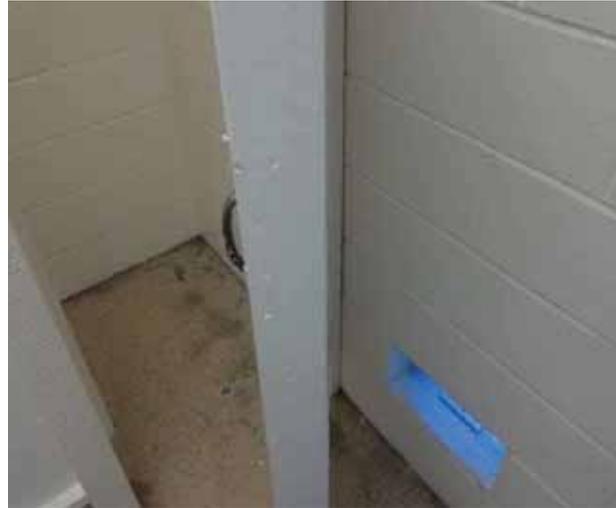
On-Site Finding Missing Hardware

Install accessible hardware on stall door \$269

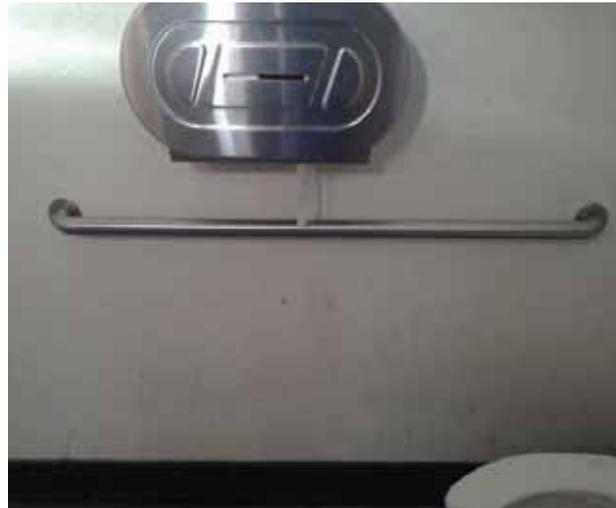
Recommendation Relocate Dispenser

Provide compliant dispenser \$277

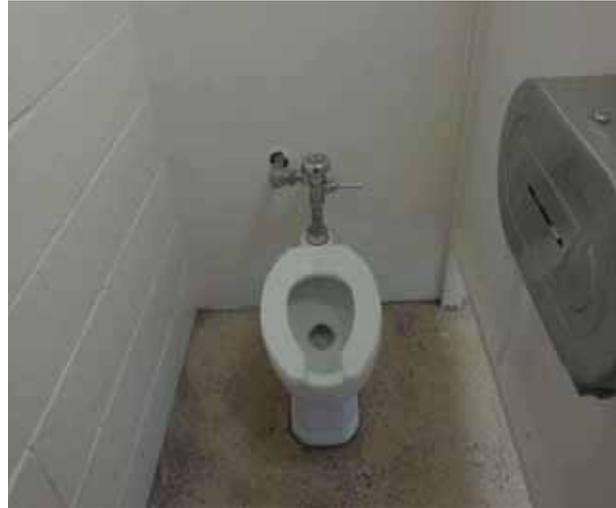
Recommendation At least 42.00 inches

Relocate fixture \$2,500

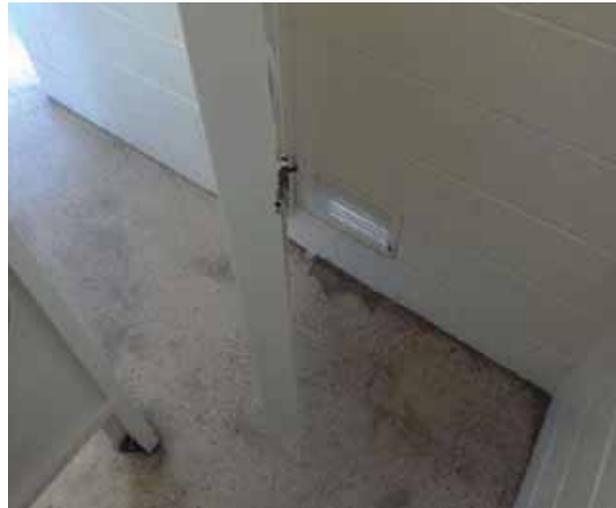
On-Site Finding Missing Hardware

Install accessible hardware on stall door \$269

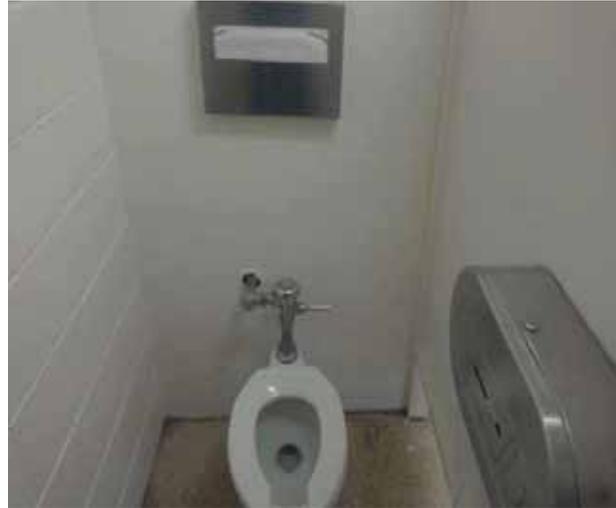
On-Site Finding None Found

Provide compliant dispenser \$277

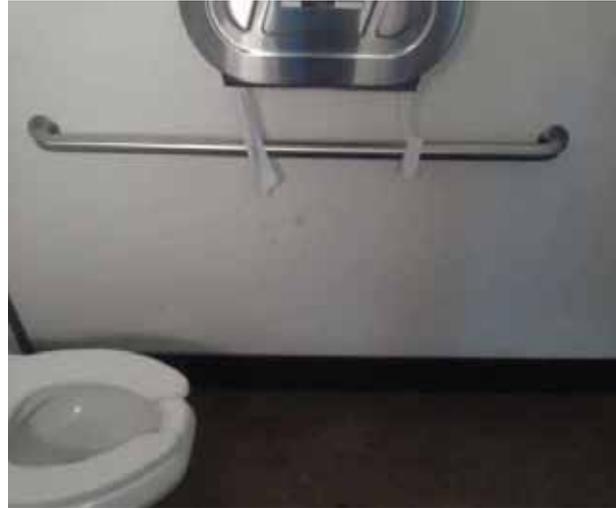
Recommendation Relocate Dispenser

Provide compliant dispenser \$277

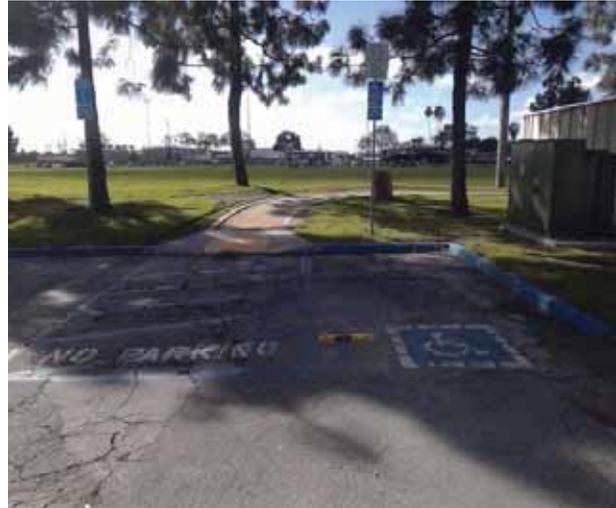
Recommendation Up to 2.08 percent

Repave surface to correct slope \$3,800 and re-stripe

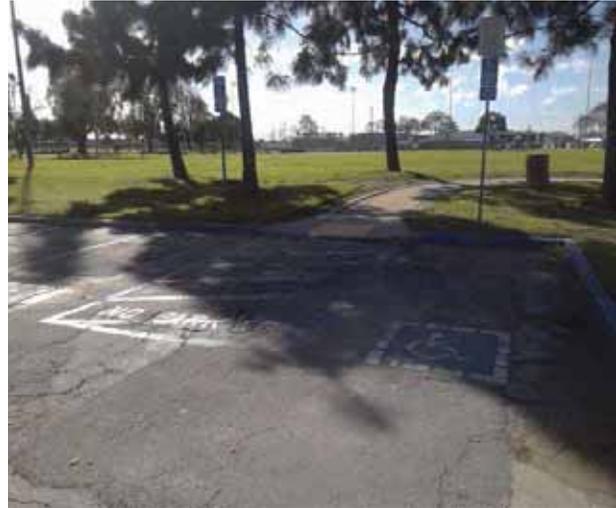
Recommendation At least 3.00 spaces

Paint ground markings and install a post mounted sign \$370

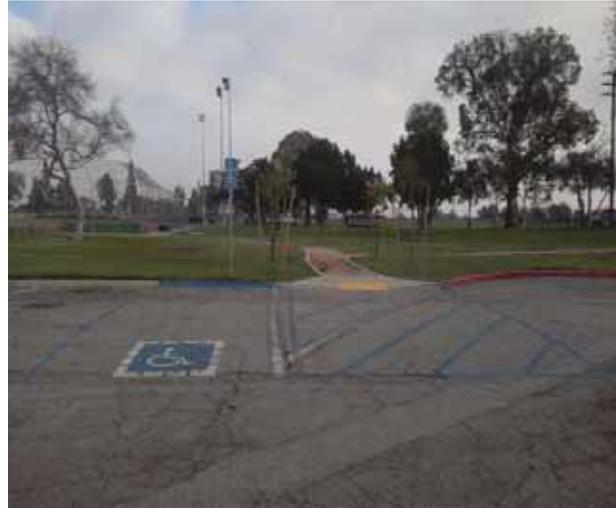
Recommendation Up to 2.08 percent

Repave surface to correct slope \$3,800 and re-stripe

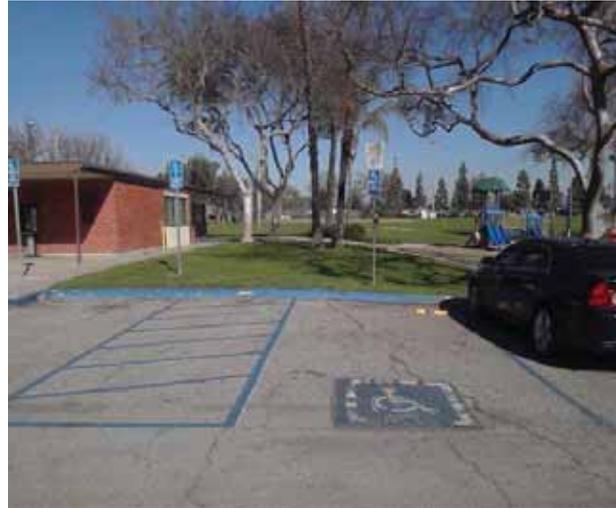
Recommendation Up to 2.08 percent

Repave surface to correct slope \$3,800 and re-stripe

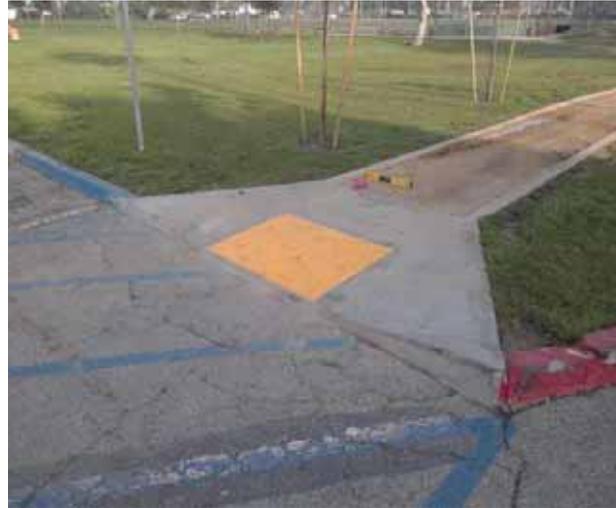
Recommendation Up to 2.08 percent

Notes : Top landing is decomposed granite.

Provide compliant landing \$1,260

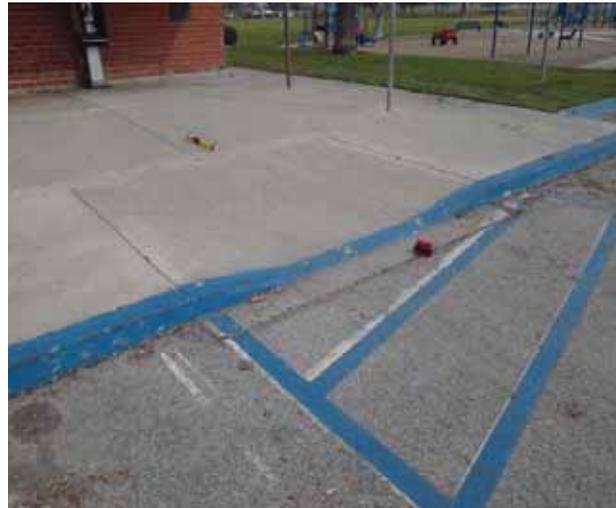
Recommendation Up to 2.08 percent

Provide compliant landing \$1,260

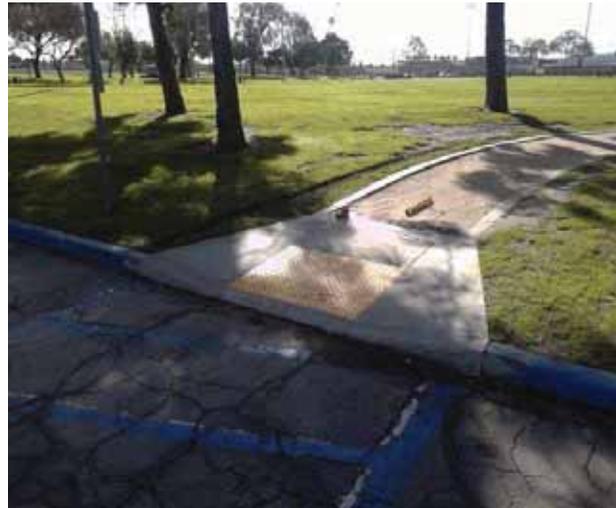
Recommendation Up to 2.08 percent

Provide compliant landing \$1,260

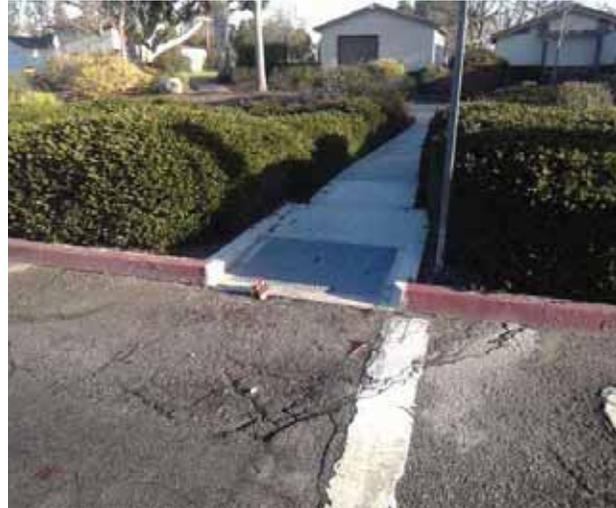
Recommendation Up to 0.50 inches

Patch lip at curb ramp \$255

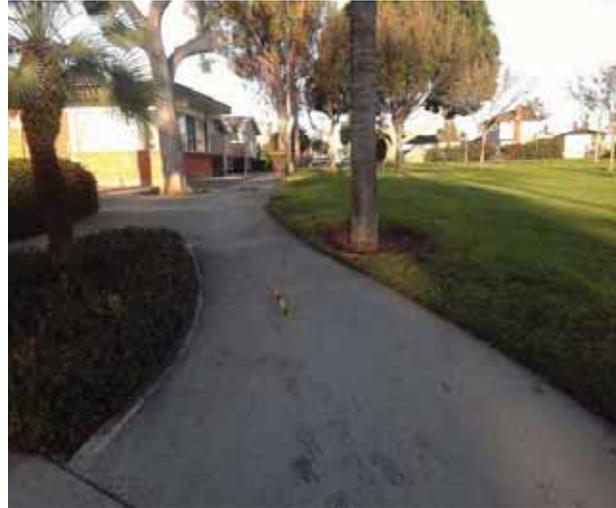
Recommendation Up to 5.00 percent

Install pathway \$3,600

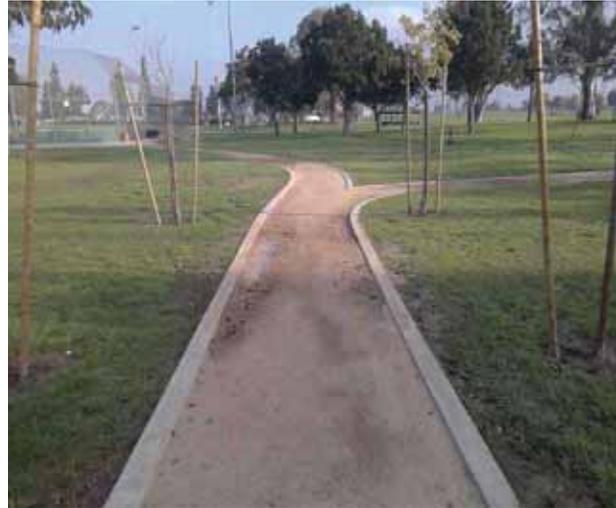
Recommendation Up to 2.08 percent

Notes : Surface accumulates water for 18 feet.

Install pathway \$3,600

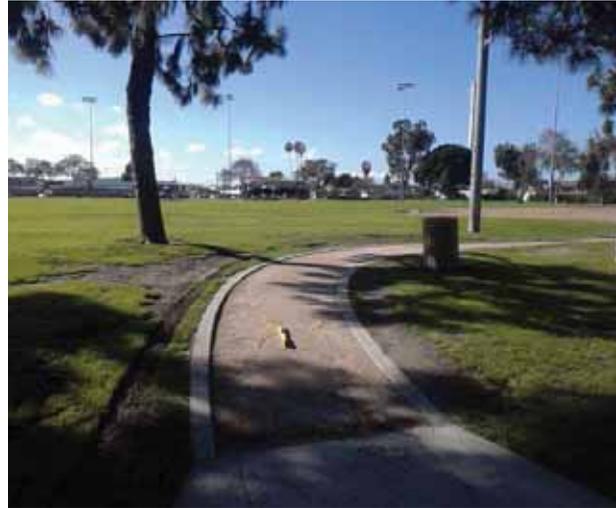
Recommendation Up to 5.00 percent

Install pathway \$3,600

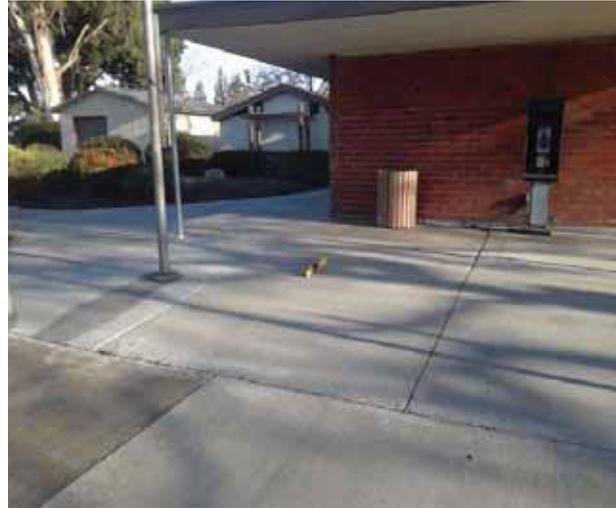
Recommendation Up to 5.00 percent

Install pathway \$3,600

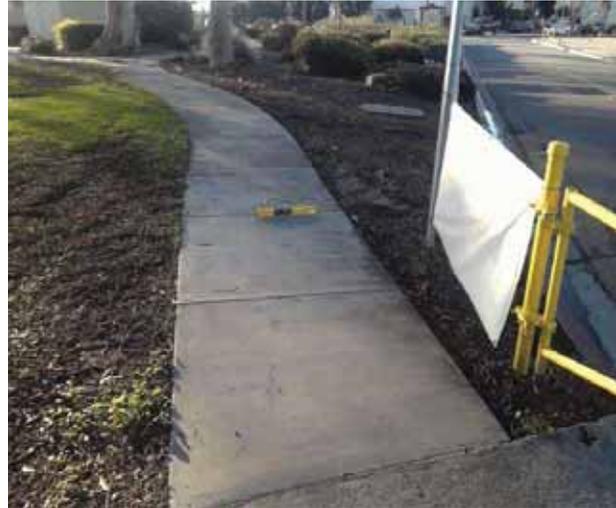
Recommendation Up to 2.08 percent

Install pathway \$3,600

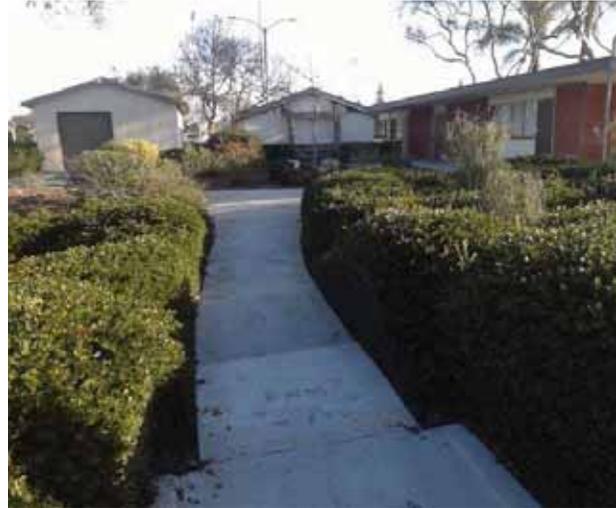
Recommendation Up to 2.08 percent

Install pathway \$3,600

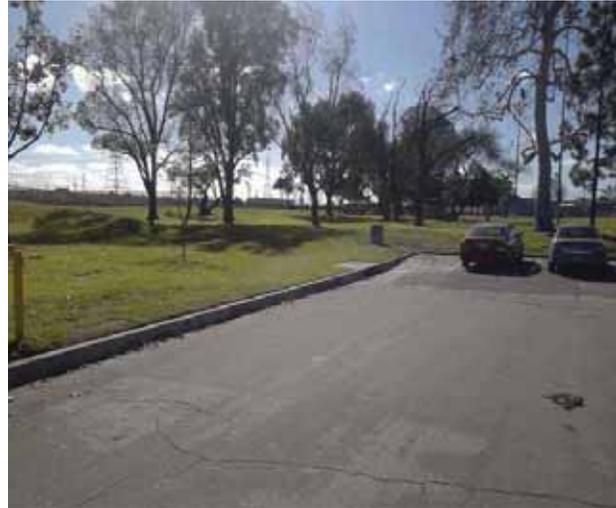
On-Site Finding None Found

Notes : There is no public sidewalk.

Install Pathway \$1,840

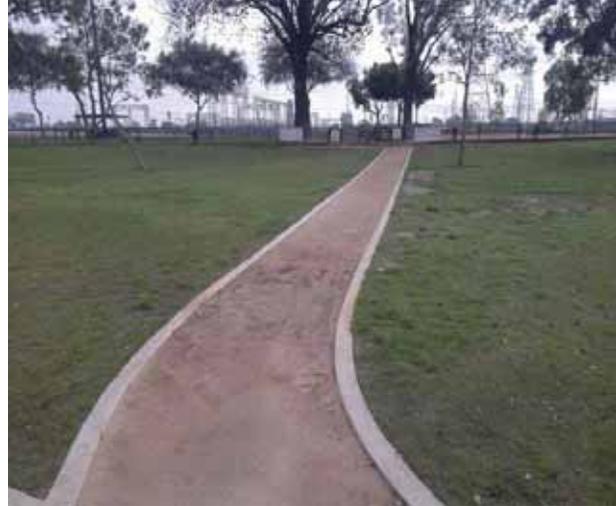
Recommendation Up to 5.00 percent

Notes : Surface accumulates water for 8 feet.

Install pathway \$3,600

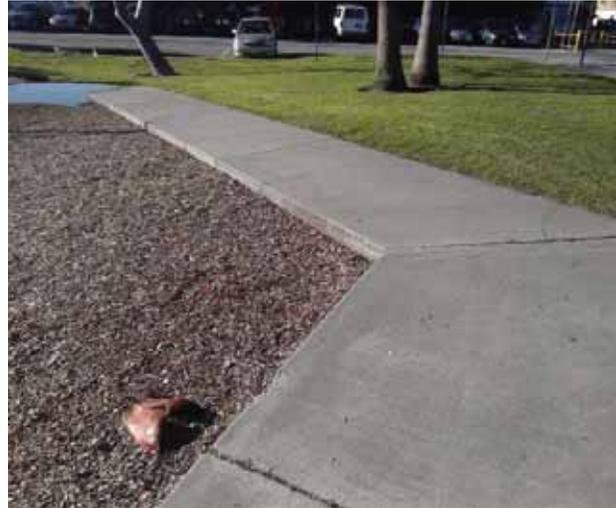
Path Of Travel , Drop Offs : Drop Off Hazard

\$1,088

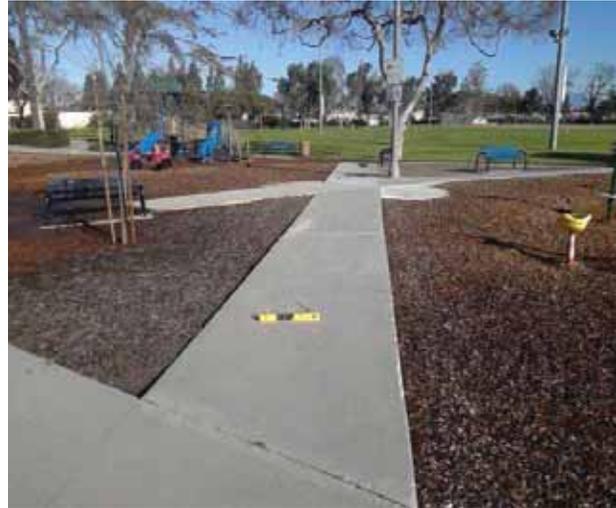
Recommendation Up to 5.00 percent

Install pathway \$3,600

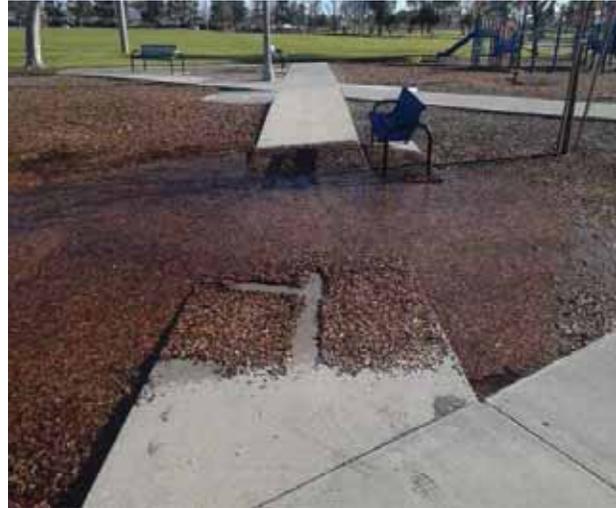
Recommendation Up to 5.00 percent

Notes : Surface accumulates water for 15 feet.

Install pathway \$3,600

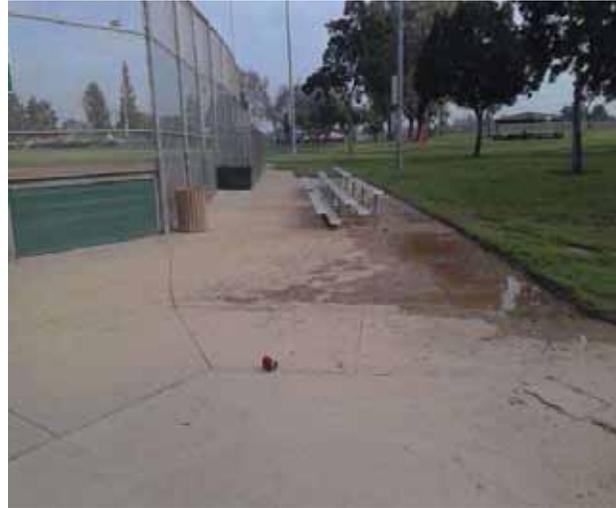
Recommendation Up to 2.08 percent

Notes : Surface accumulates water for 30 feet.

Install pathway \$3,600

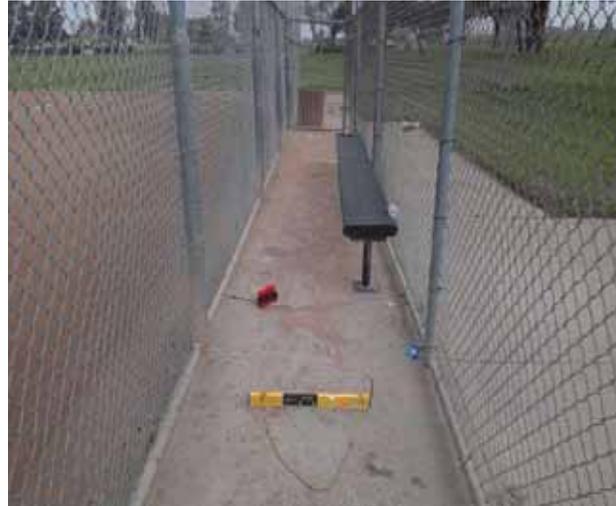
Recommendation Up to 2.08 percent

Install pathway \$3,600

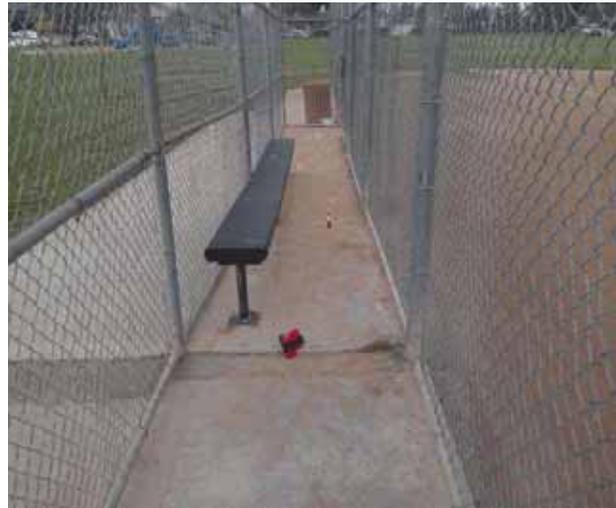
Recommendation Up to 5.00 percent

Install pathway \$3,600

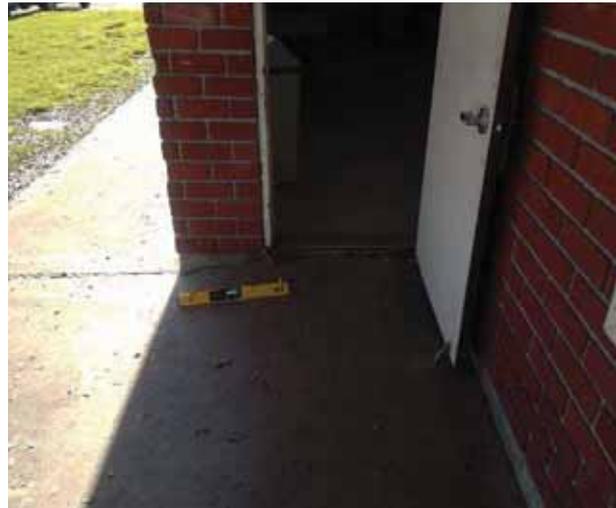
Recommendation Up to 2.08 percent

Correct slopes \$1,500

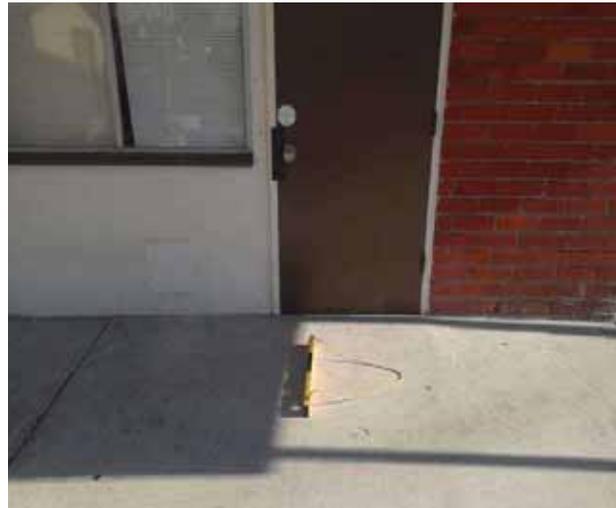
Recommendation Up to 2.08 percent

Correct slopes \$1,500
