Accessibility Survey

Rio San Gabriel Park

9612 Ardine Street
Downey, CA 90240

Date of Inspection
1/17/2017

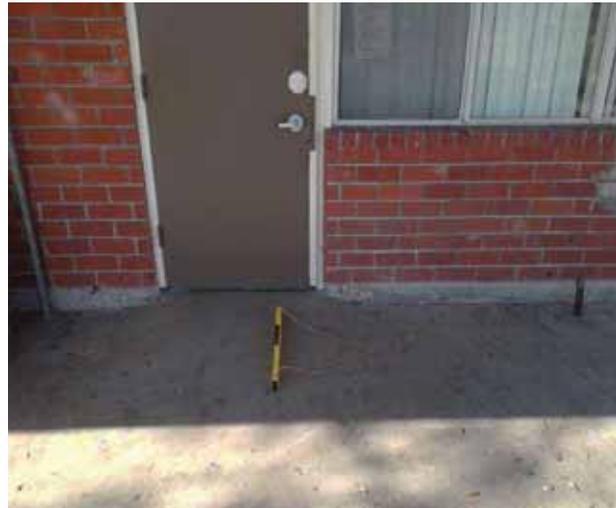
Recommendation Up to 2.08 percent

Correct slopes \$1,500

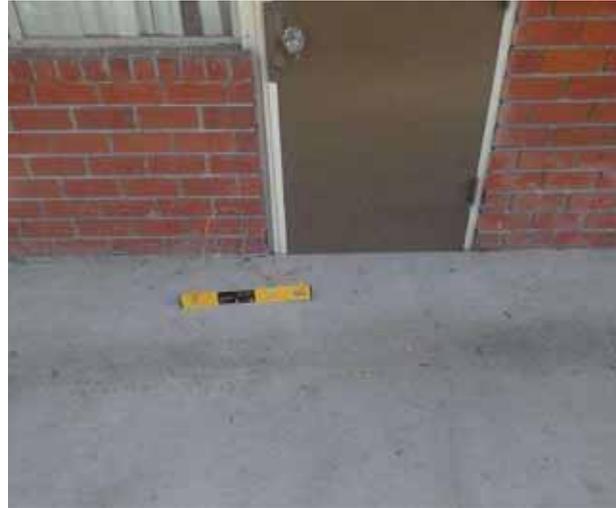
Recommendation Up to 2.08 percent

Correct slopes \$1,500

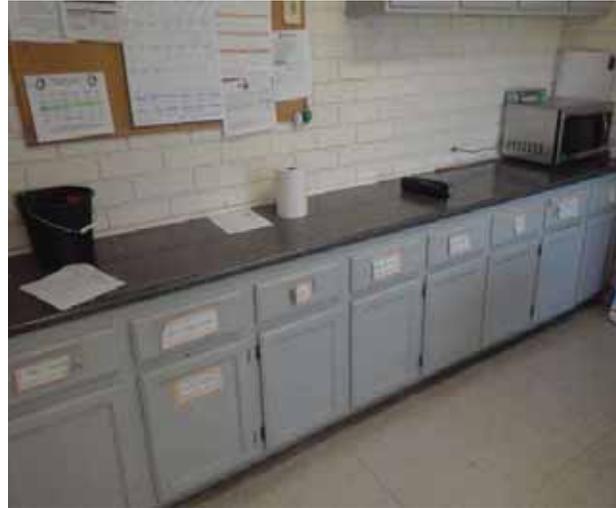
Recommendation 28.00 - 34.00 inches

Provide compliant counter \$3,500

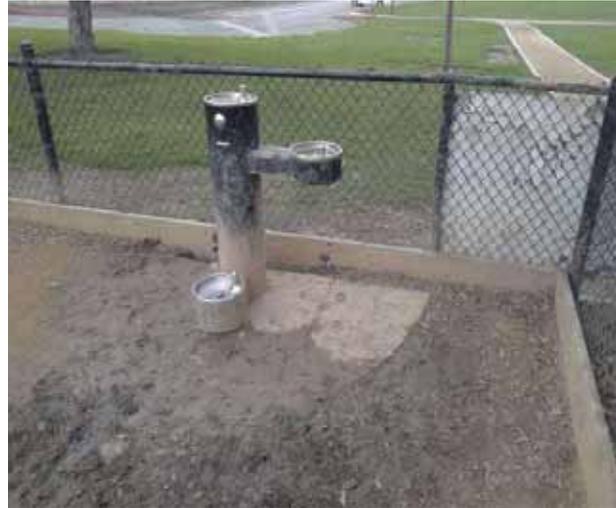
Recommendation At least 4.00 inches

Install new high/low fountain \$2,500

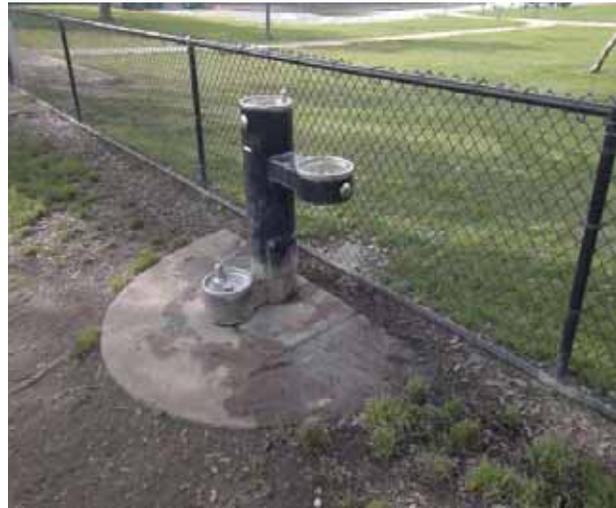
On-Site Finding None Found

\$1,840

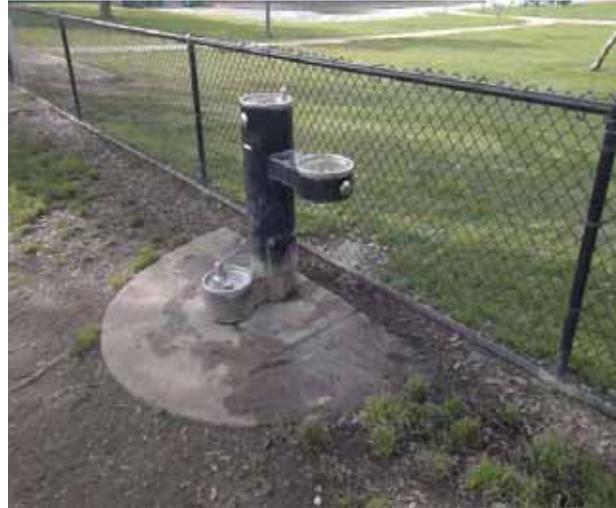
Recommendation At least 4.00 inches

Install new high/low fountain \$2,500

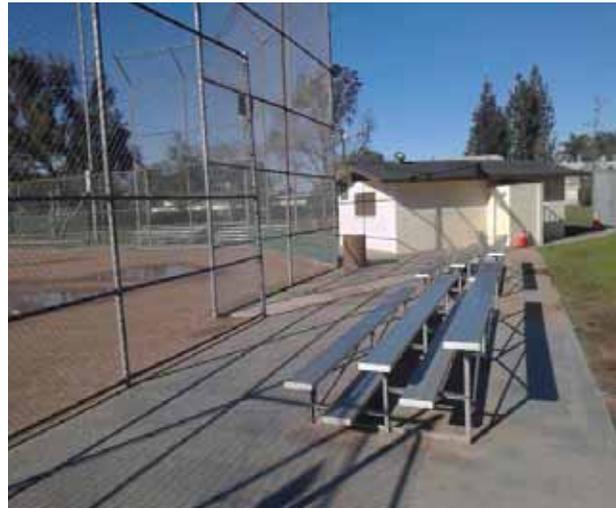
On-Site Finding None Found

Recommendation At least 4.00 seats

Requires re-design \$600

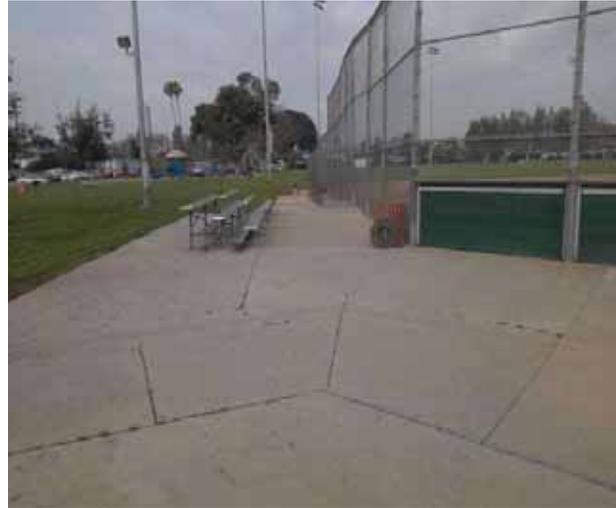
On-Site Finding None Found

Recommendation At least 4.00 seats

Requires re-design \$600

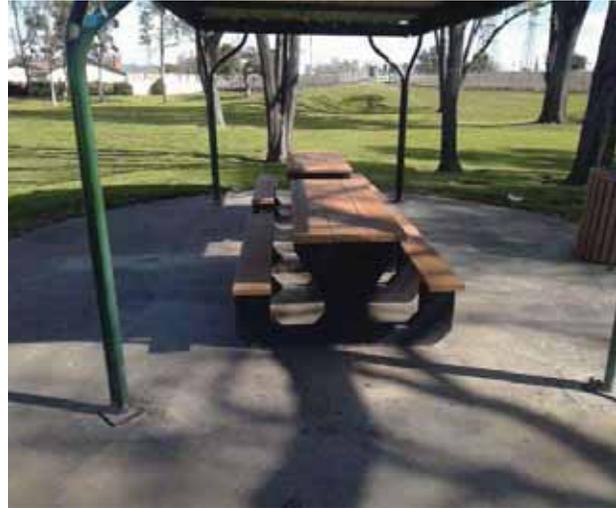
On-Site Finding None Found

Provide compliant route \$1,440

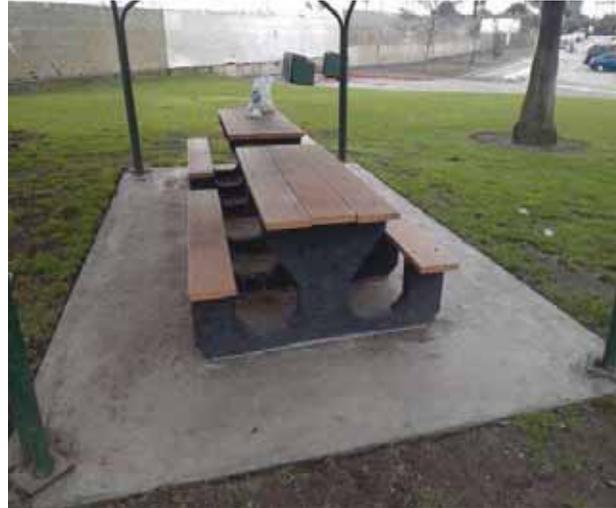
On-Site Finding None Found

Provide compliant route \$1,440

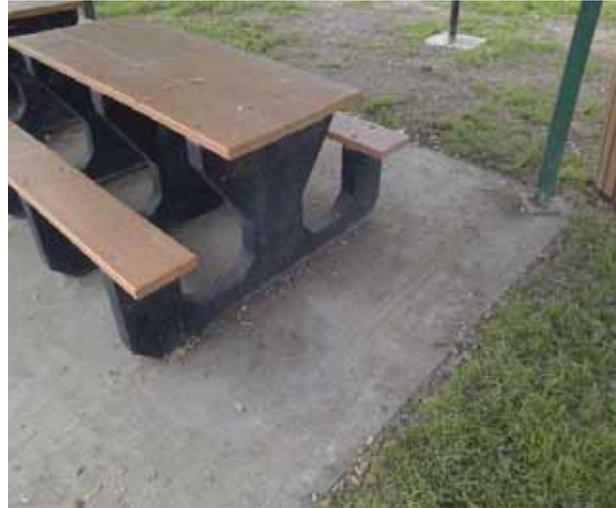
On-Site Finding None Found

Provide compliant route \$1,440

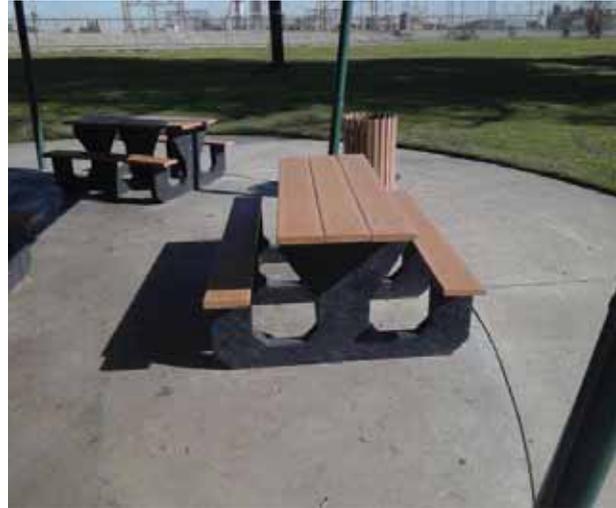
On-Site Finding None Found

Provide compliant route \$1,440

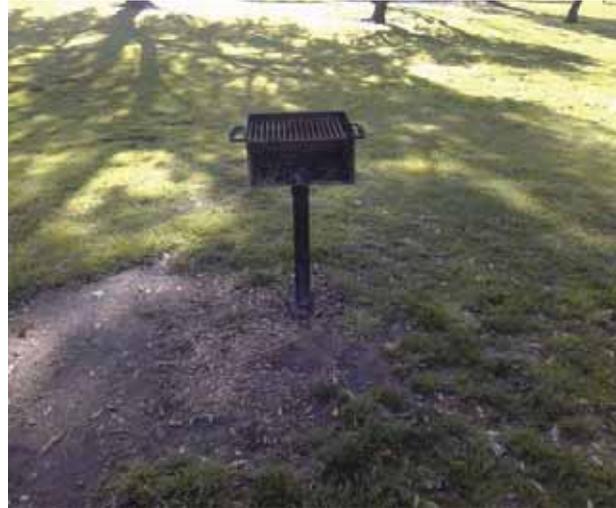
Notes : Landing is grass/dirt.

\$1,260

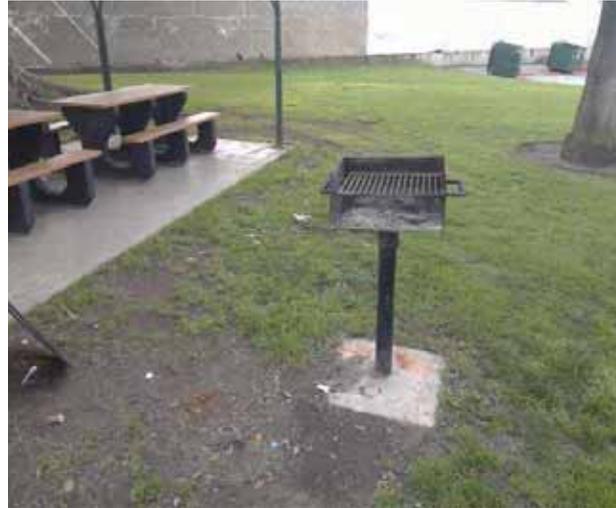
Notes : Landing is grass/dirt.

\$1,260

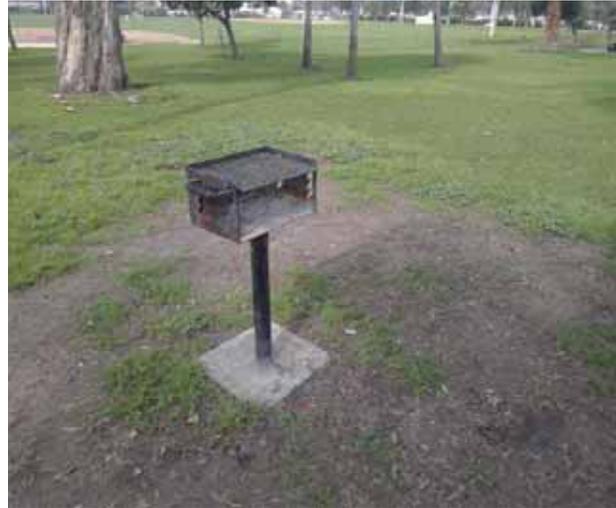
Notes : Landing is grass/dirt.

\$1,260

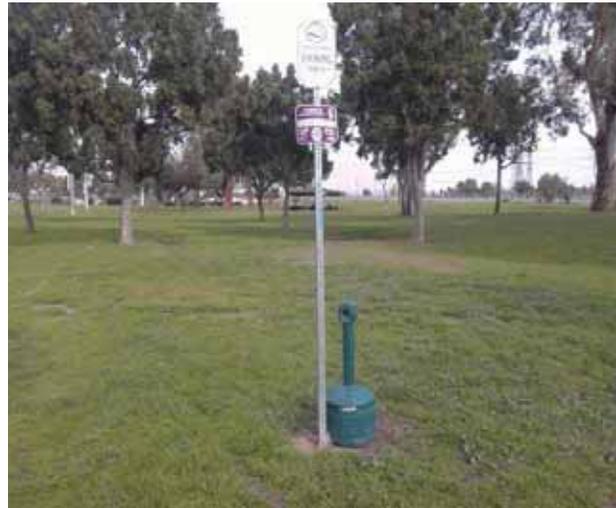
Notes : Landing is grass/dirt.

\$1,260

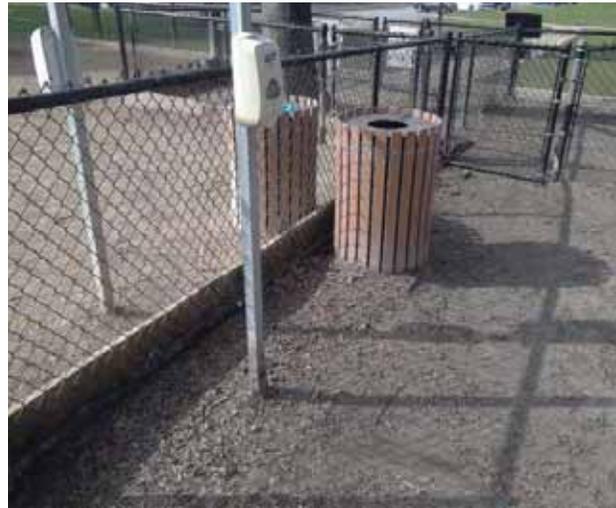
Notes : Landing is grass/dirt.

Recommendation Up to 2.08 percent

Redesign space \$2,200

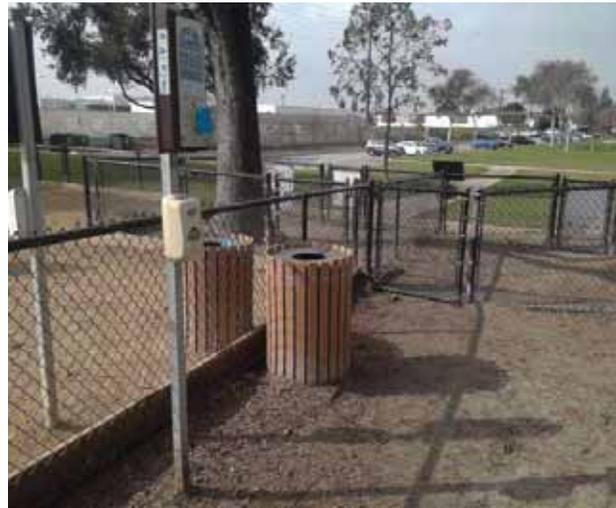
Notes : Landing is grass/dirt.

\$1,260

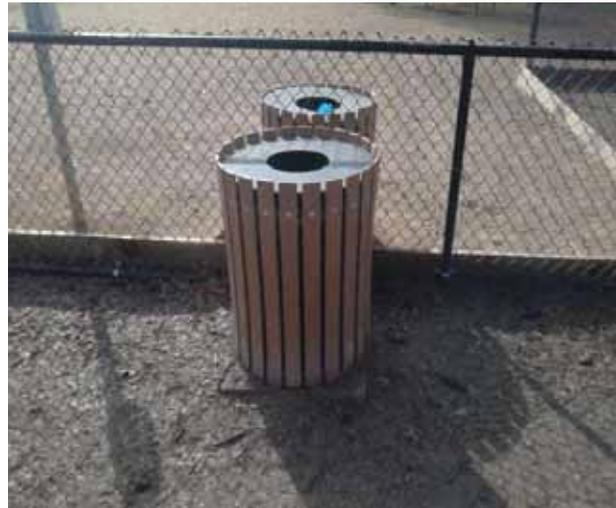
Notes : Landing is grass/dirt.

Recommendation Up to 2.08 percent

Redesign space \$2,200

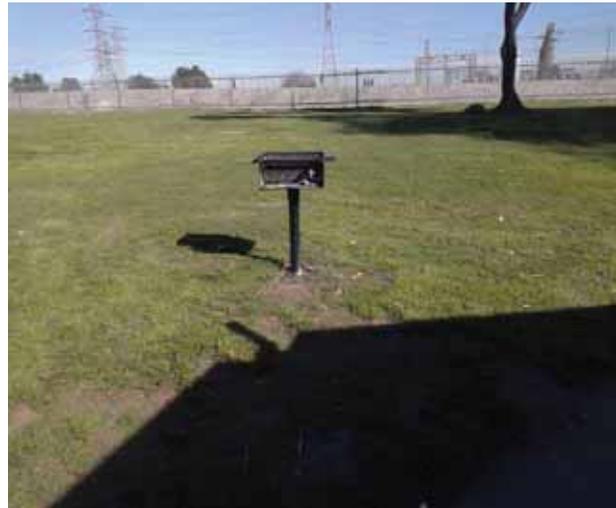
Notes : Landing is grass/dirt.

\$1,260

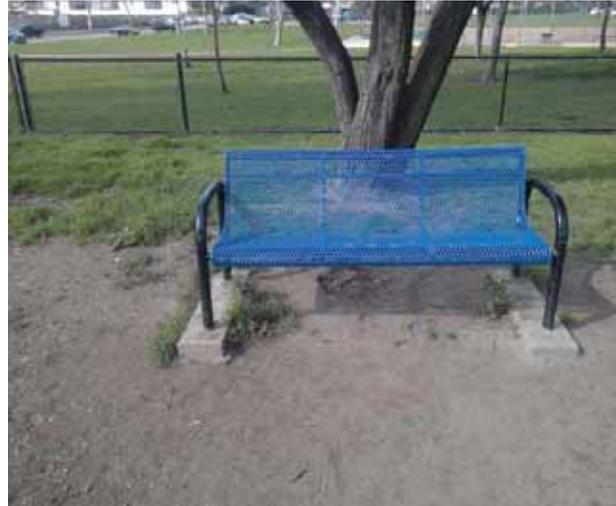
Notes : Landing is grass/dirt.

Provide compliant route \$1,840

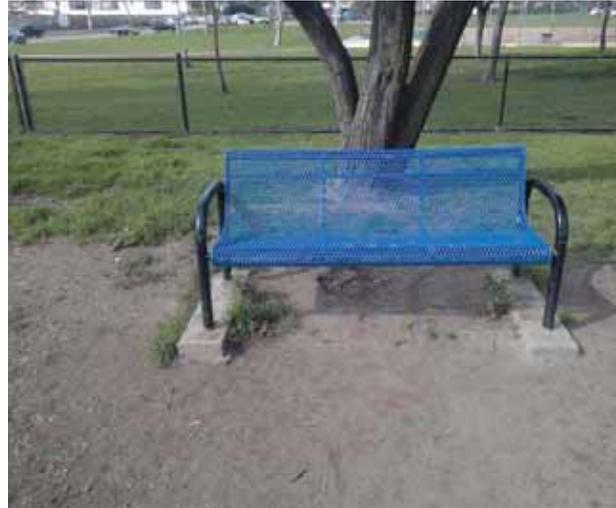
On-Site Finding Not Found

Notes : Landing is grass/dirt.

\$1,840

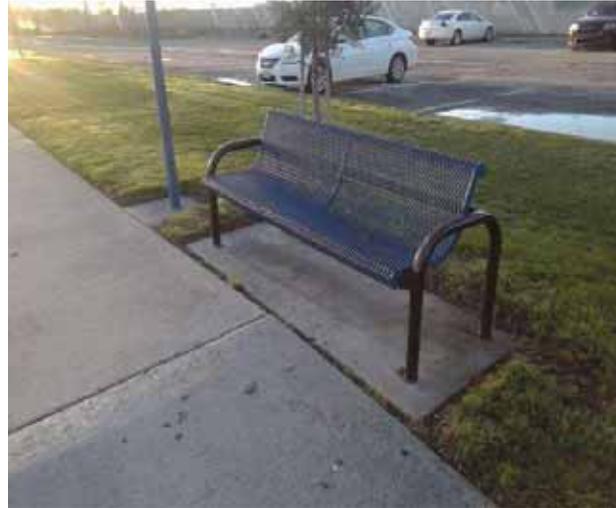
On-Site Finding Not Found

\$1,840

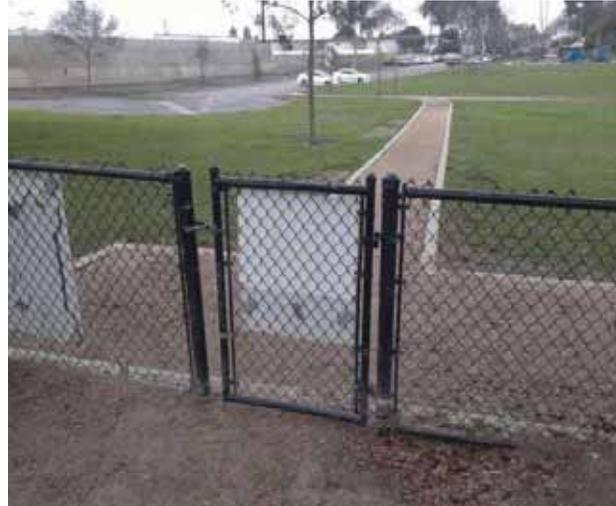
Notes : Landing is dirt.

Provide the recommended clear floor space on the push side of the door.

Recommendation At least 48.00 inches

Install automatic door opener \$4,000

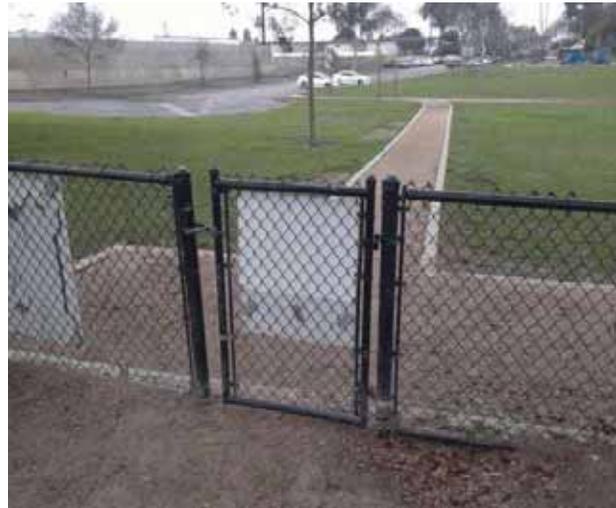
Notes : Landing is dirt.

Provide the recommended clear floor space on the push side of the door.

Recommendation At least 36.00 inches

Install automatic door opener \$4,000

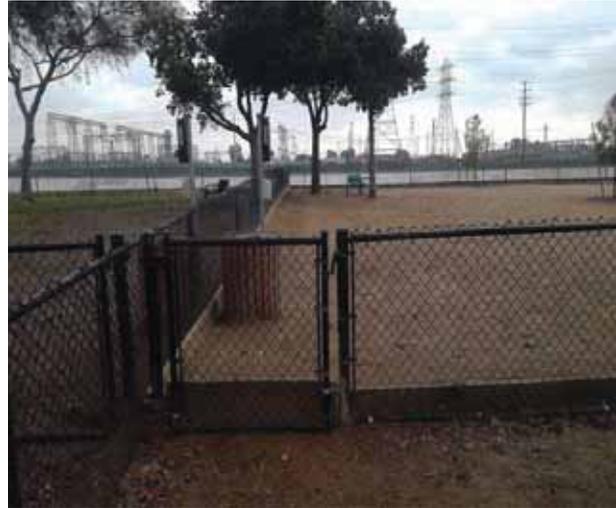
Notes : Landing is dirt.

Recommendation At least 24.00 inches

Install automatic door opener \$2,921

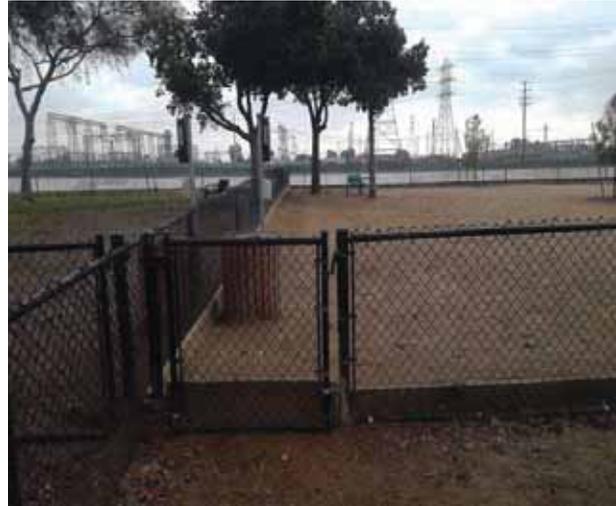
Notes : Landing is dirt.

Provide the recommended clear floor space on the pull side of the door.

Recommendation At least 60.00 inches

Install automatic door opener \$2,921

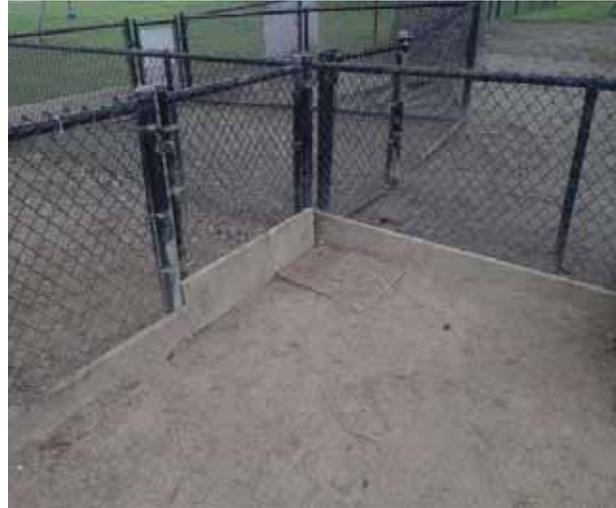
Notes : Landing is dirt.

Provide the recommended clear floor space on the push side of the door.

Recommendation At least 48.00 inches

Install automatic door opener \$4,000

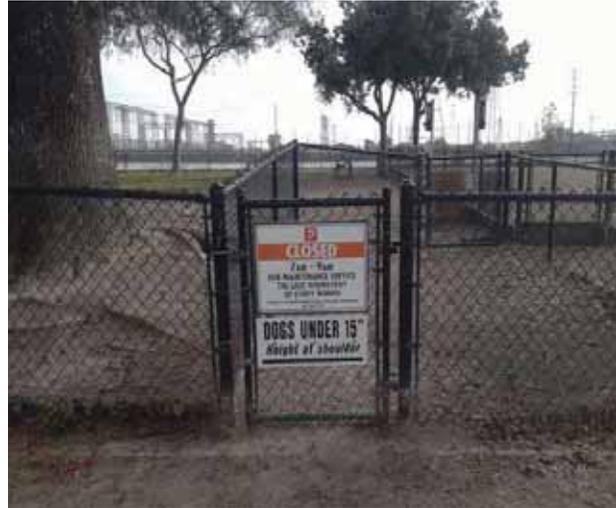
Notes : Landing is dirt.

Recommendation At least 24.00 inches

Install automatic door opener \$2,921

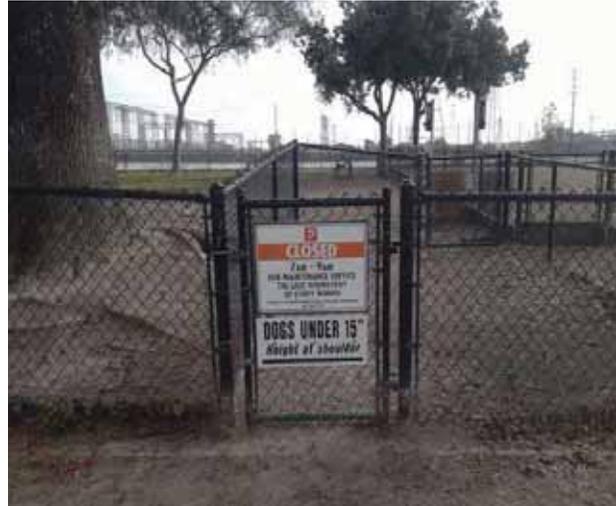
Notes : Landing is dirt.

Provide the recommended clear floor space on the pull side of the door.

Recommendation At least 60.00 inches

Install automatic door opener \$2,921

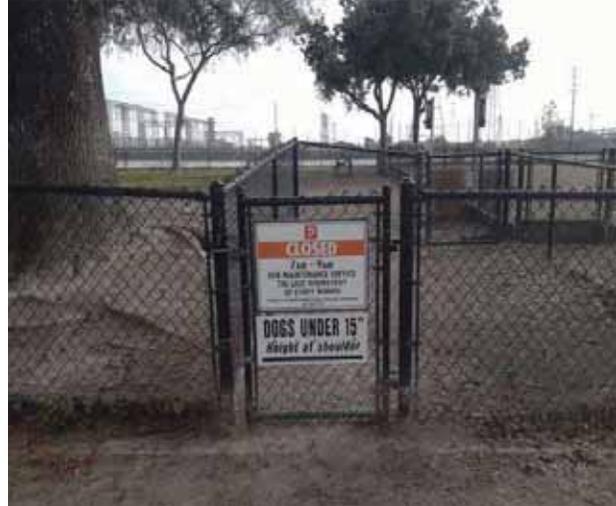
Notes : Landing is dirt.

Provide the recommended clear floor space on the pull side of the door.

Recommendation At least 30.00 inches

Install automatic door opener \$2,921

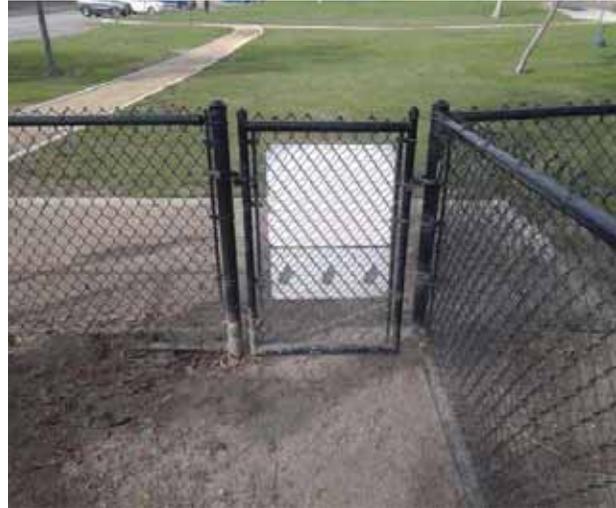
Notes : Landing is dirt/grass/gravel.

Provide the recommended clear floor space on the push side of the door.

Recommendation At least 48.00 inches

Install automatic door opener \$4,000

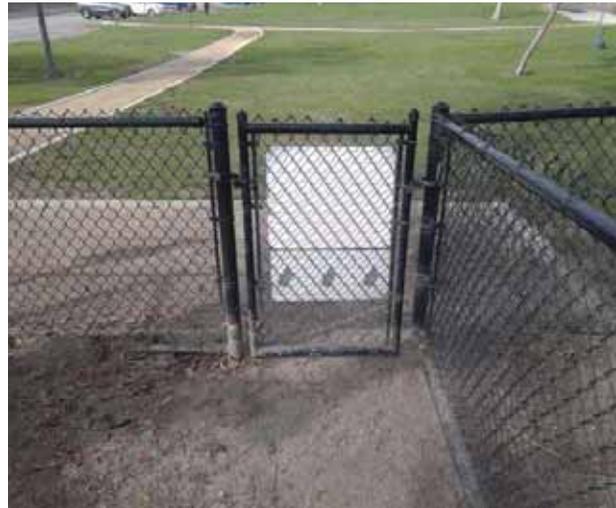
Notes : Landing is dirt/grass/gravel.

Provide the recommended clear floor space on the push side of the door.

Recommendation At least 36.00 inches

Install automatic door opener \$4,000

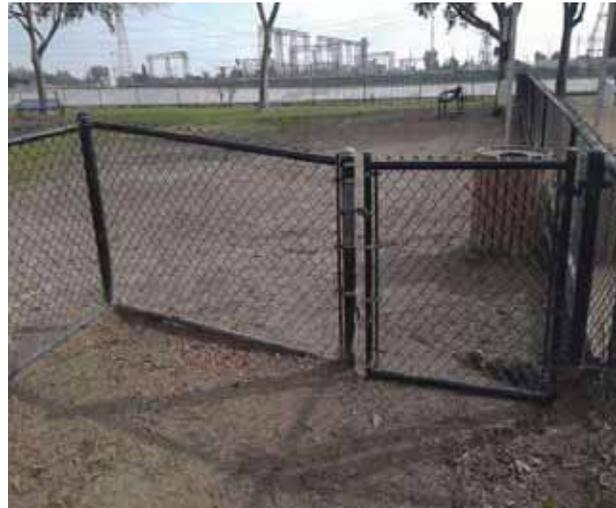
Notes : Landing is dirt.

Recommendation At least 24.00 inches

Install automatic door opener \$2,921

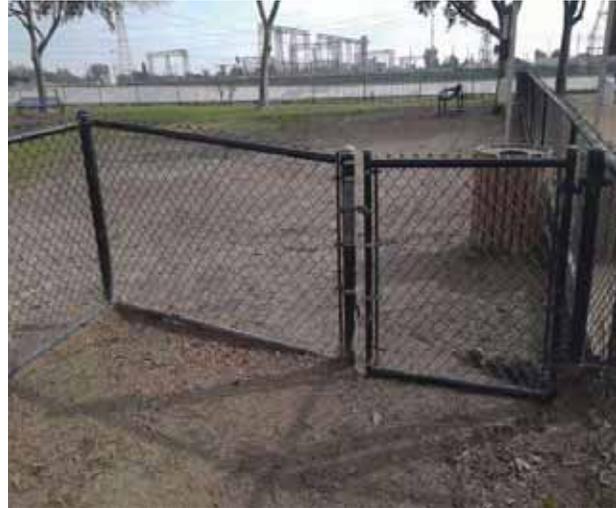
Notes : Landing is dirt.

Provide the recommended clear floor space on the pull side of the door.

Recommendation At least 60.00 inches

Install automatic door opener \$2,921

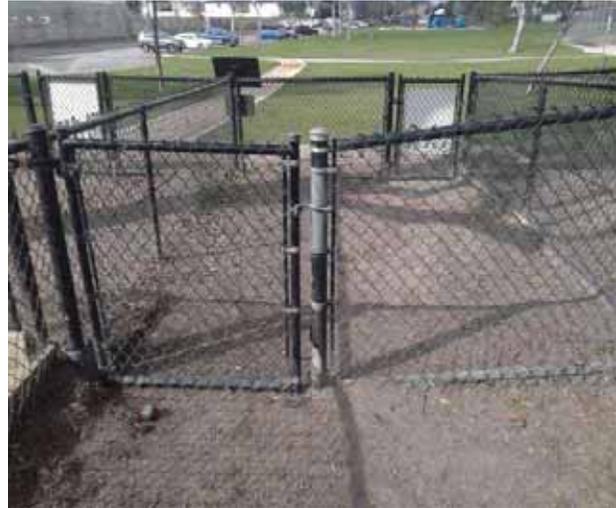
Notes : Landing is dirt.

Provide the recommended clear floor space on the push side of the door.

Recommendation At least 48.00 inches

Install automatic door opener \$4,000

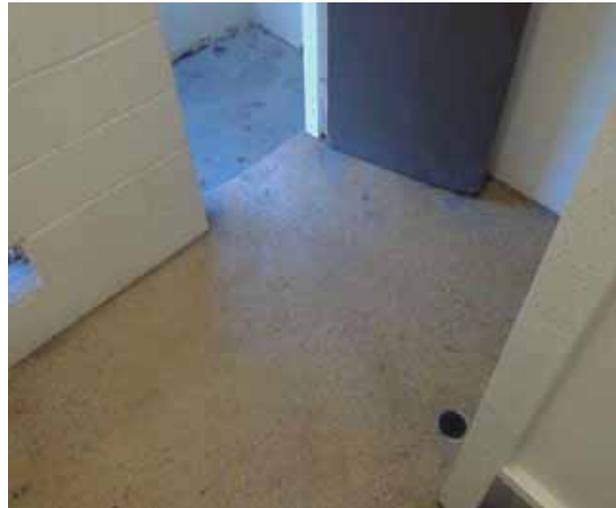
Notes : Urinal shield obstructs clear floor space length.

Provide the recommended clear floor space on the pull side of the door.

Recommendation At least 60.00 inches

Install automatic door opener \$2,921

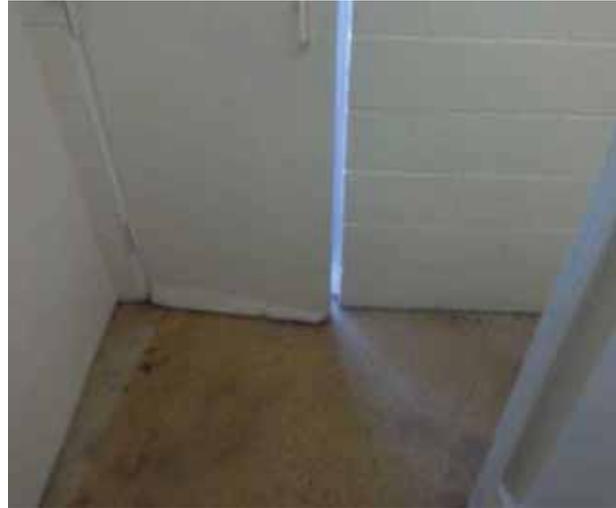
Notes : Toilet comparrment wall obstructs clear floor space length.

Provide the recommended clear floor space on the pull side of the door.

Recommendation At least 60.00 inches

Install automatic door opener \$2,921

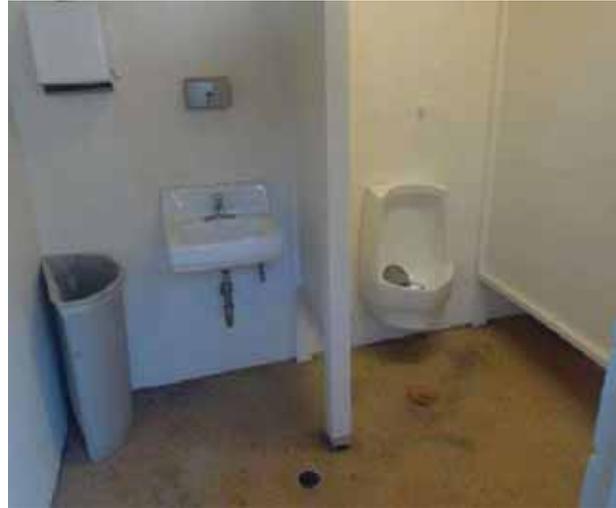
Notes : Urinal shield obstructs turning space diameter.

Recommendation At least 60.00 inches

Install single-use toilet room \$14,000

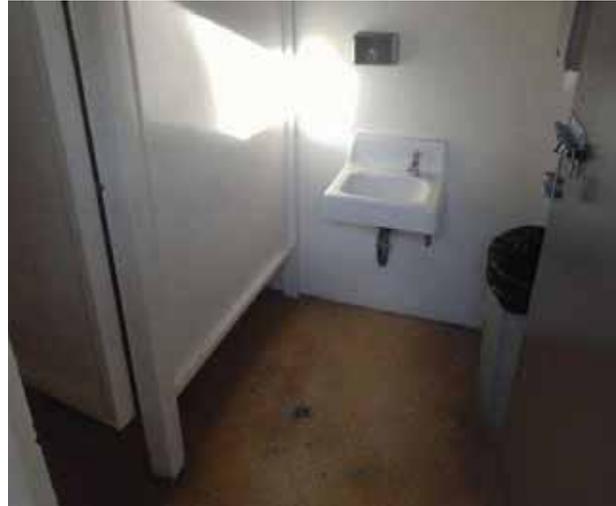
Notes : Compartment wall obstructs turning space diameter.

Recommendation At least 60.00 inches

Install single-use toilet room \$14,000
